**Subject: Follow-Up Spill Report – Spill of Greywater under Kitchen - Gahcho Kué Mine – March 28, 2018 (GNWT Spill # 2018-107)**

**Incident Summary:**

## **Root Cause Analysis:**

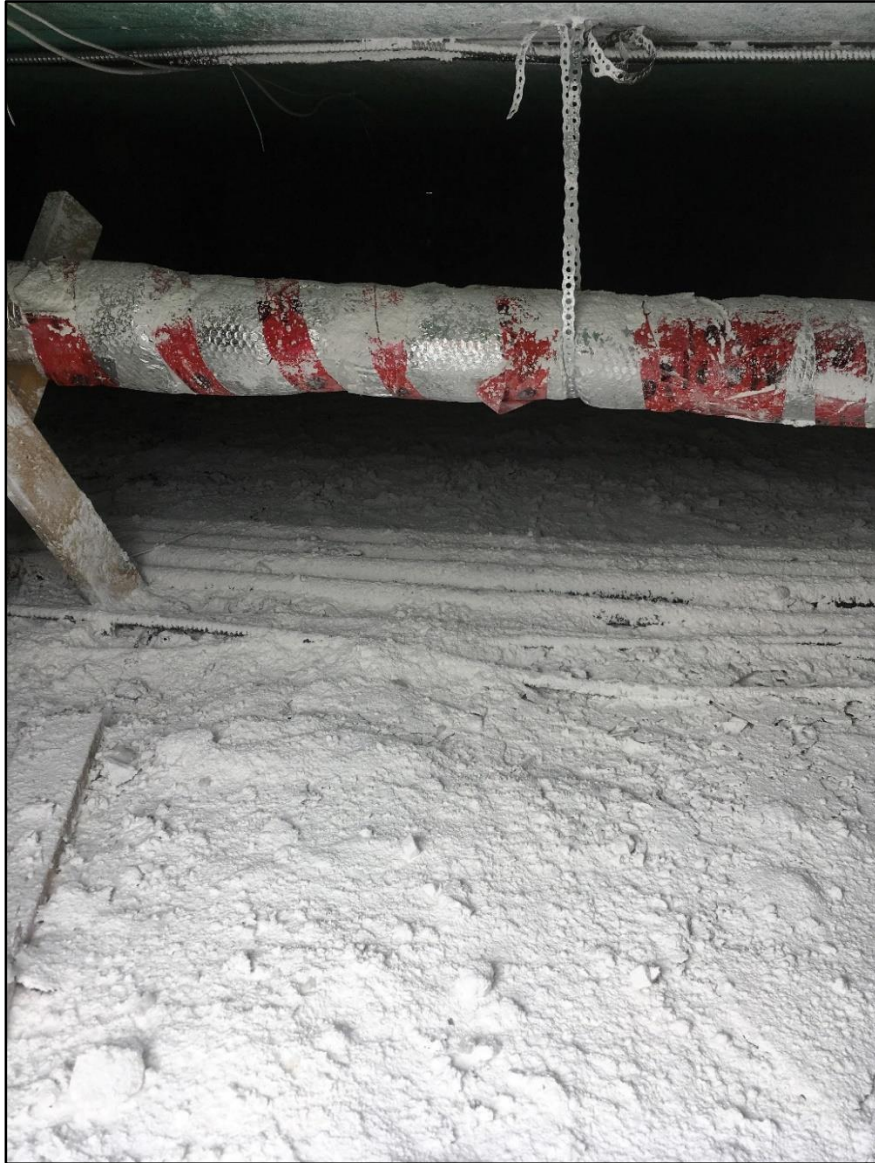
The results of an internal De Beers investigation determined that the cause of the spill was improper fastening of two metal pipe hangers to insecure material (oriented strand board), which failed to support the weight and caused a section of the pipe to drop to the ground and break.

Photo showing the replaced pipe after corrective actions were completed. The metal pipe hanger has been re-secured to wood instead of OSB material. As visible on the ground, Lime was applied to mitigate odours and prevent microbial growth.

1. Lime was spread over the affected area to limit microbial growth and eliminate odours in order to reduce the potential to attract wildlife. This action was completed on March 29;
2. The damaged section of pipe, along with the failed pipe hangers, were replaced, and the pipe was re-suspended off the ground, with the hangers attached to secure wood floor joist. This action was completed on March 28;
3. Additional blocking was installed to provide additional support beneath the suspended pipe. This action was completed on March 28.

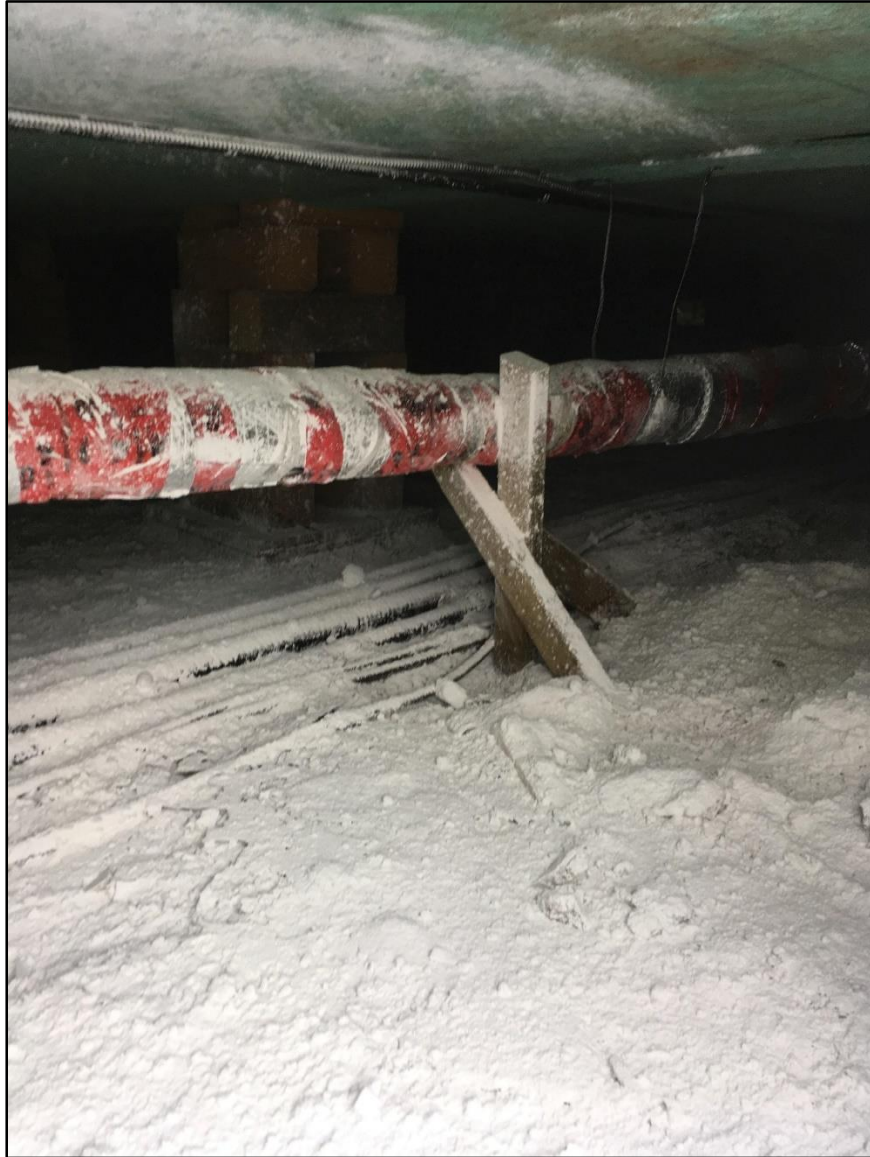
Photo showing the replaced pipe after corrective actions were completed. Blocking was added as extra support beneath the metal hanger supported sections of the pipe.
