**Re: Land Use Permit MV2012C0009
Mineral Exploration
Lac de Gras Area, NT**

ENVIRONMENTAL INSPECTION REPORT

Location(s) Inspected:	HW Camp.
------------------------	----------

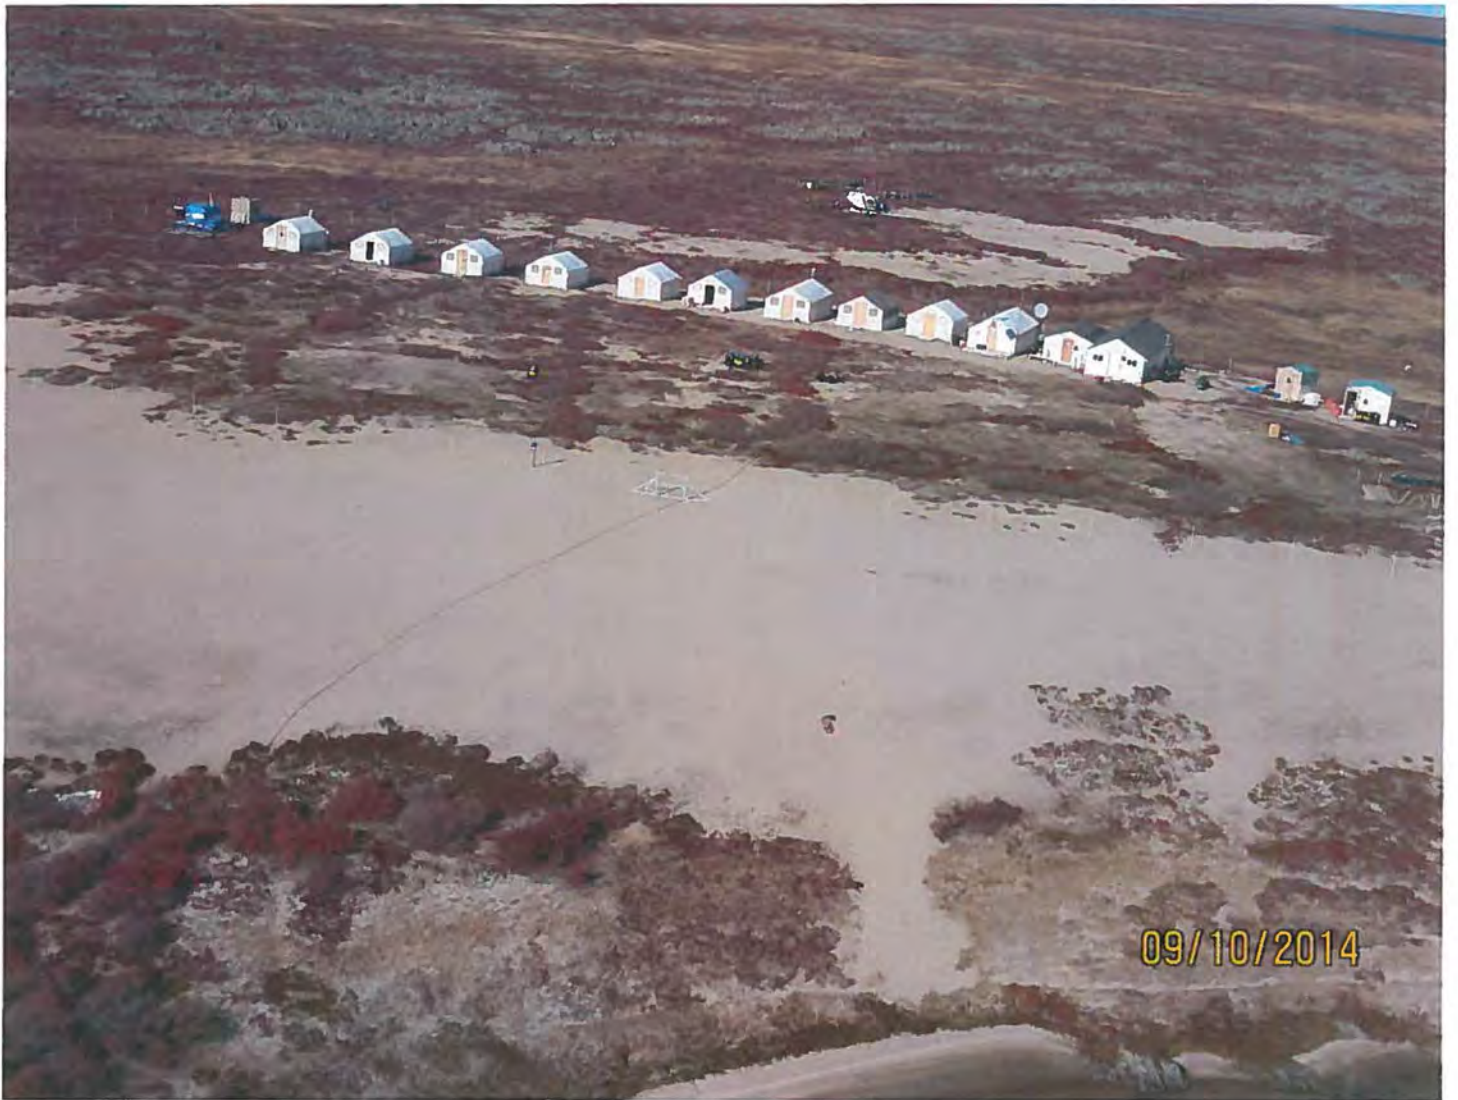
An inspection of the HW Camp (Photo #1) was conducted by Inspectors Clint Ambrose and Joe Heron on September 10th, 2014. The inspection was conducted to ensure that all operating conditions annexed to the above noted land use permit are being adhered to during this operation. All findings of the inspection were discussed with onsite personnel throughout the inspection.

Photo #1 - MV2012C0009 - DDEC Mineral Exploration - Lac de Gras Area, NT
An aerial view of an active HW Camp on the southern shore of Lac de Gras.

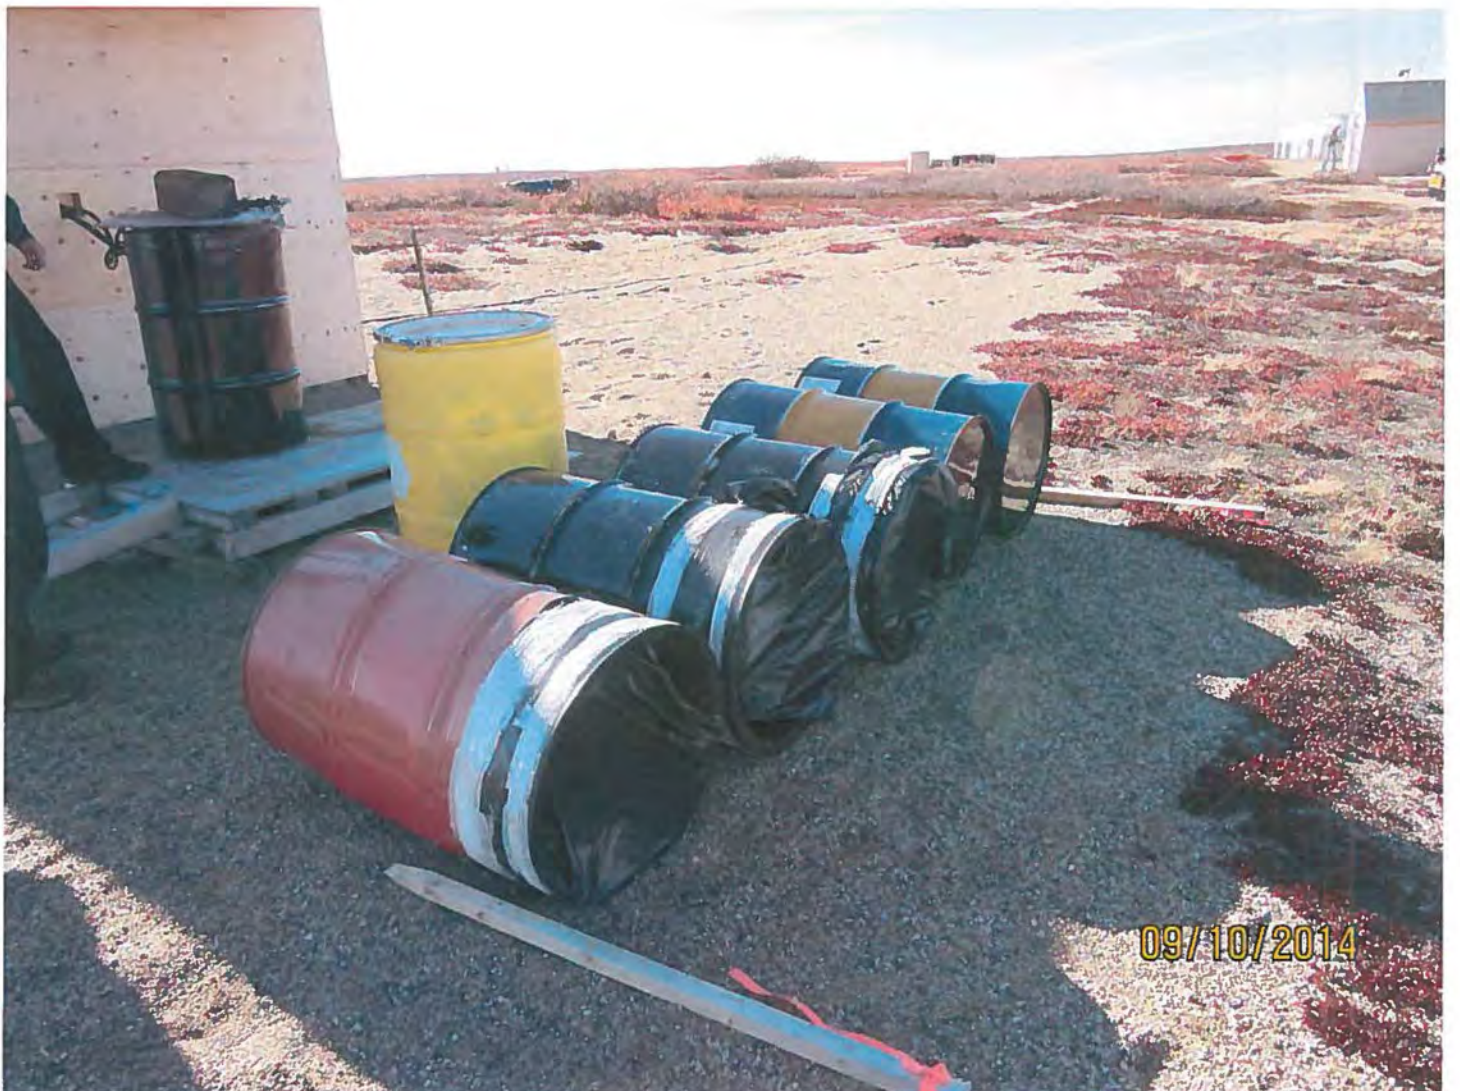
No major concerns were noted at the camp since all aspects of camp operations, waste handling and disposal, waste water disposal, and overall organization appeared satisfactory with one exception. Three drums of properly containerized incinerator ash noted in the previous inspection were still present (Photo #2) on site. Camp personnel informed Inspectors that the ash will be backhauled off site and disposed of once the airborne survey is completed for the season.

Photo #2 - MV2012C0009 - DDEC Mineral Exploration - Lac de Gras Area, NT
Properly sealed drums of ash waiting for shipment off site.

The camp continues to be well managed and the only concern noted was the requirement for the Permittee to ship the ash barrels off site for proper disposal. Your copy of the environmental inspection report is enclosed and should be self-explanatory.

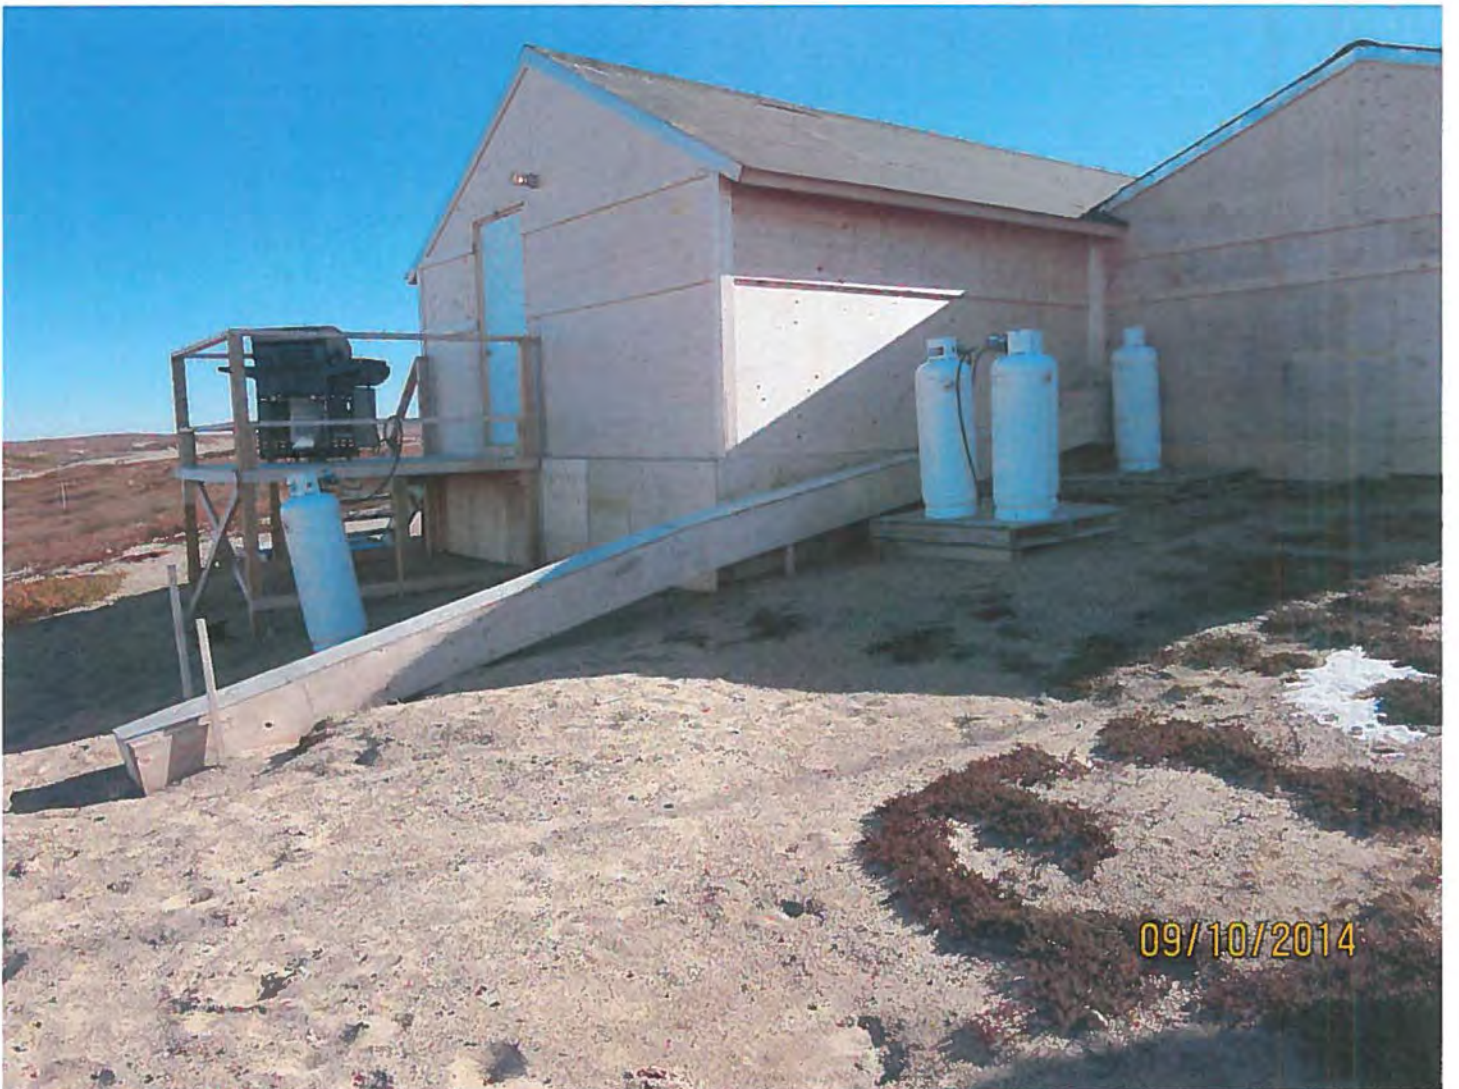
Inspectors were pleased to see proper living quarter diesel fuel drums wrapped with hydrocarbon absorbent matting and with secondary containment present (Photo #3). Also noted the kitchen grey water sump was well maintained (Photo #4). Full fuel drums were laid out in a tidy manner, with well-maintained walkways in between for ease of inspection (Photo #5). Bungs were mainly placed at the 3 o'clock and 9 o'clock positions to help mitigate possible fuel leaks. Empty 45-gallon drums were properly stored together, empty and ready for shipment off site (Photo #6).

Photo #4 - MV2012C0009 - DDEC Mineral Exploration - Lac de Gras Area, NT
Well maintained, covered grey water line and sump from camp kitchen.

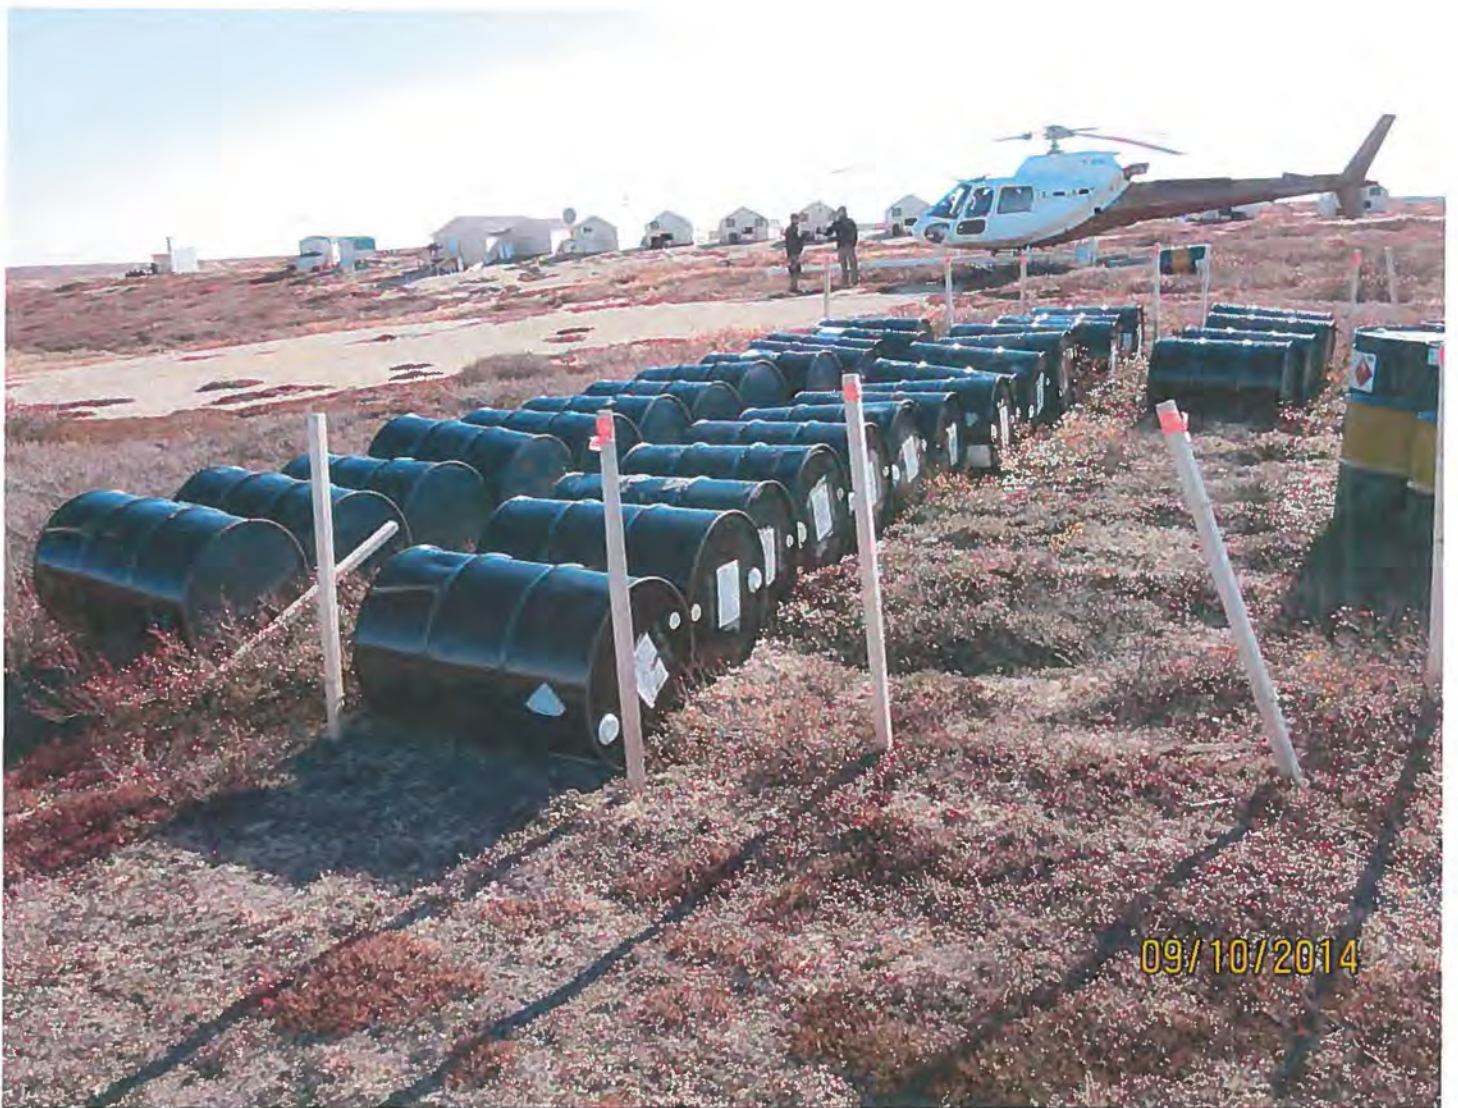
Photo #5 - MV2012C0009 - DDEC Mineral Exploration - Lac de Gras Area, NT
Organized 45-gallon fuel drum laydown at the helicopter landing pad.

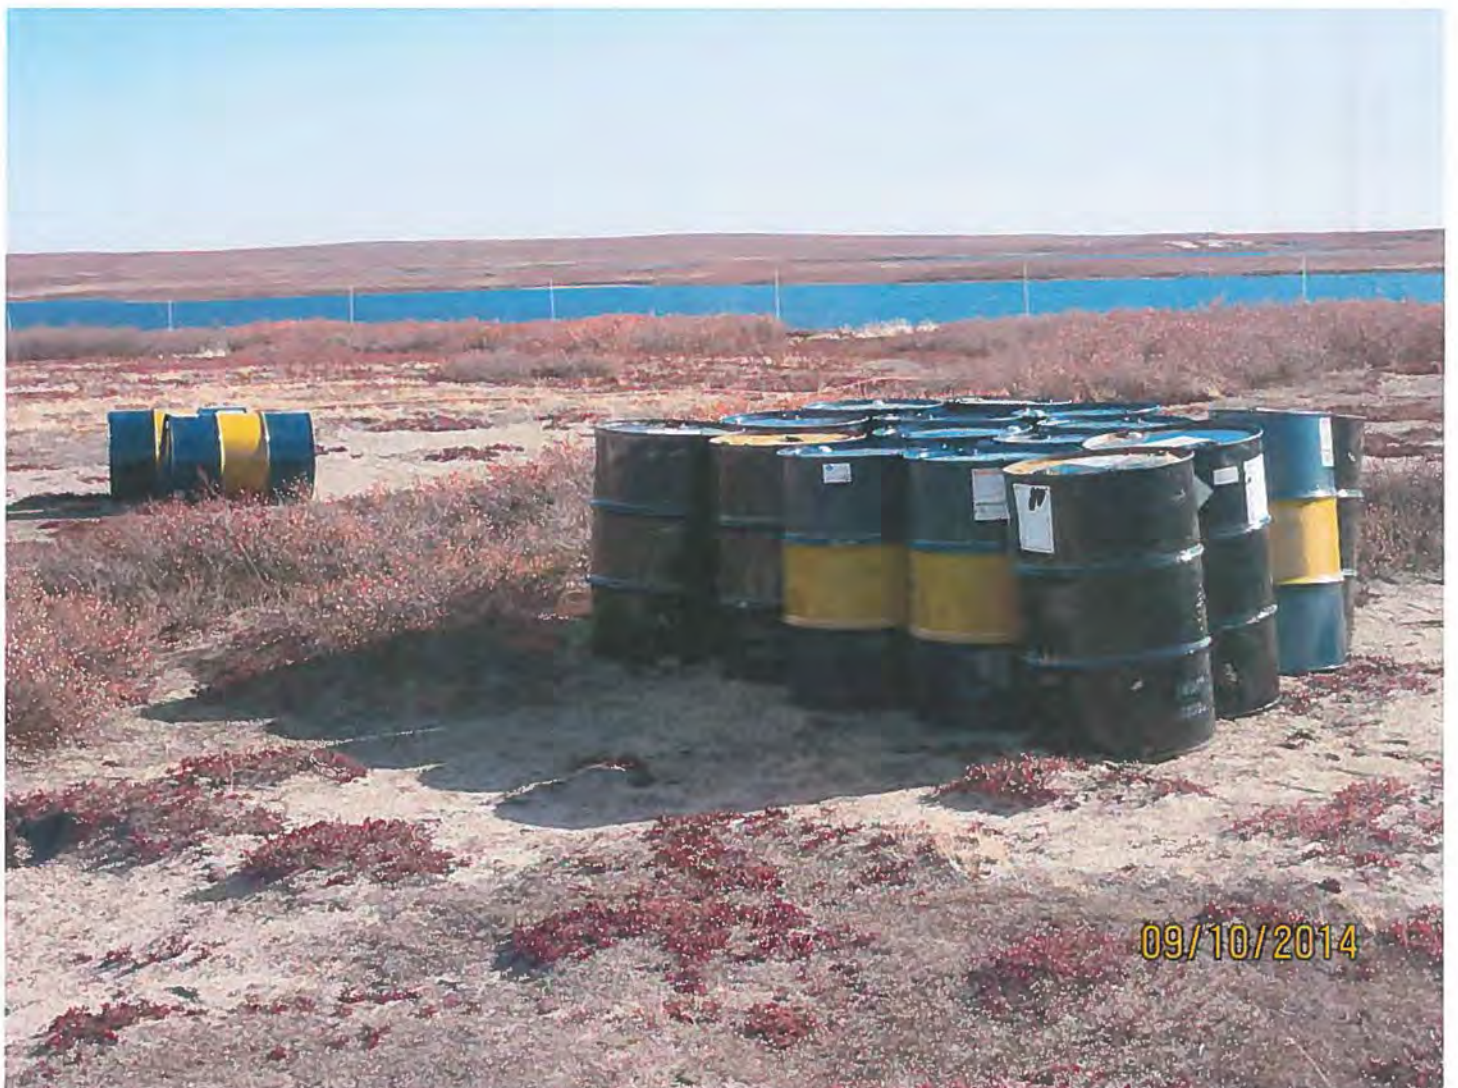
Photo #6 - MV2012C0009 - DDEC Mineral Exploration - Lac de Gras Area, NT
Empty 45-gallon drums awaiting shipment off site.
