Information Package to Working Group on 2015 Tarping of Roaster Complex Waste

ROASTER COMPLEX DECONSTRUCTION WASTE MANAGEMENT PLAN

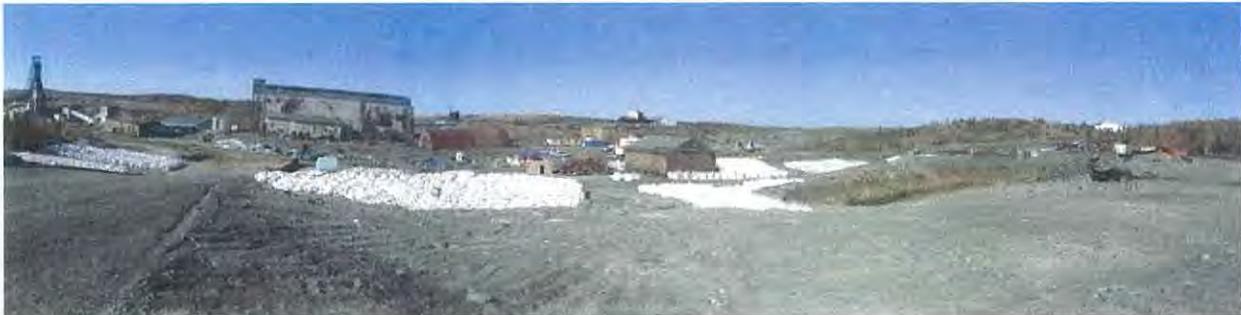
Figure 10 – Temporary Waste Laydown Area (facing northwest)

Based on this assessment the preferred option is to store the non-hazardous waste in the Temporary Waste Laydown area for the Roaster Deconstruction Program. An insert to the WMP has been prepared and is attached as Appendix 1. The insert is intended to be a standalone section in the WMP and will become section 2.4.7.3 once any input has been addressed.

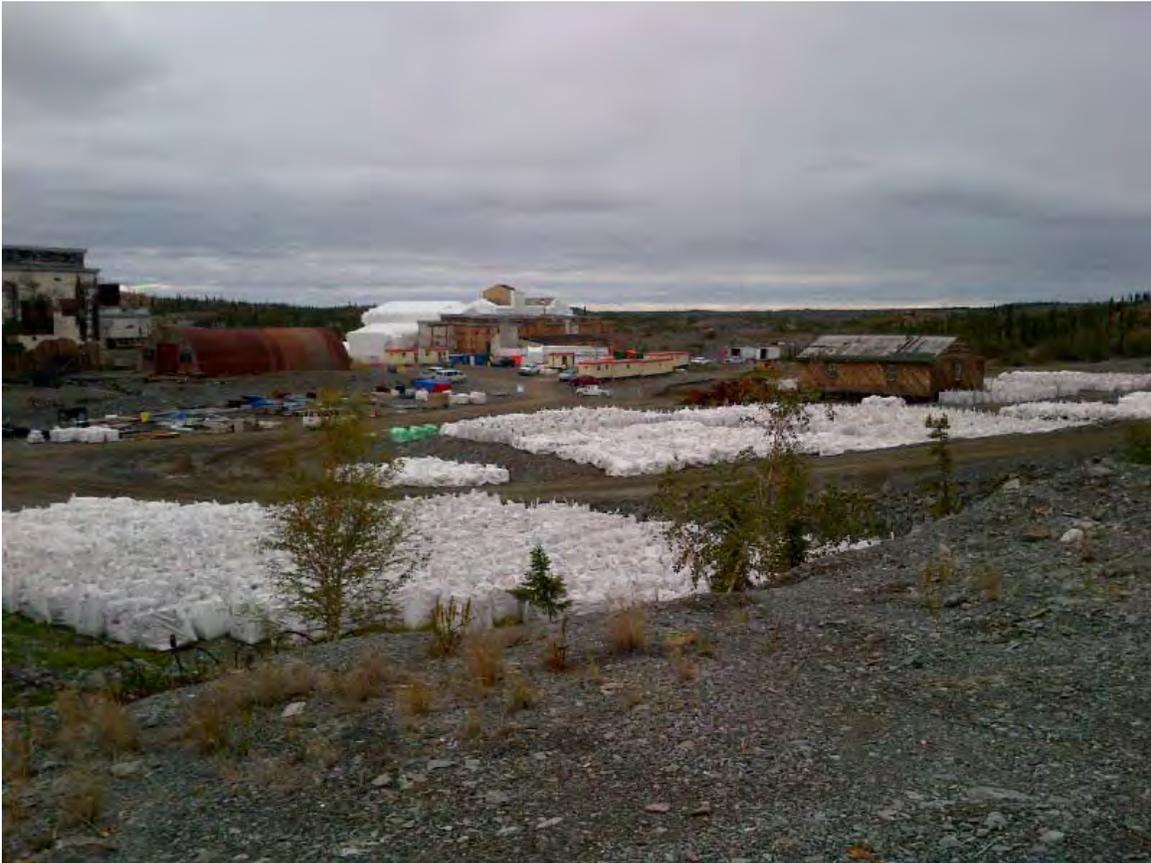
Figure 10 – Temporary Waste Transport Staging Area (looking NW)

Non-hazardous materials will be sorted and stored in the Temporary Waste Transport Staging Area. Refer to 2.2 for further details on the Temporary Waste Transport Staging Area; refer to Figure 10 for the location of the area.

To allow for the inspections of the non-hazardous waste, which will occur on a weekly basis during active placement and, at minimum, monthly during all other periods, and to allow for ease of access to move and recycle the waste will be placed in a manner to allow ease of movement and inspection.

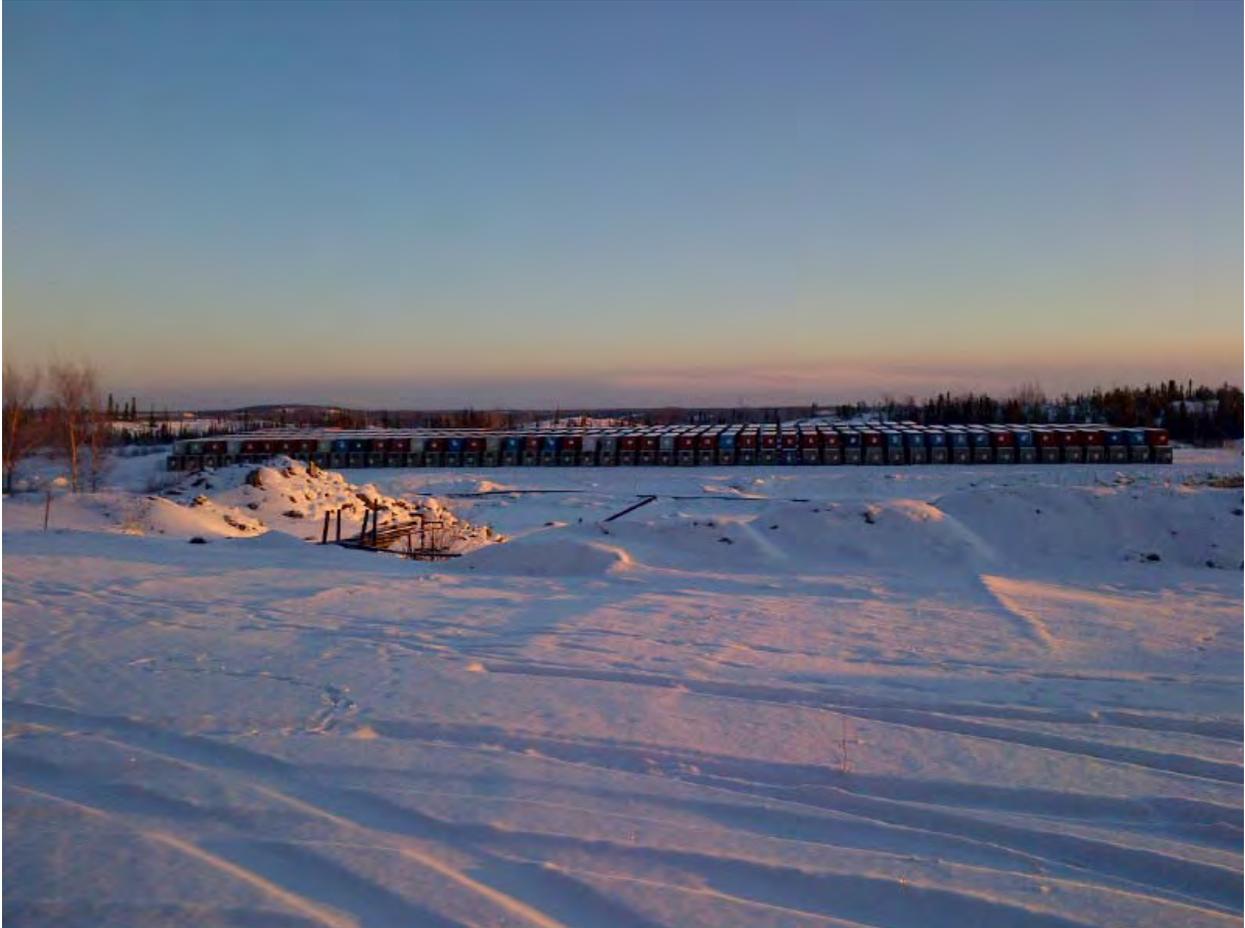
Figure 19 - Temporary Waste Storage Area on the Central Tailings Pond (looking east)

The surface water management system is described in Section 3.3 below, which remains unchanged from the approved Waste Management Plan. Briefly, runoff from the Temporary Waste Storage Area is managed such that runoff from the storage area is captured and directed to a perimeter ditch that

discharges into the North Tailings Pond. Water from the North Tailings Pond is blended with water from the Northwest Tailings Pond before being treated in the existing Effluent Treatment Plan.
