RE: Water Licence MV2012L8-0010 – Giant Mine – Inspection

WATER LICENCE ENVIRONMENTAL INSPECTION REPORT

Location(s) Inspected:	West Pond, Baker Creek, Fuel Transfer Area, Hazard’s Waste Area and Temporary Storage area.
------------------------	---

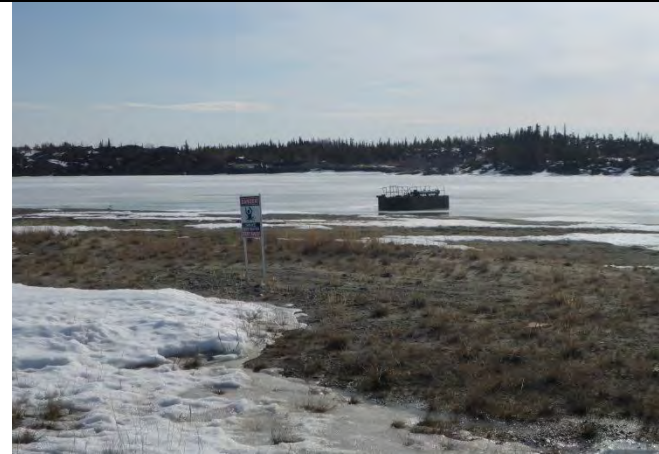
Photo 1: Northwest Pond Frozen.

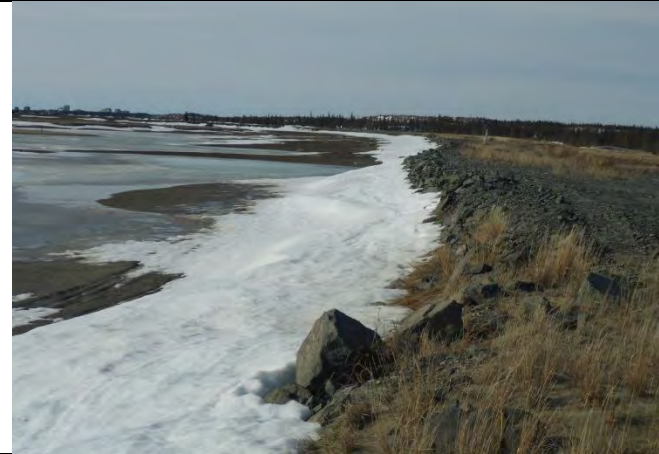
No water was being discharged to the environment at the time of the inspection for the regulated SNP station and the water levels in the northwest pond were very low, roughly 1/3 the capacity.

Photo 2: Low Water Levels in Northwest Pond.

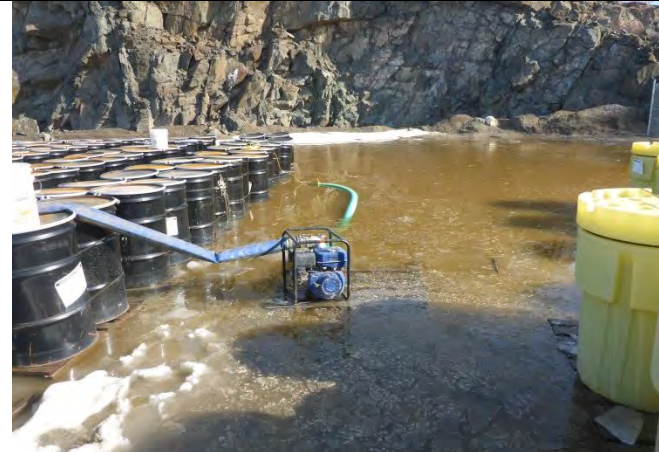
The Hazardous containment area had some flooding in the southeast corner as illustrated in photo 3. A pumping system had been setup to pump the ponded water into the northwest pond. Ms. Mora explained to the Inspectors that site personnel were ready to pump the ponded water shortly after the inspection.

Photo 3: Area flooded in the Hazardous Waste Storage area.

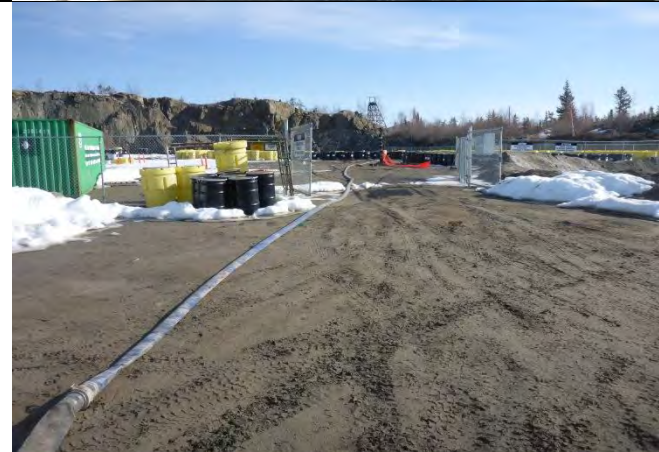
Photo 4: Piping to be used to pump the flooded area in Photo 3 to Northwest Pond.

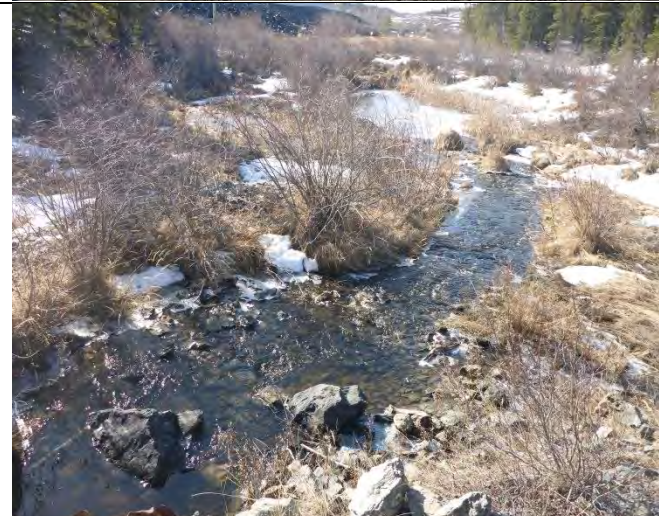
At the time of the inspection, Bake Creek has minimal flow and the water levels are very low (Photo #5).

Photo 5: Baker Creek Near Bridge

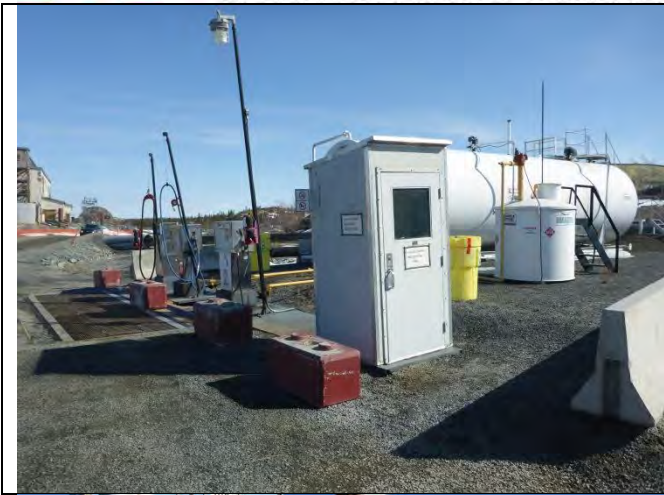
The fuel transfer area located near the office building had some hydrocarbon staining within the transfer area. The Inspectors requested that staff use a drip tray under the fuel nozzle to catch any dripping/minor spills during the refueling of equipment. The containment area that is currently in place catches the hydrocarbon but rain can cause this area to flood and hydrocarbons run out to the surrounding environment.

Photo 6: Fuel Transfer area

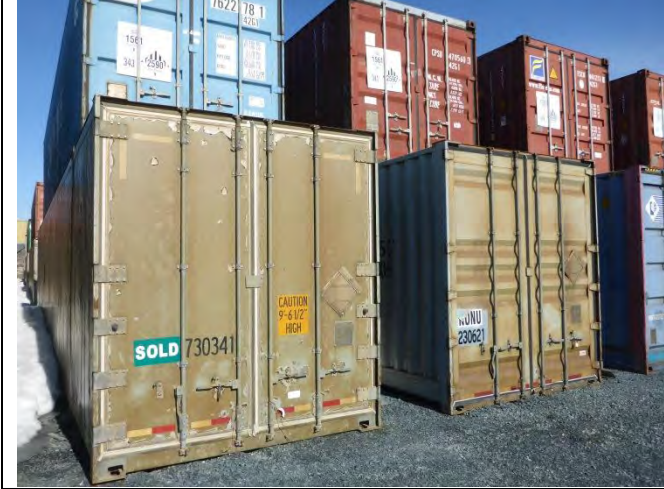
Photo 7: Dry Storage Container Area
