**Re: Land Use Permit MV2012S0019  
Drilling and Soil Testing  
Giant Mine, NT**

## ENVIRONMENTAL INSPECTION REPORT

Location(s) Inspected:	Proposed drill sites, equipment, and the proposed tailings stockpile location by the B1 Pit.
------------------------	--

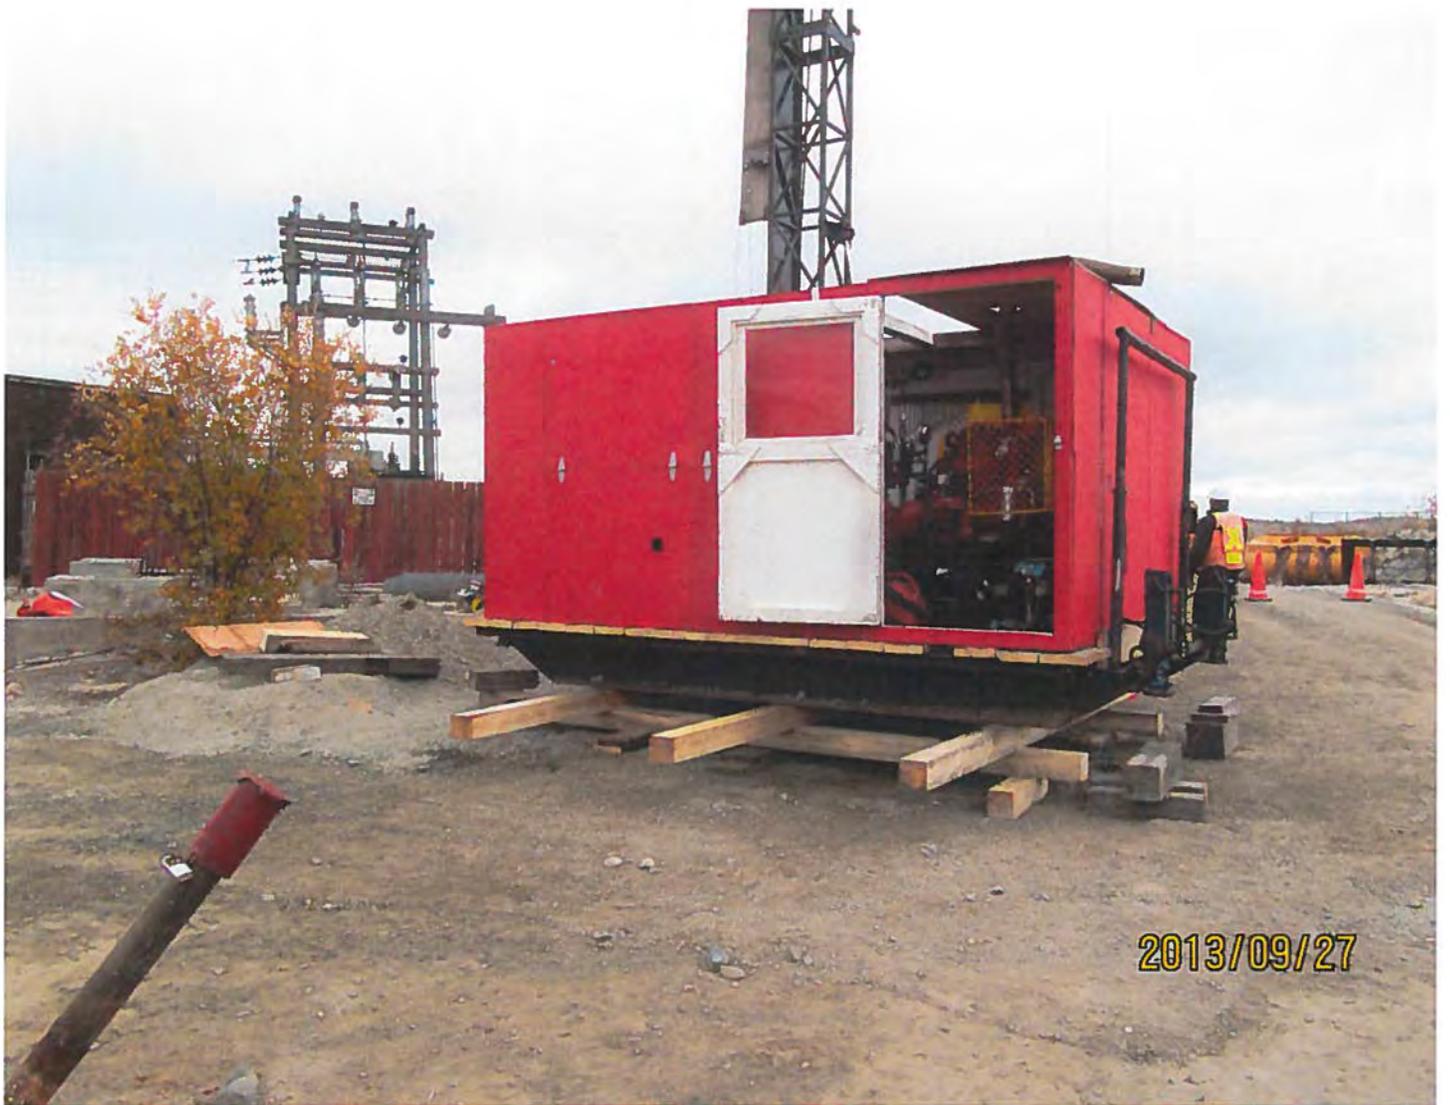
At the time of the inspection, the drills were not turning but both the Foraco diamond drill (Photo #1) and McCaw's air track drill (Photo #2) were present in the land use area. The Inspector was informed that drilling for both of these drills could commence as early as Saturday, September 28<sup>th</sup>, 2013.

Photo #1 - MV2012S0019 - AANDC-CARD  
Froraco diamond drill setting up on the first target of the program.

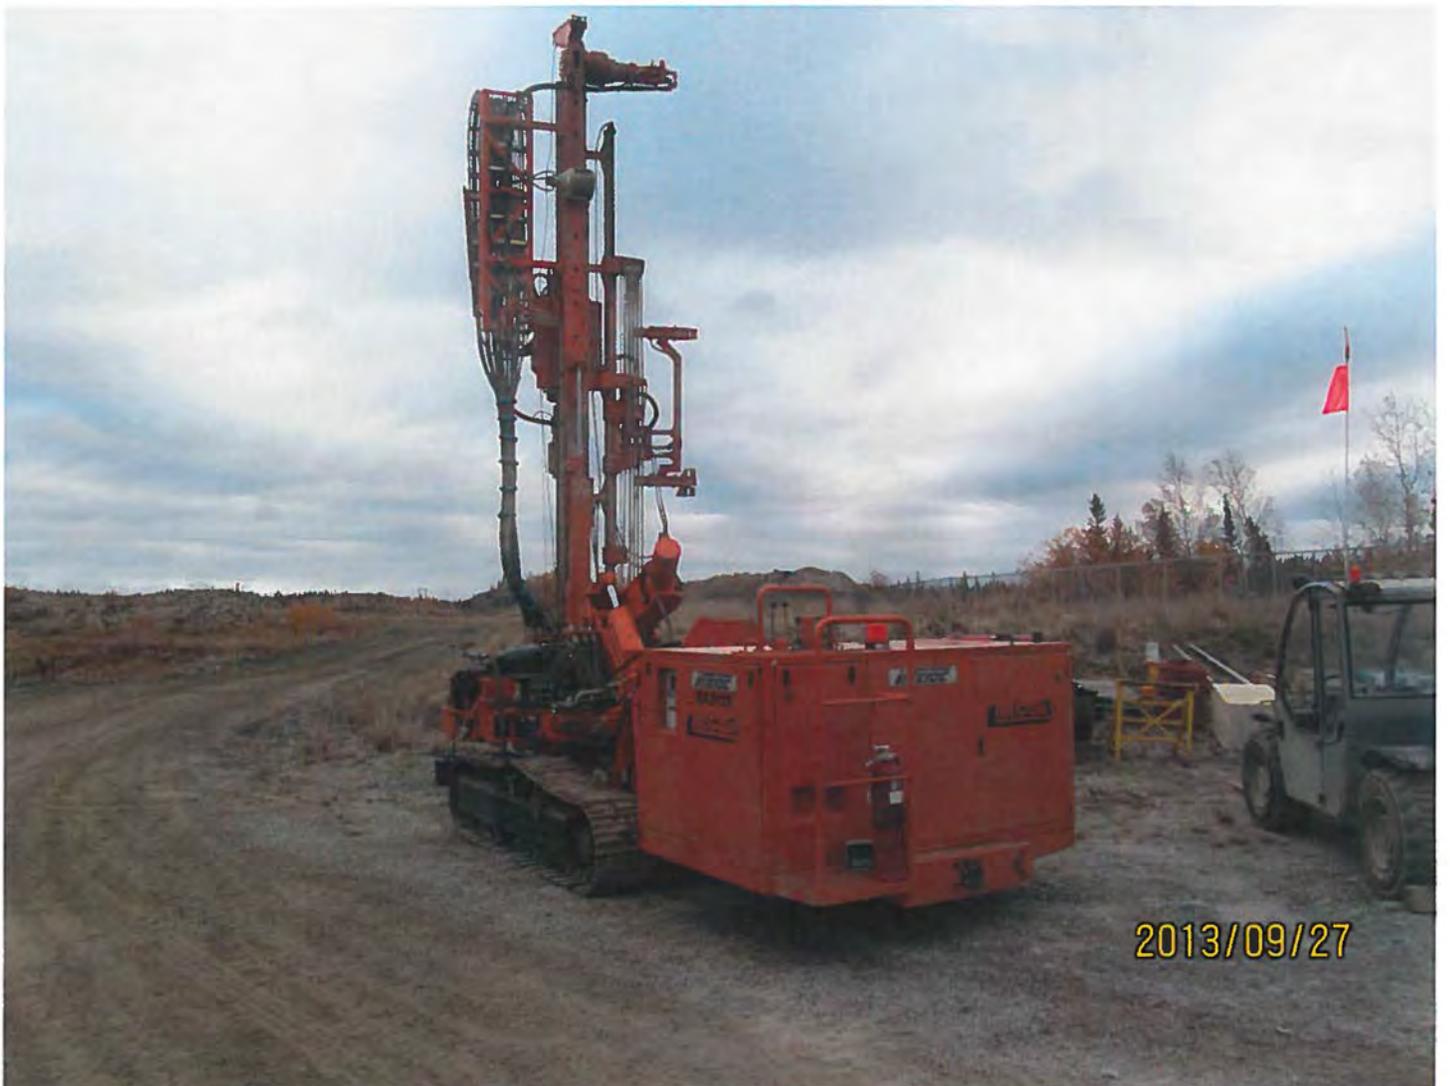
Photo #2 - MV2012S0019 - AANDC-CARD  
McCaw's air track drill that is being prepared for the upcoming program.

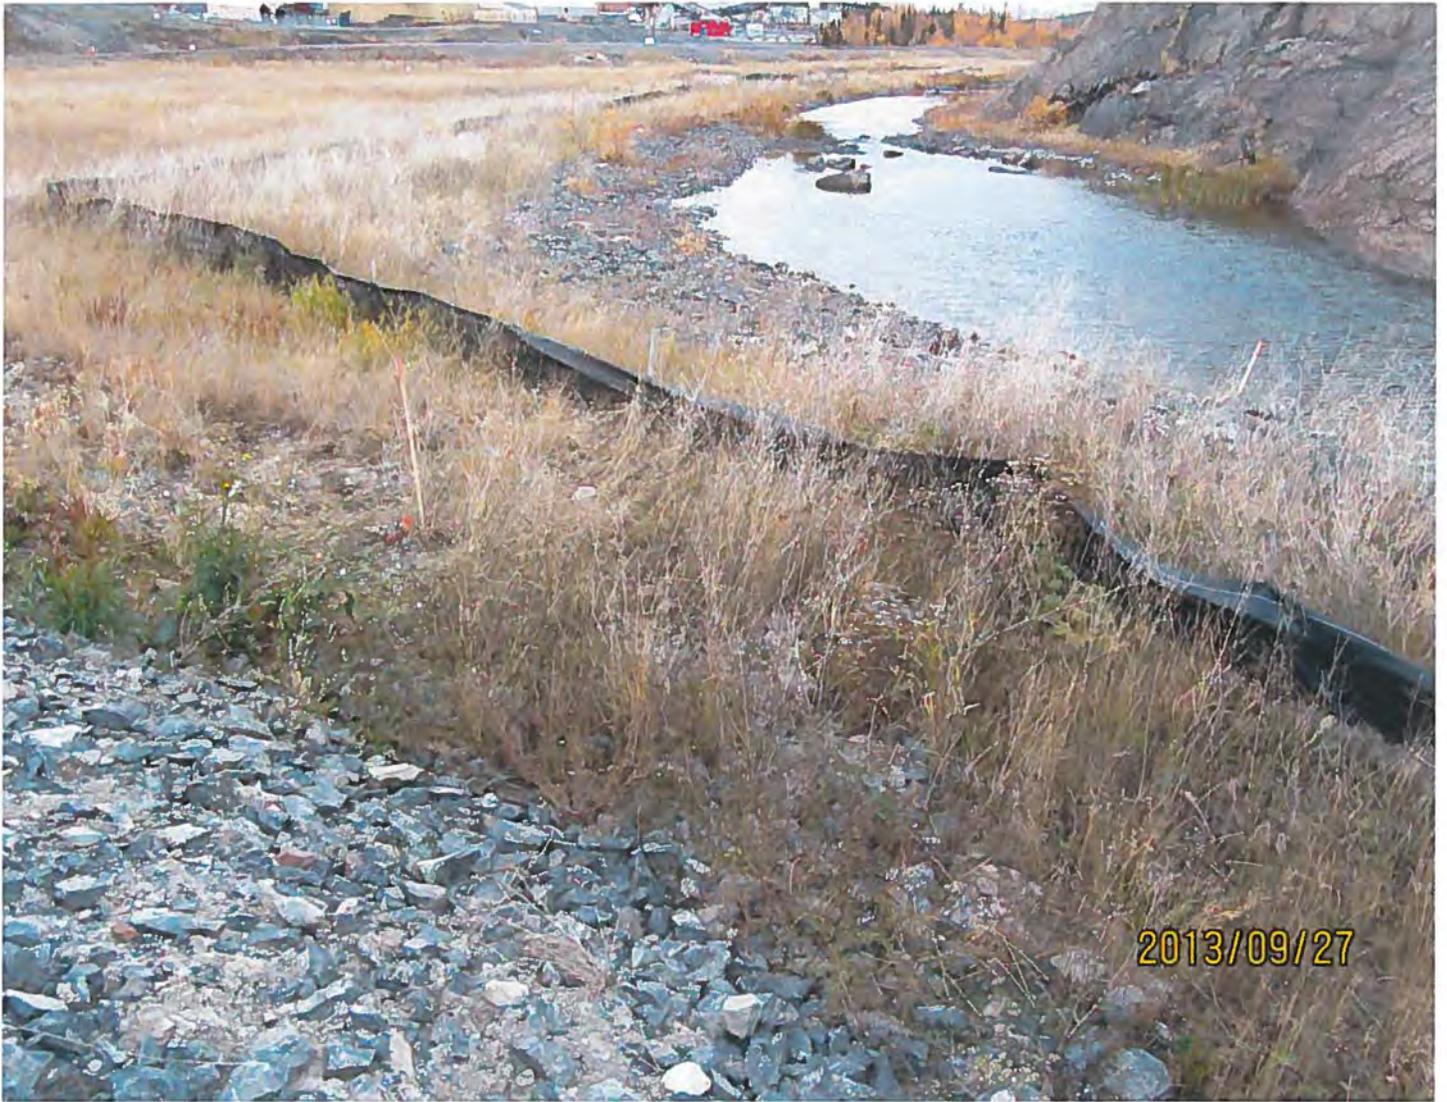
As viewed in Photo #3, a proposed drill target is in close proximity to Baker Creek, but the Inspector is pleased to report that the McCaw air track drill will be utilized for this target and the benefit of this drill, minimal to no water is used in the drilling process.

**Photo #3 - MV2012S0019 - AANDC-CARD**  
Stake on the left hand side of the photo is where the drill hole will be collared.

Other measures that will be implemented to help reduce the potential for cuttings to enter the watercourse is as follows; a rock pad consisting of 6" minus rock with minimal fines will be placed at this target, silt fencing will be keyed into the underlying soils between the drill and Baker creek, diligent monitoring will occur, cuttings will be slightly wetted to prevent airborne mobilization, the tanks viewed in Photo #4 will be used to collect cuttings for removal and disposal in the Northwest Pond, and a thorough cleanup of the ground surface will be conducted once the drill pulls off this target.

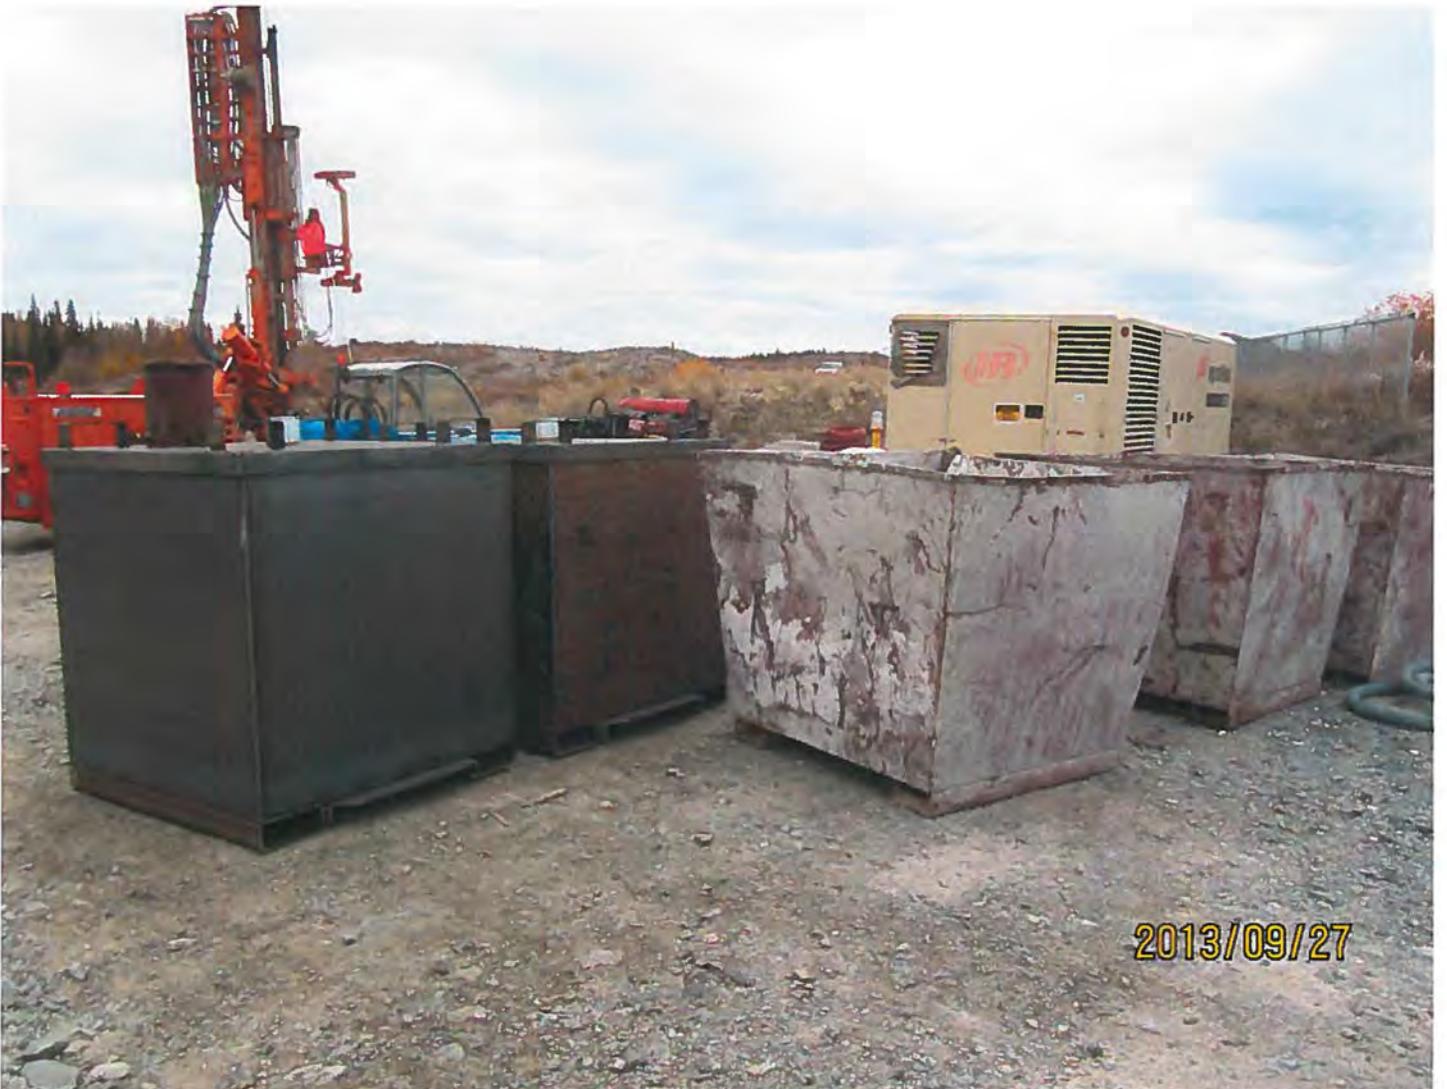
**Photo #4 - MV2012S0019 - AANDC-CARD**  
Both drill contractor's have cuttings tanks on site for transport to the Northwest Pond.

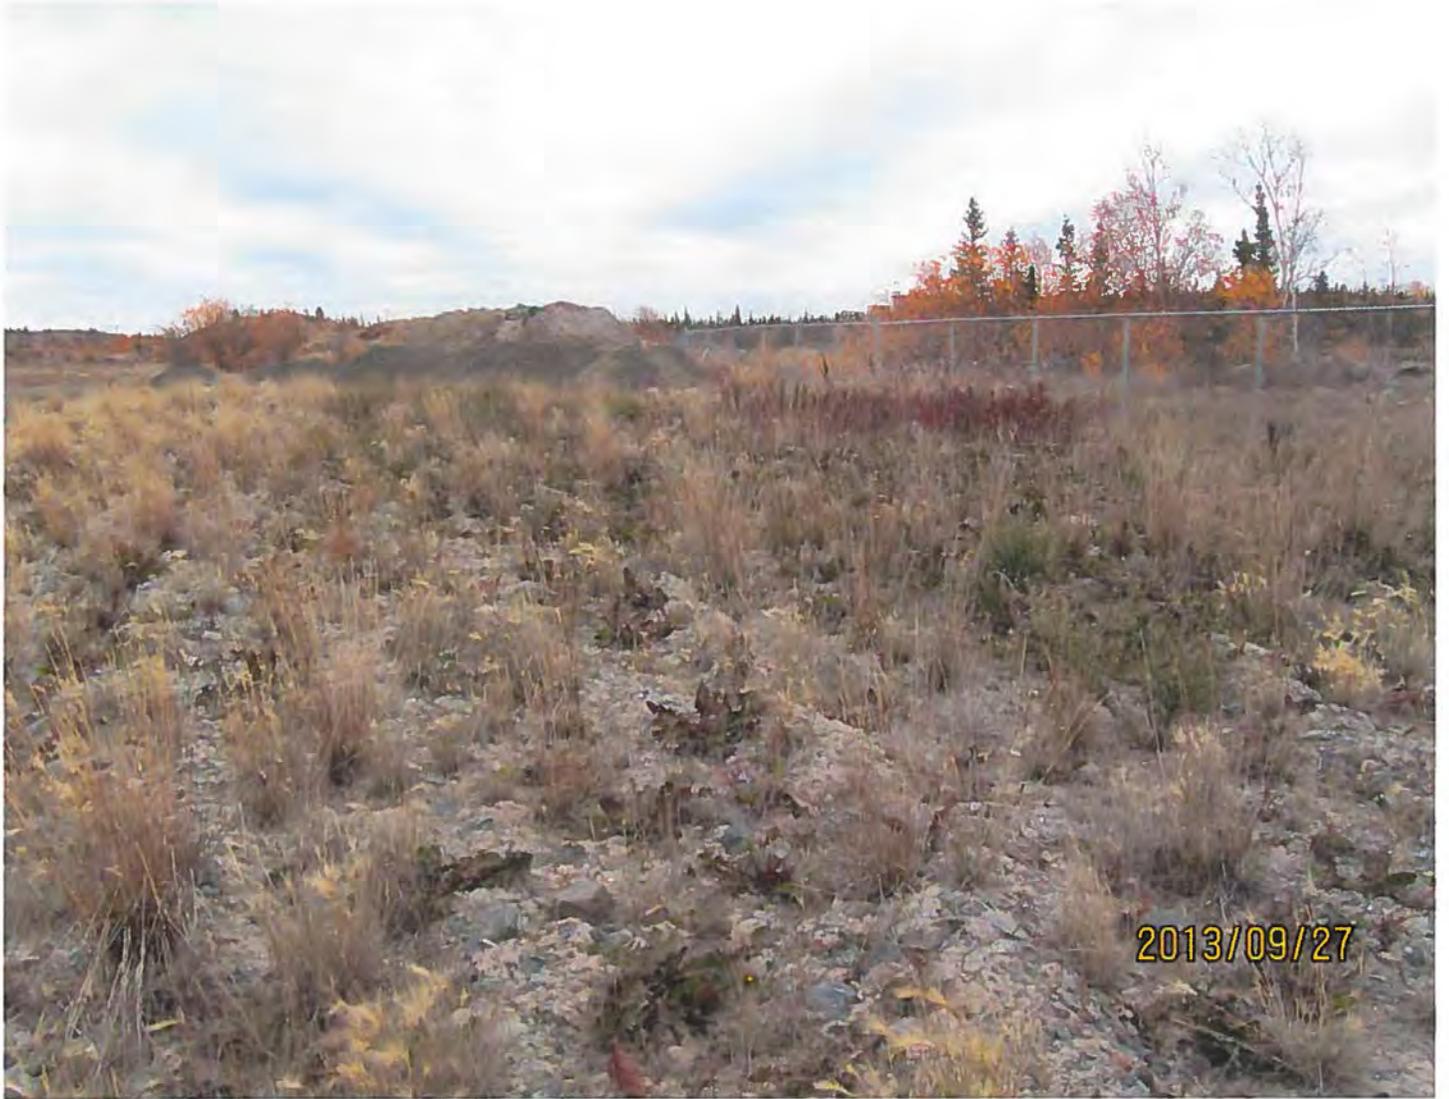
On September 19<sup>th</sup>, 2013 the Board approved the Underground Stabilization Plan that was submitted as requirement of Part H, Item 3 of water licence MV2012L8-0010. The Permittee/Licensee will be constructing a tailings stockpile pad to hold approximately 5,000 m<sup>3</sup> of material adjacent to the B1 Pit and the location can be viewed in Photo #5.

**Photo #5 - MV2012S0019 - AANDC-CARD**  
This area will be prepared for the stockpiling of tailings for the paste backfill program.

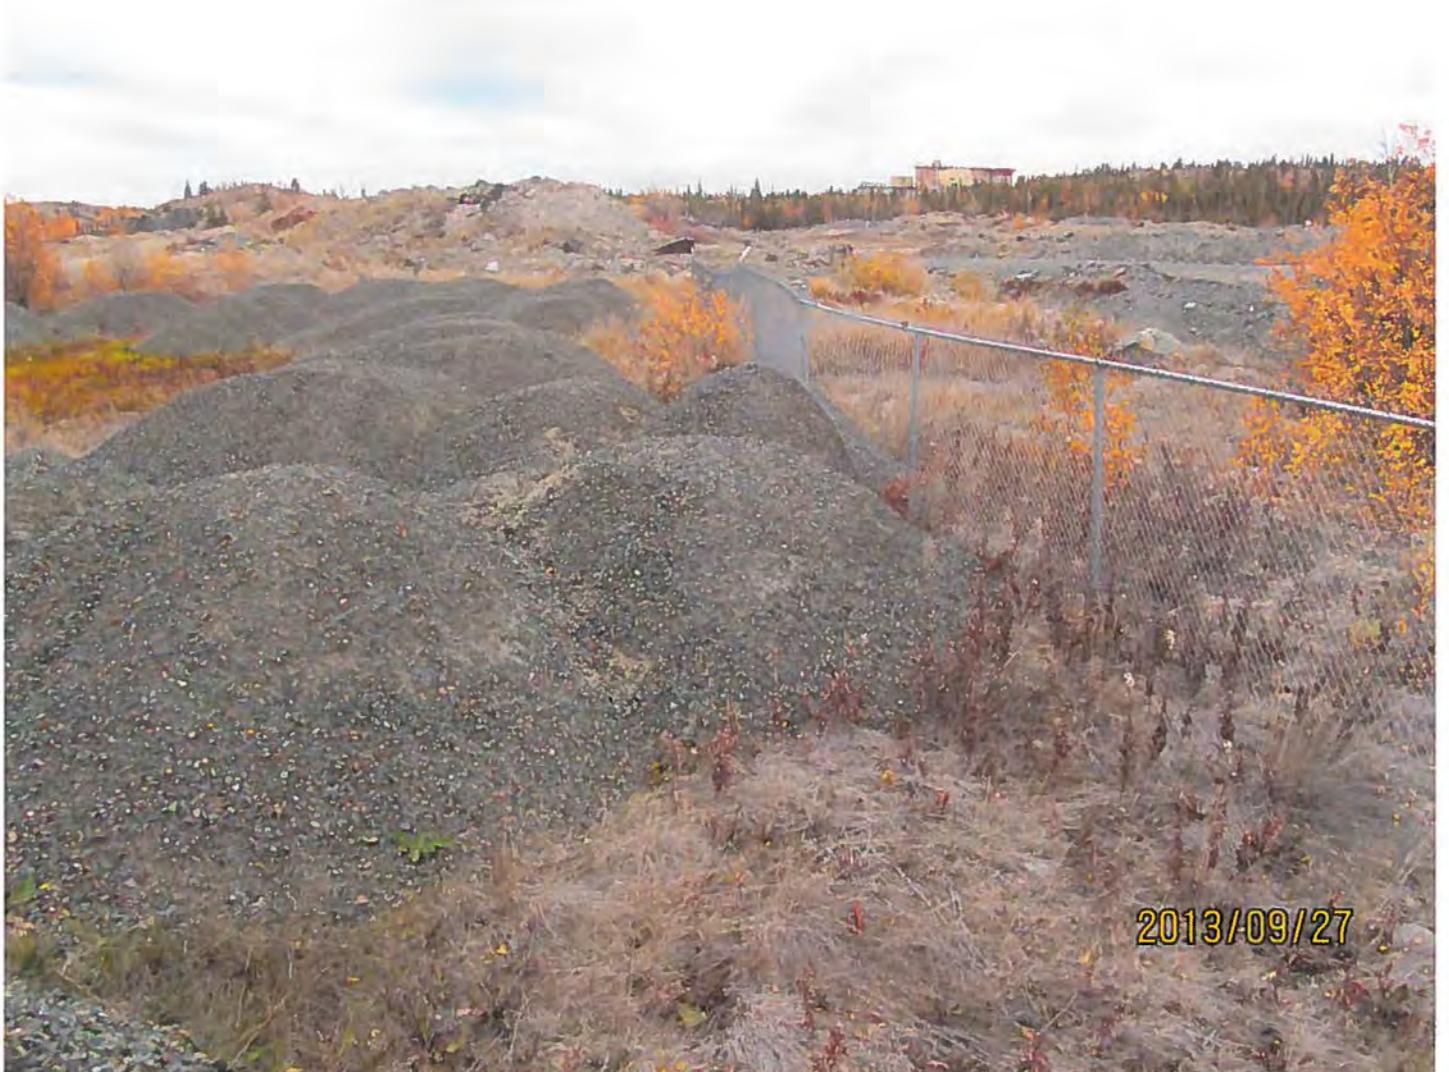
In discussions with the Contractor and Sub-Contractor, this area will be leveled and graded towards the B1 Pit, bedding sand placed, lined with an HDPE liner, concrete blocks used as berms, and drainage established in the area viewed in Photo #6. The construction of this pad appears to be consistent with the approved Underground Stabilization Plan, and as a reminder, once tailings are placed in this facility they must be covered at all times.

**Photo #6 - MV2012S0019 - AANDC-CARD**  
Drainage from the stockpile location will be directed through this area to the B1 Pit.
