**Re: Land Use Permit MV2013J0006
Campsite/Lodge
Mackay Lake, NT**

ENVIRONMENTAL INSPECTION REPORT

Location(s) Inspected:	Mackay Lake Lodge
------------------------	-------------------

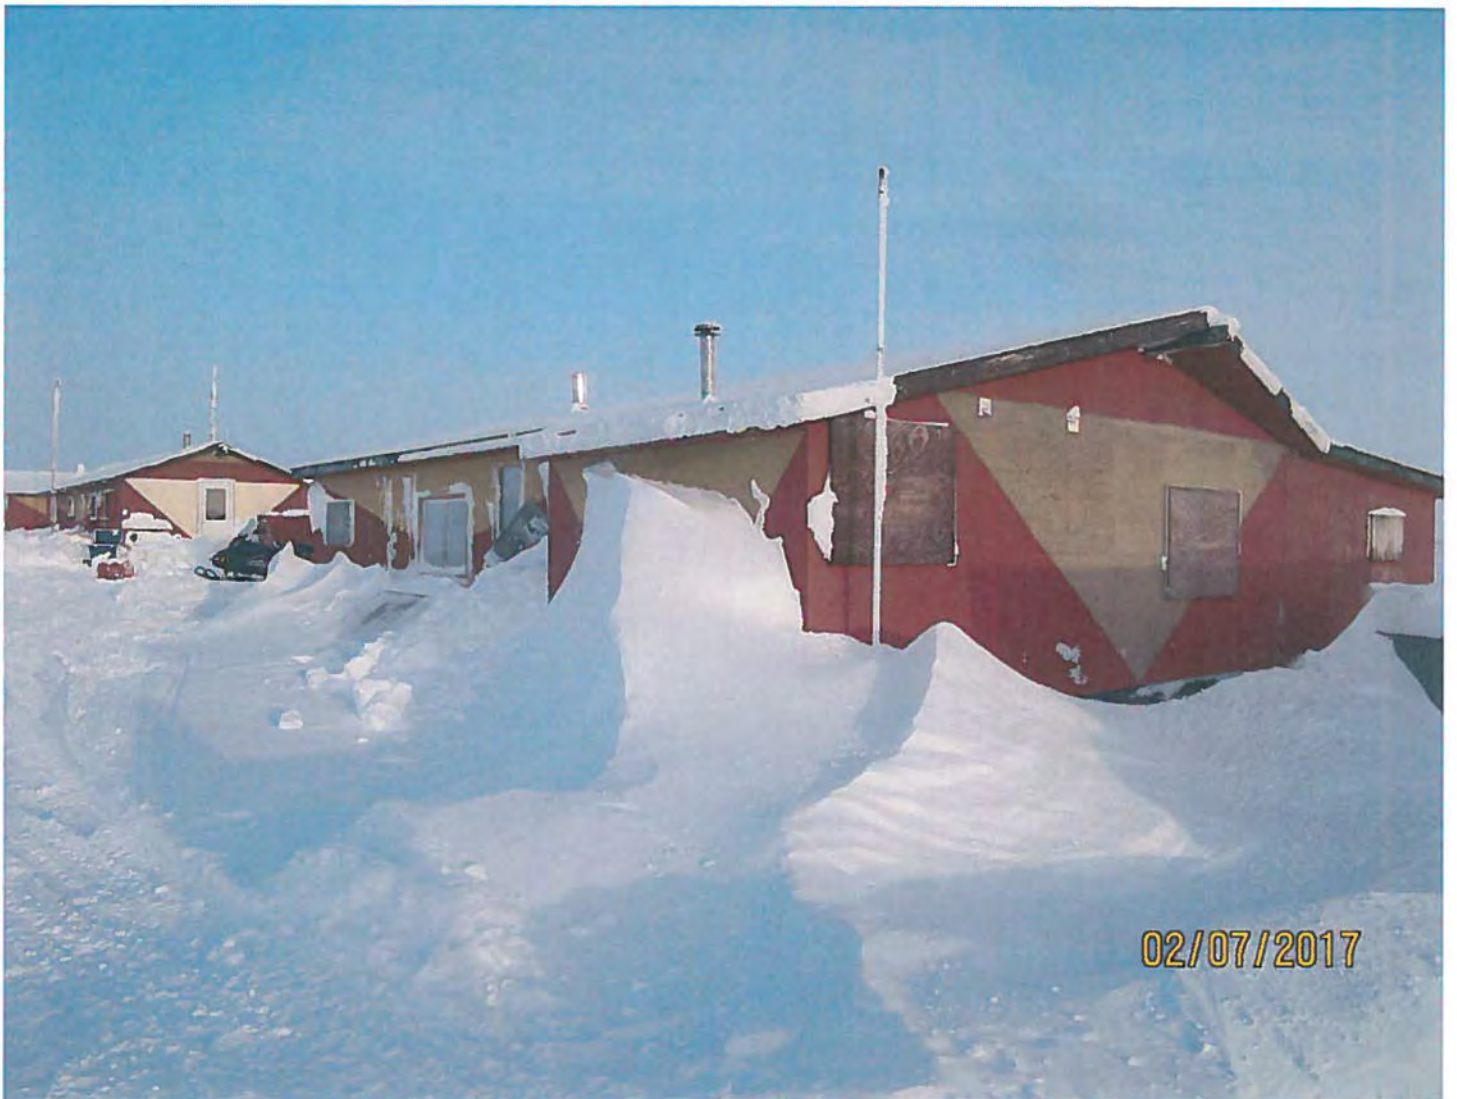
Photo #1 - MV2013J0006 True North Safaris Ltd.
Two of the active buildings at Mackay Lake Lodge.

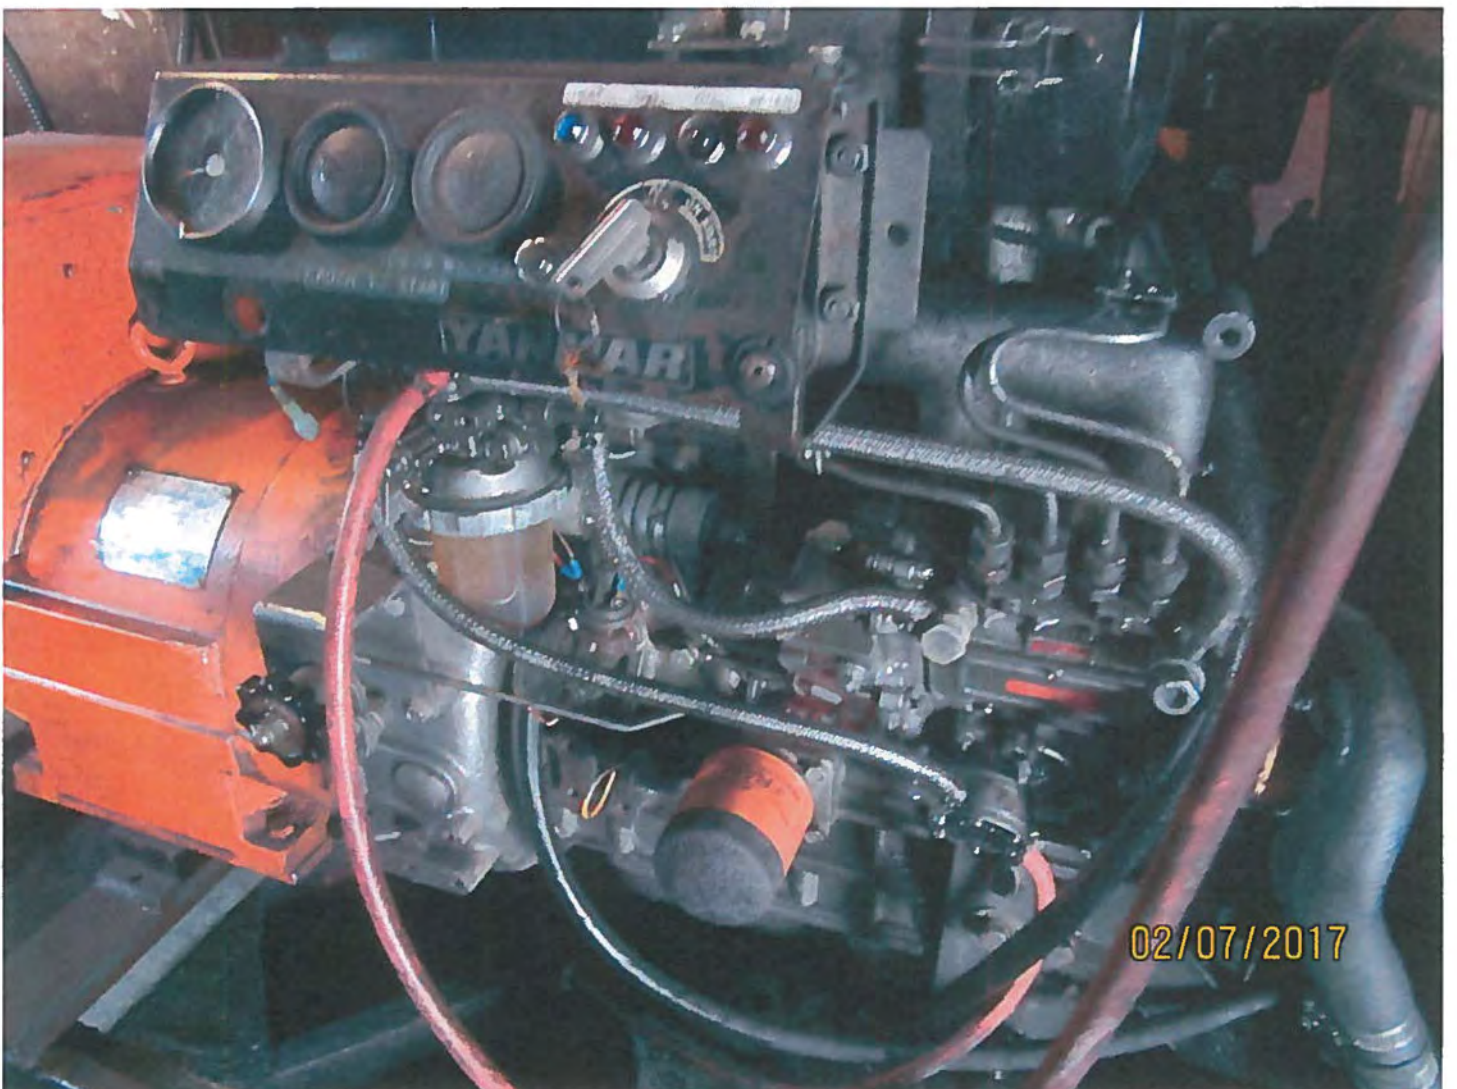
The only concern noted during the current inspection involved an active fuel leak at the camp generator in the generator shack. Fuel was leaking from the fuel filter of the generator and though secondary containment was present under the generator, the containment was overtopping and hydrocarbons were impacting the underlying soils (Photos #2 & #3). The Permittee must ensure hydrocarbons remain fully contained and do not impact the surrounding soils as per Condition #36 of the permit. Impacted soils resulting from a spill must be cleaned up to satisfy Condition #42 and the soils are to be properly containerized and disposed of at an authorized offsite disposal facility (Condition #43).

Photo #2 - MV2013J0006 True North Safaris Ltd.
Fuel was leaking from the fuel filter of the camp generator.

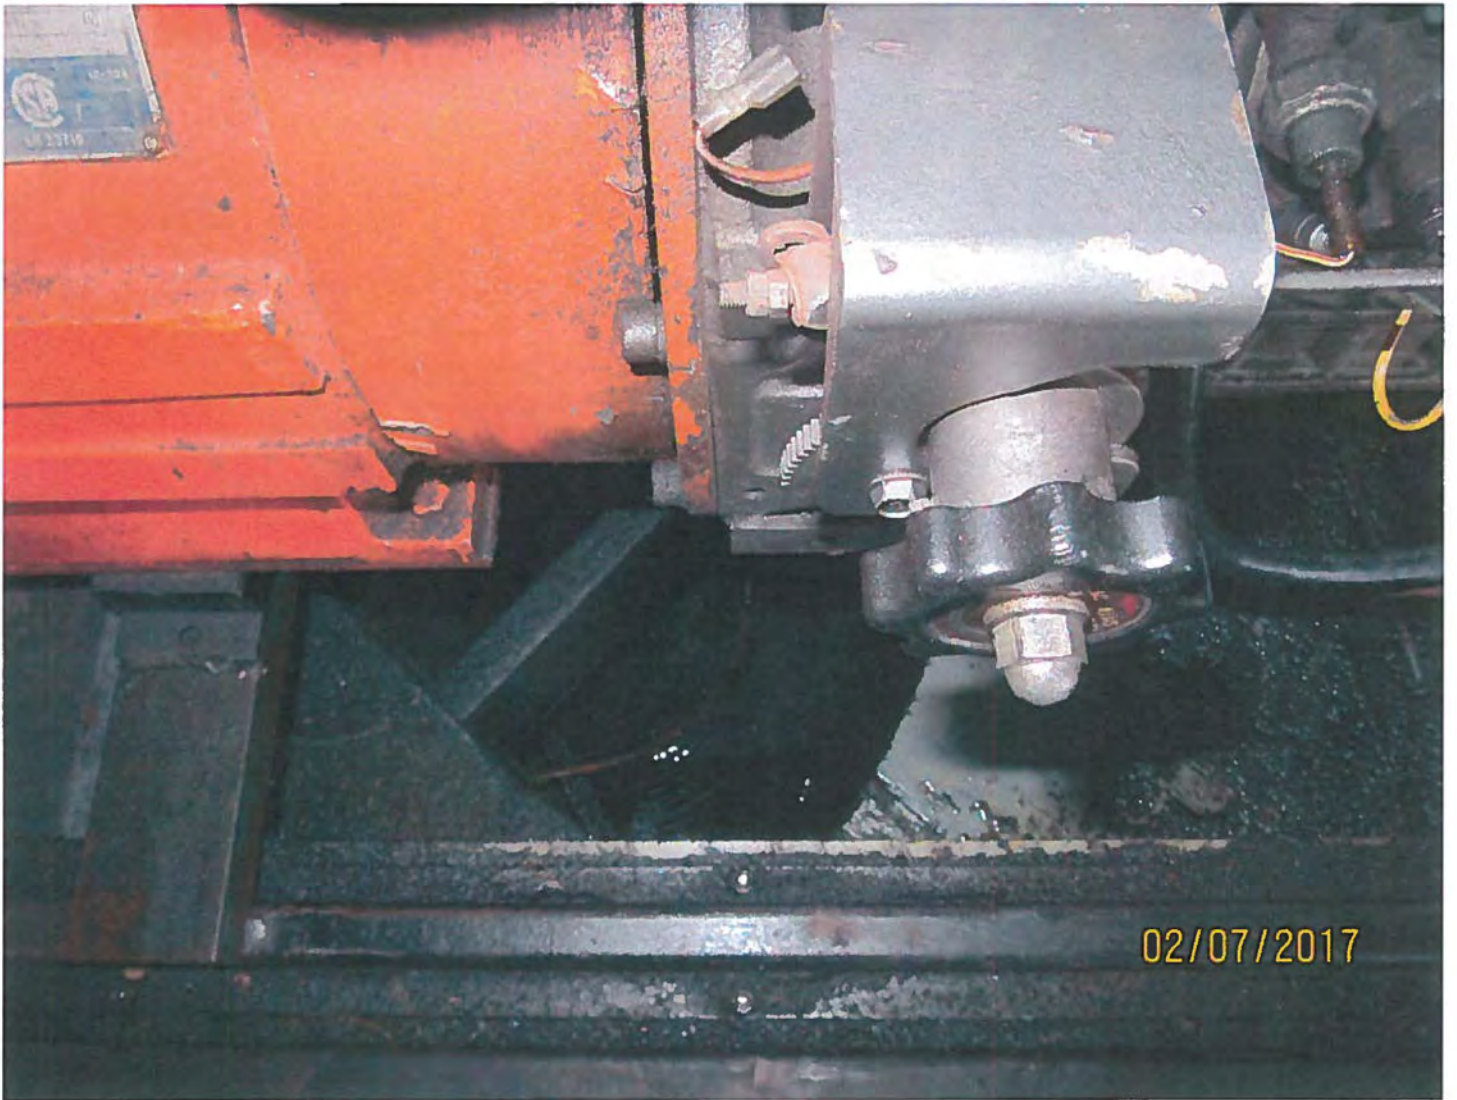
Photo #3 - MV2013J0006 True North Safaris Ltd.
Though there was secondary containment under the camp generator, the containment was overtopping and impacting the surrounding soils.

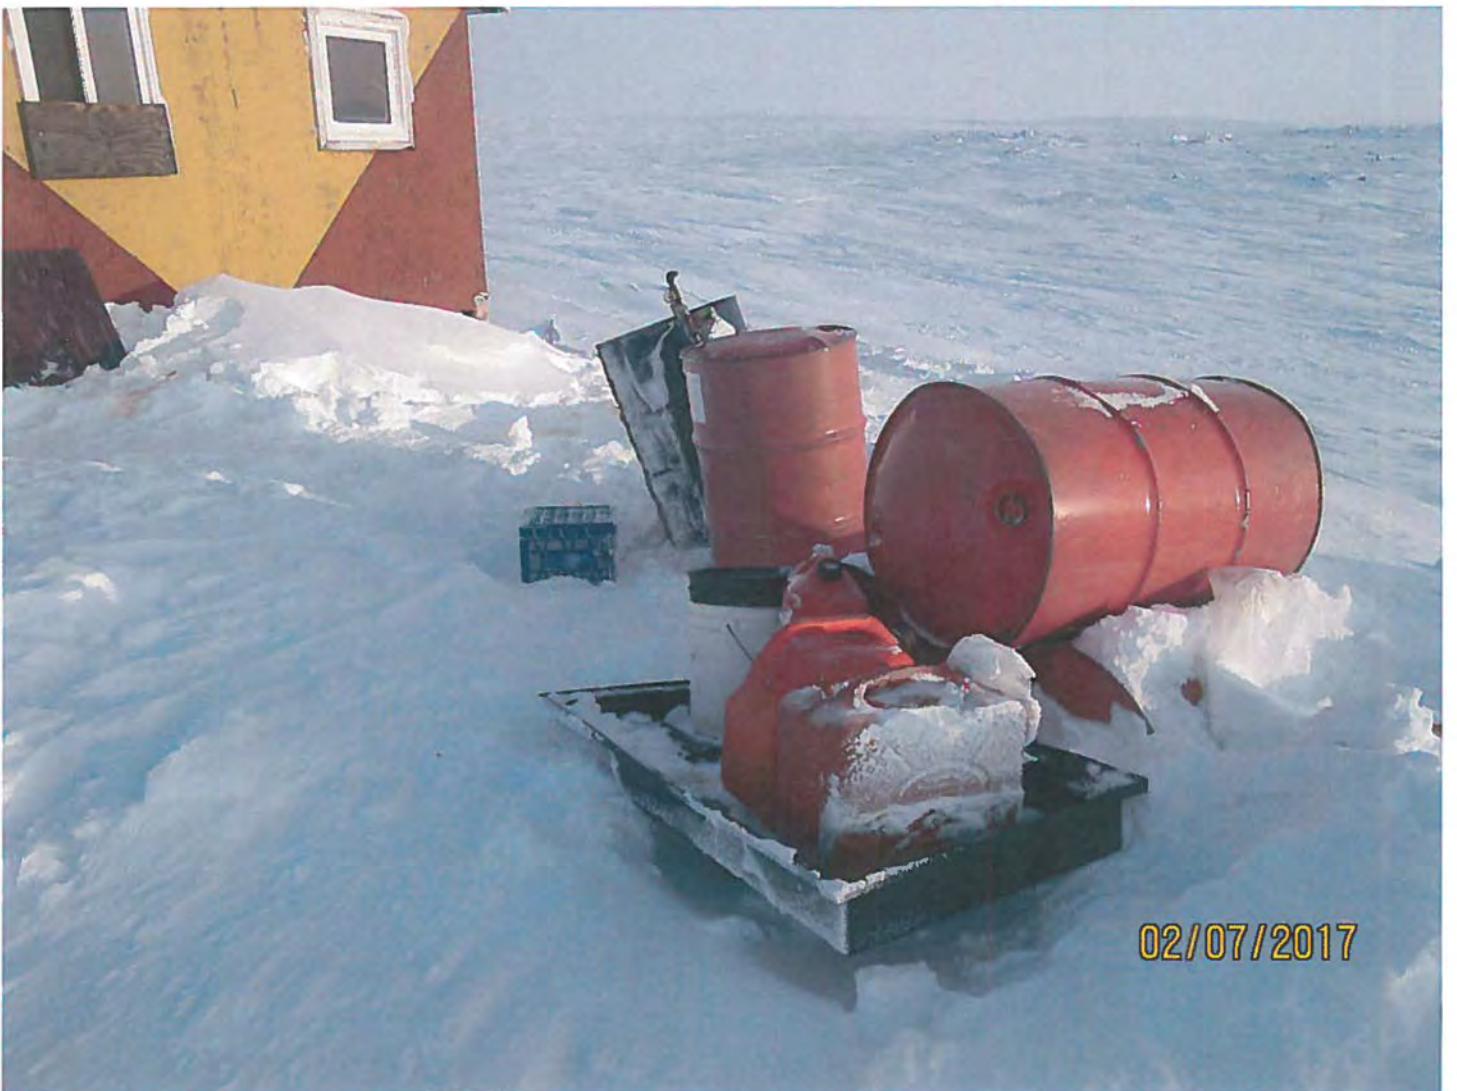
Photo #4 - MV2013J0006 True North Safaris Ltd.
Fuel drums appeared to be properly stored and active fuel containers were in secondary containment.
