**Re: Land Use Permit MV2017C0022
Mineral Exploration
Glowworm Lake Area, NT**

ENVIRONMENTAL INSPECTION REPORT

| Location(s) Inspected: | The fuel cache (N64° 41' 13.4" W109° 20' 15.0" (NAD-83)) and ice strip in the Glowworm Lake Area. |

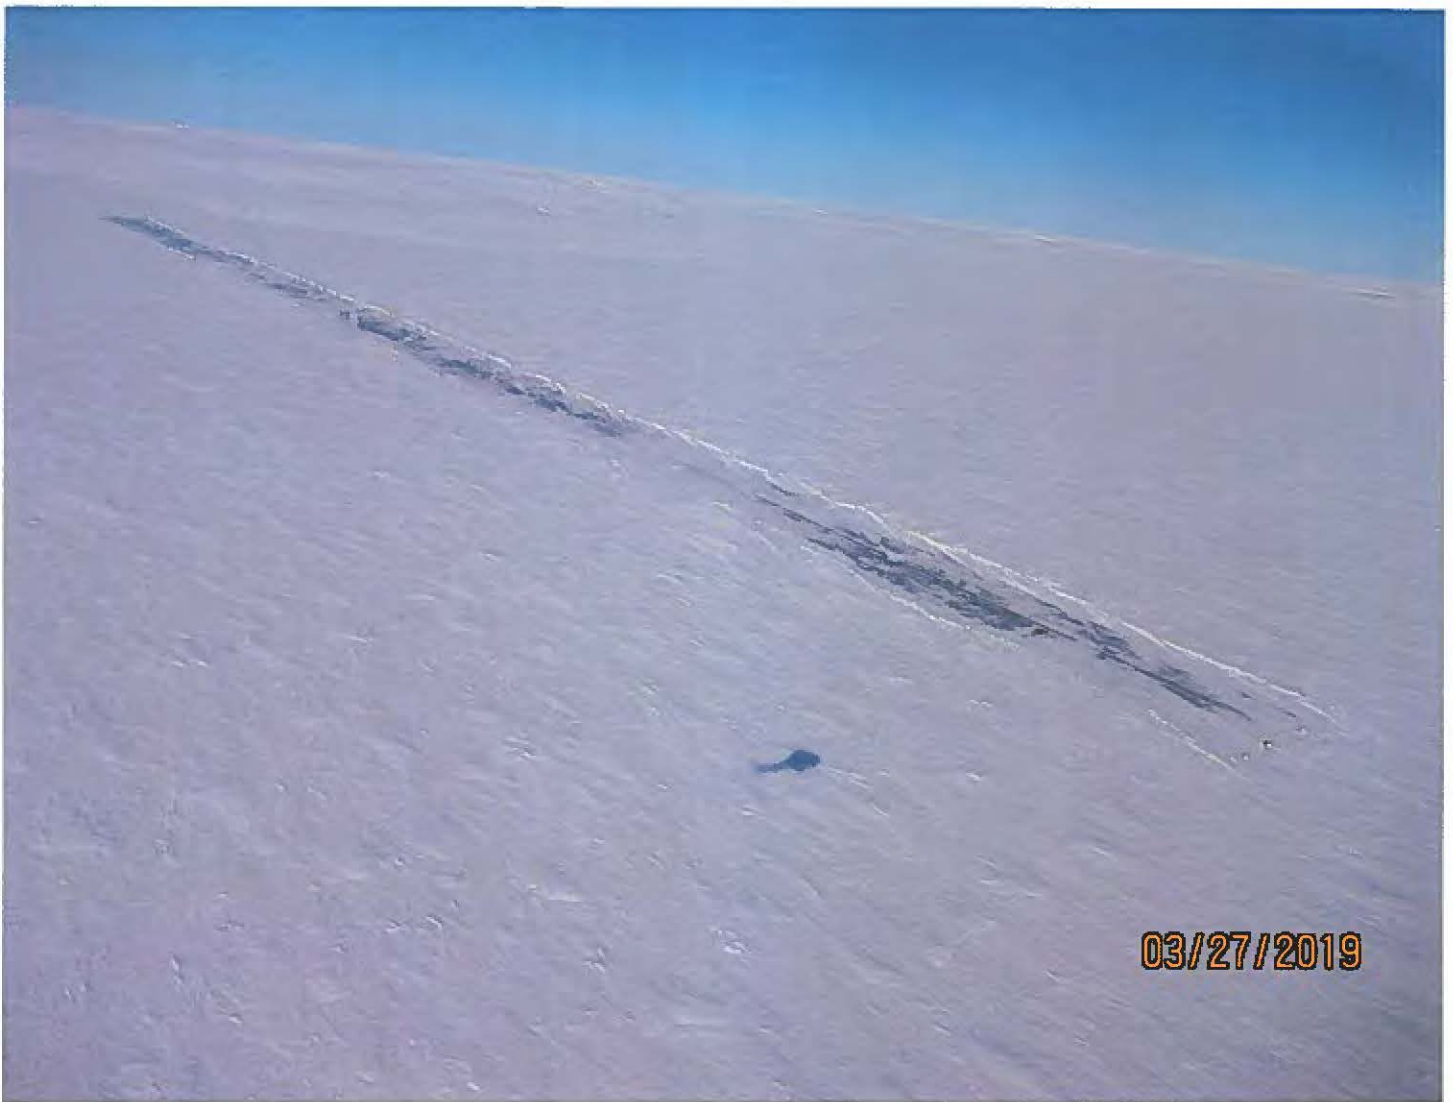
Photo #1 - MV2017C0022 - Glowworm Lake
An airstrip was cleared on the ice surface of Glowworm Lake to accommodate the use of a Dash 7 aircraft for fuel delivery.

The Permittee provided notification to Inspectors on February 26th, 2019 (Condition #5 & #6 of the land use permit) stating that land use operations would commence on March 1st, 2019. Initial work proposed was to set up a temporary camp and clear the snow on Glowworm lake for an airstrip that would accommodate a Dash 7 aircraft for the delivery of fuel drums for an upcoming exploration program.

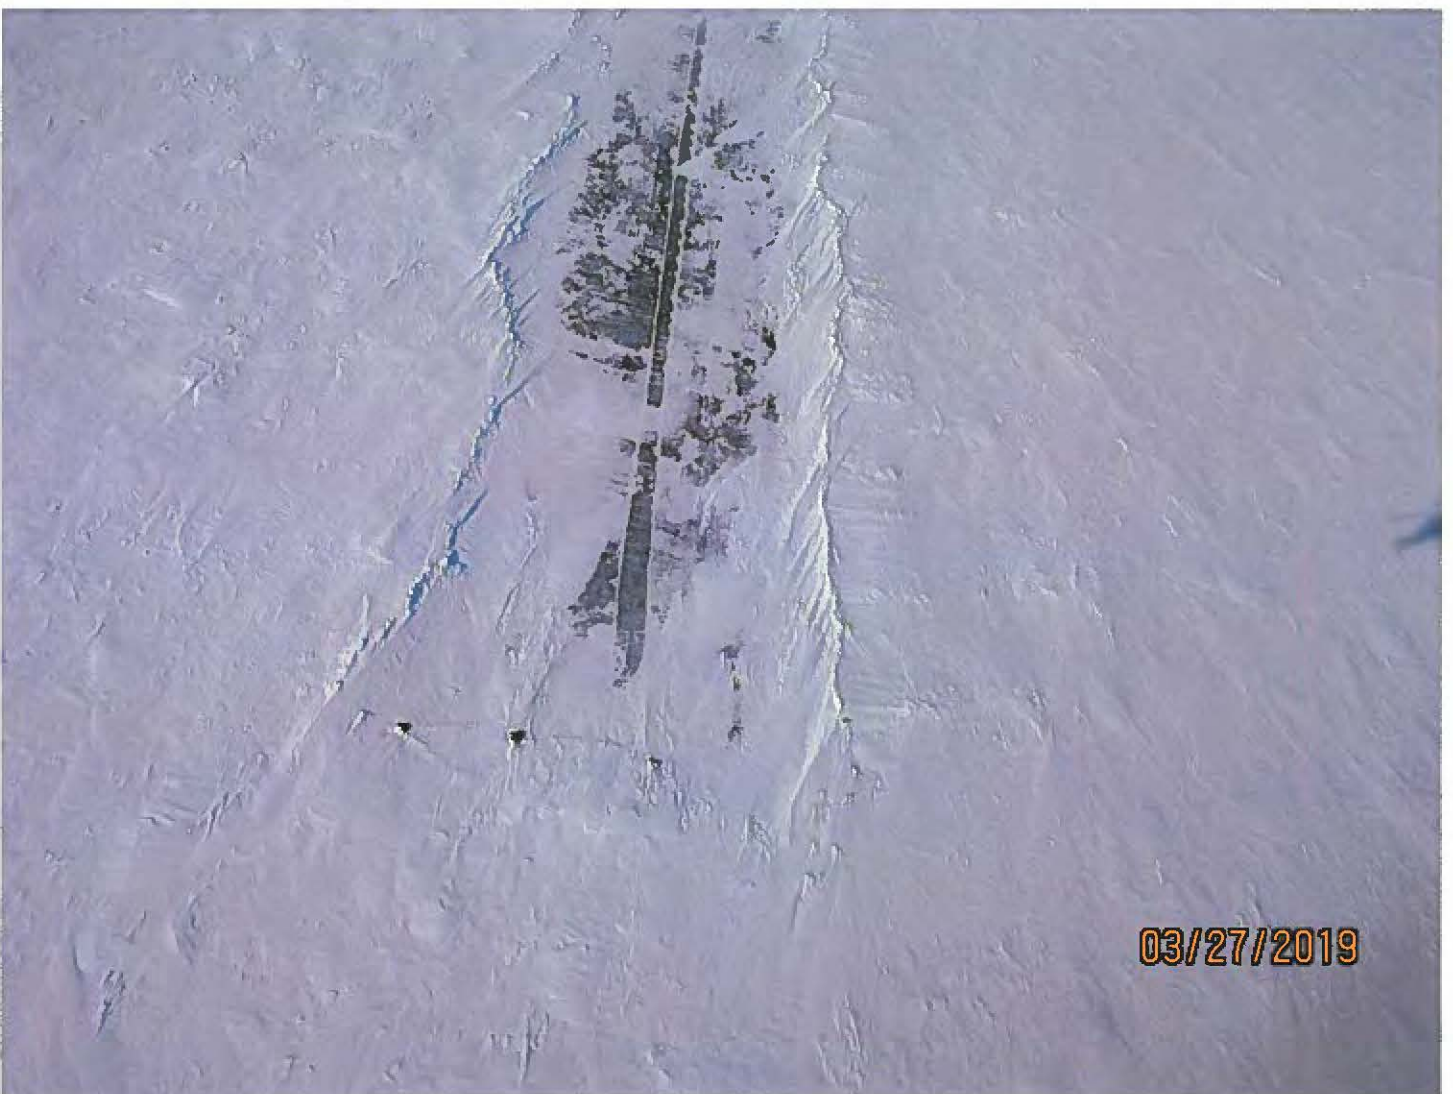
The airstrip can be viewed in Photo #1 & #2 and the only concern noted was the requirement for the Permittee to retrieve the airstrip markers that were left on site. This concern was brought to the attention of Mr. Marshall and Inspectors were informed that a plan to retrieve the markers is in the works and this concern will be addressed prior to spring freshet. This cooperation is appreciated and please let Inspectors know when this task is completed.

Photo #2 - MV2017C0022 - Glowworm Lake
Airstrip markers were left on the airstrip and must be removed by the Permittee.

Land use operations commenced on March 1st, 2019 with the clearing of the ice surface of Glowworm Lake for an airstrip and the delivery of fuel drums for an upcoming exploration program. The only concern noted was the requirement for the Permittee to retrieve the airstrip markers that were left on site (Photo #2) and the Inspectors are confident that this will occur well in advance of spring freshet. Your copy of the Environmental Inspection Report is enclosed and should be self-explanatory.

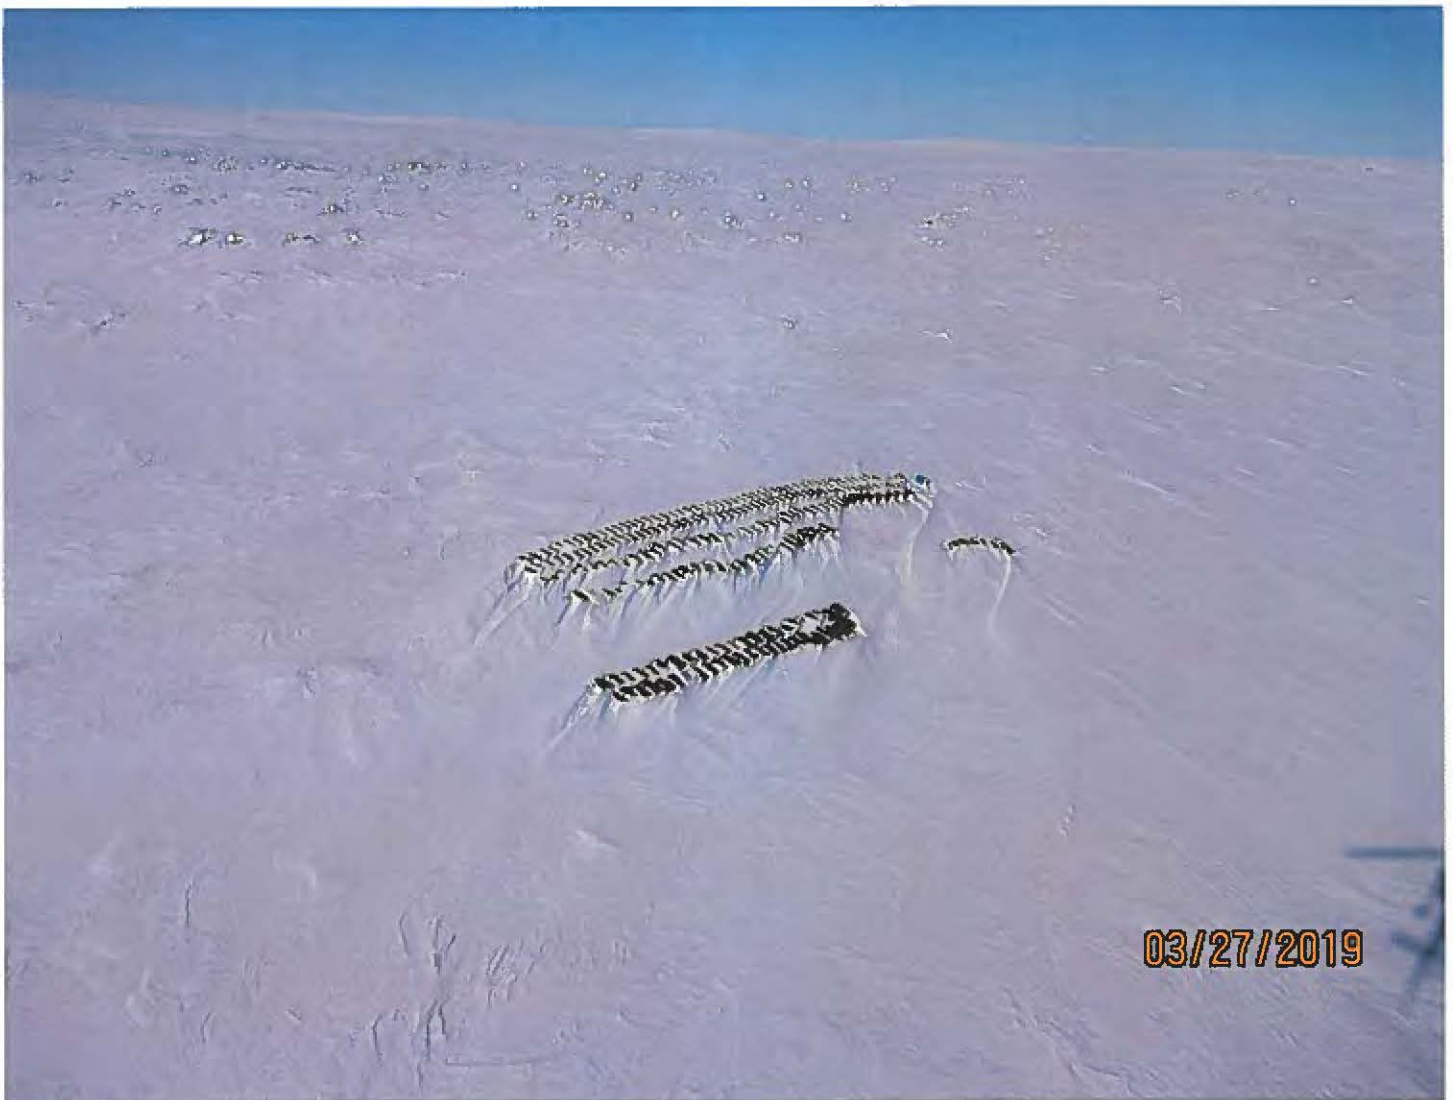
The fuel cache can be viewed in Photo #3 & #4 and consists of 166 drums of jet fuel, 47 drums of diesel, 6 drums of gasoline, and 1 propane cylinder. No concerns were noted with the fuel cache since it appears to have been positioned greater than 100 metres from the ordinary high water mark of Glowworm Lake, wooden stakes are present to mark the fuel location, the majority of the bungs appeared to be at three and nine o'clock, and a spill kit was present.

Photo #3 - MV2017C0022 - Glowworm Lake
A fuel cache has been established in the land use area.

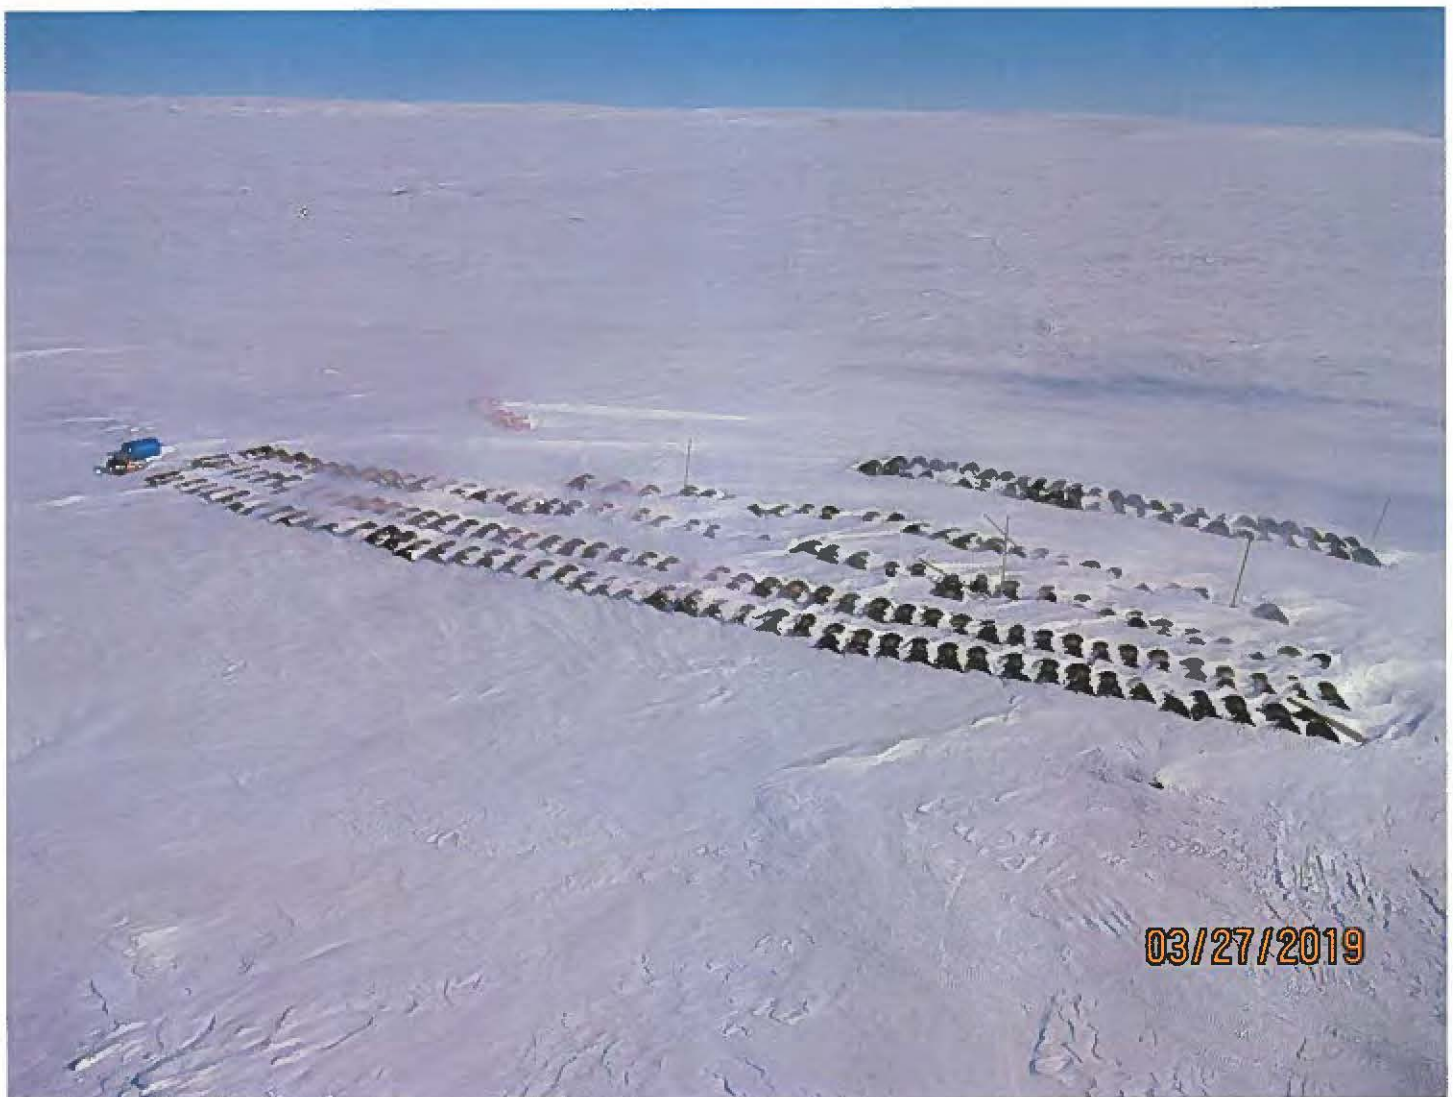
Photo #4 - MV2017C0022 - Glowworm Lake
Another view of the fuel cache and a spill kit is present.
