File Number MV2017C0024
Type of Operation MINERAL EXPLORATION - Drilling
Location N42 Pine Point area

ENVIRONMENTAL INSPECTION REPORT

Permittee:	Pine Point Mining Limited	Permit Expiry Date:	July 19, 2022
Land Use Permit No.	MV2017C0024 (replaces MV2016C0023)	Previous Inspection:	First Inspection for MV2017C0024
Quarrying Permit No.	N/A	Inspection Date:	October 25, 2017
Contractor:	Foraco	Subcontractor:	
Location(s) Inspected:	N42		
Current Stage of Operation:	Active		
Program Modifications Approved:	N/A

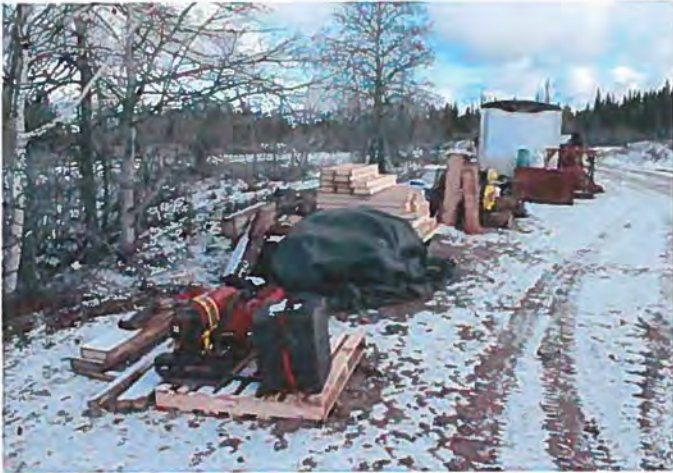
Figure 1
Staging area

Items on site: boxes for drill cores, hoses, pull trailer, trailer on skids, and a flat deck trailer.
Fuel and chemicals: drill rod grease, lubricating oil, 100lb propane tank, and others.

The staging area was clean and well maintained. There was a sump near the staging area that should be reclaimed when practical.

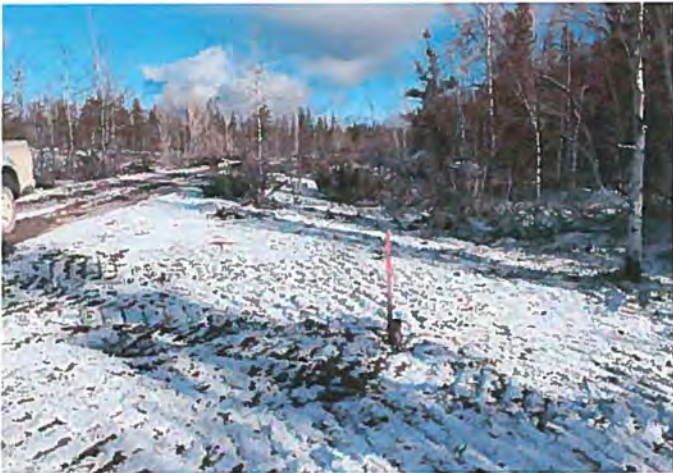
Figure 3
Holes are not capped or cut

During the inspection Foraco was moving the equipment to a new hole in N42. The drilled holes had not been cut or capped yet as per Condition 16 of the Land Use Permit.

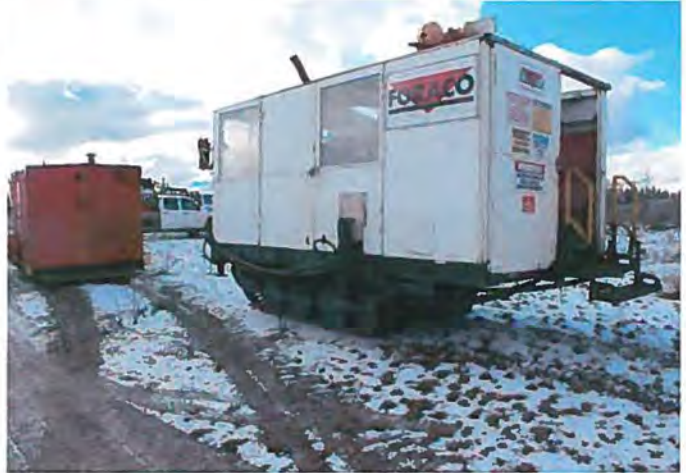
Figure 4
Equipment ready for the move to a new hole

Equipment on site: Mooraka MST 80D, First Aid Truck, 4 pickup trucks, 3 trailers on skids, John Deere 700J, drill on tracks, and a water truck.
