**Re: Land Use Permit MV2017C0022  
Mineral Exploration  
Glowworm Lake Area, NT**

## ENVIRONMENTAL INSPECTION REPORT

Location(s) Inspected:	The fuel cache (N64° 41' 13.4" W109° 20' 15.0" (NAD-83)) and ice strip in the Glowworm Lake Area.
------------------------	---

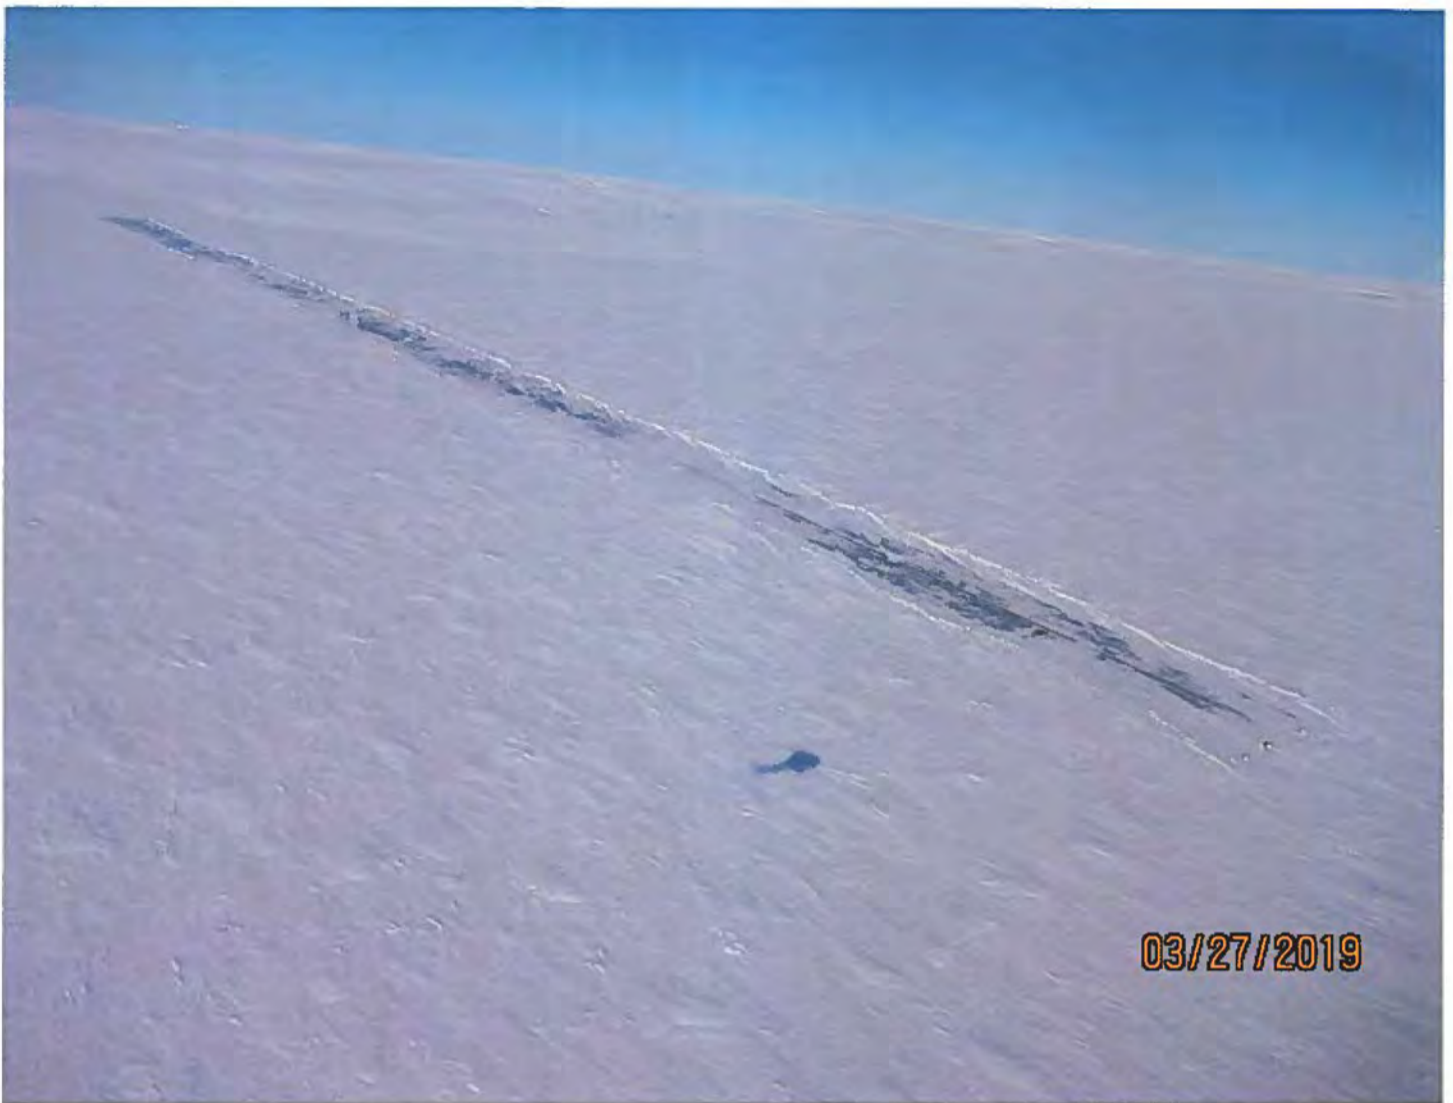
The Permittee provided notification to Inspectors on February 26<sup>th</sup>, 2019 (Condition #5 & #6 of the land use permit) stating that land use operations would commence on March 1<sup>st</sup>, 2019. Initial work proposed was to set up a temporary camp and clear the snow on Glowworm lake for an airstrip that would accommodate a Dash 7 aircraft for the delivery of fuel drums for an upcoming exploration program.

Photo #1 - MV2017C0022 - Glowworm Lake  
An airstrip was cleared on the ice surface of Glowworm Lake to accommodate the use of a Dash 7 aircraft for fuel delivery.

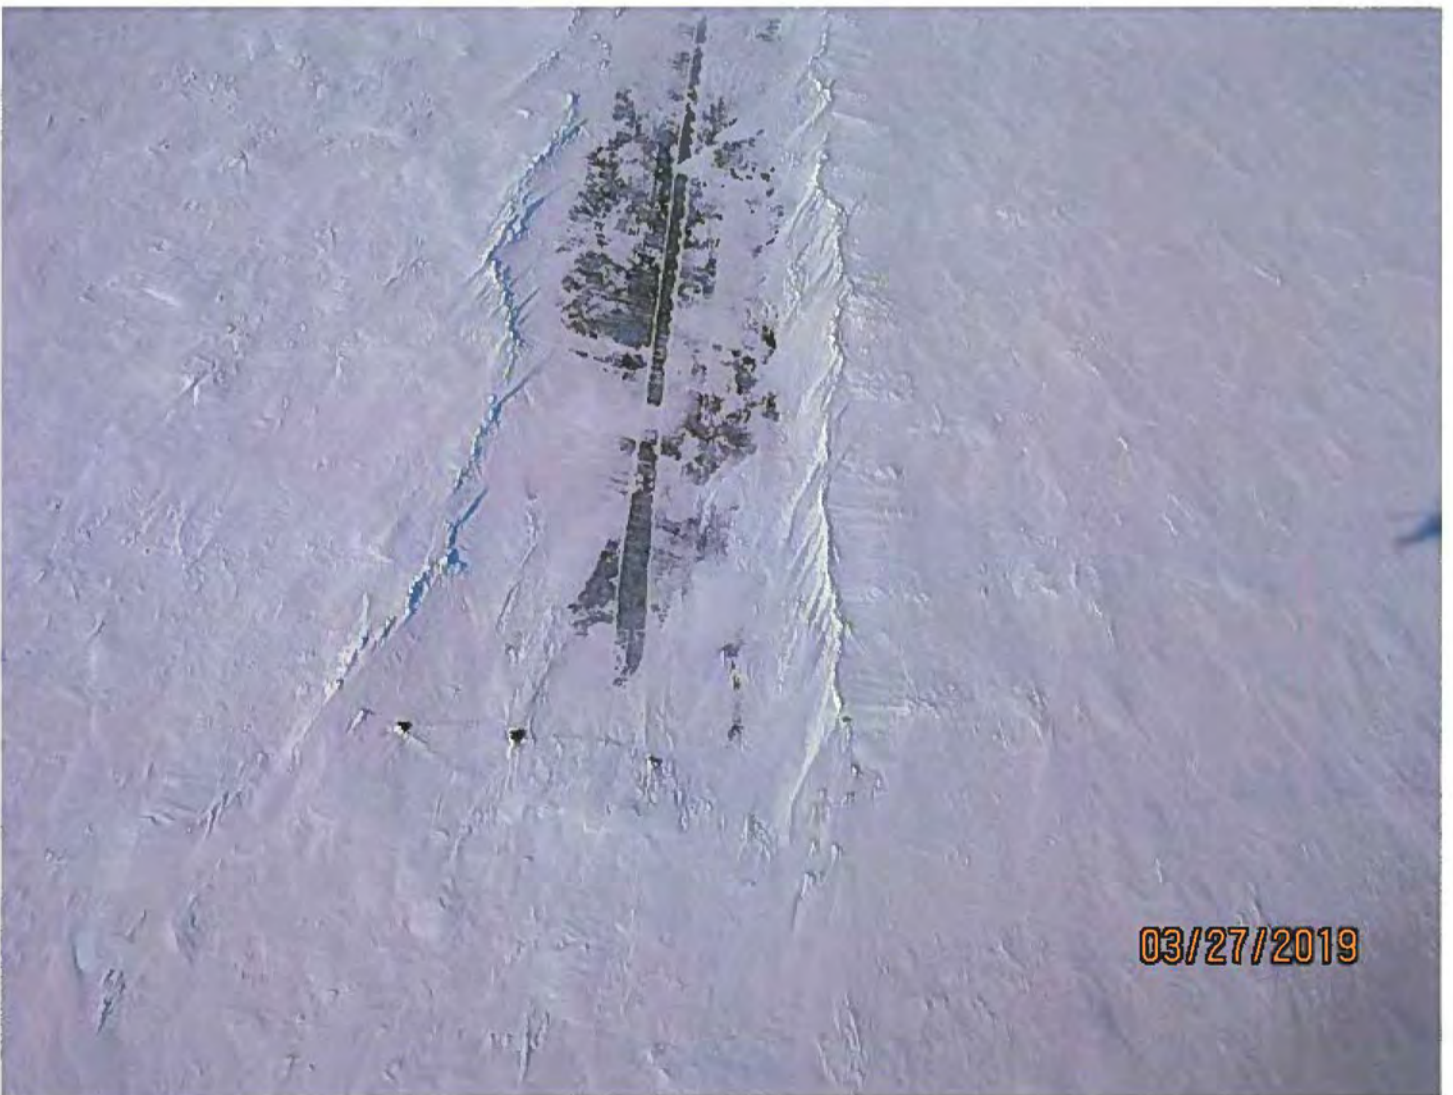
The airstrip can be viewed in Photo #1 & #2 and the only concern noted was the requirement for the Permittee to retrieve the airstrip markers that were left on site. This concern was brought to the attention of Mr. Marshall and Inspectors were informed that a plan to retrieve the markers is in the works and this concern will be addressed prior to spring freshet. This cooperation is appreciated and please let Inspectors know when this task is completed.

Photo #2 - MV2017C0022 - Glowworm Lake  
Airstrip markers were left on the airstrip and must be removed by the Permittee.

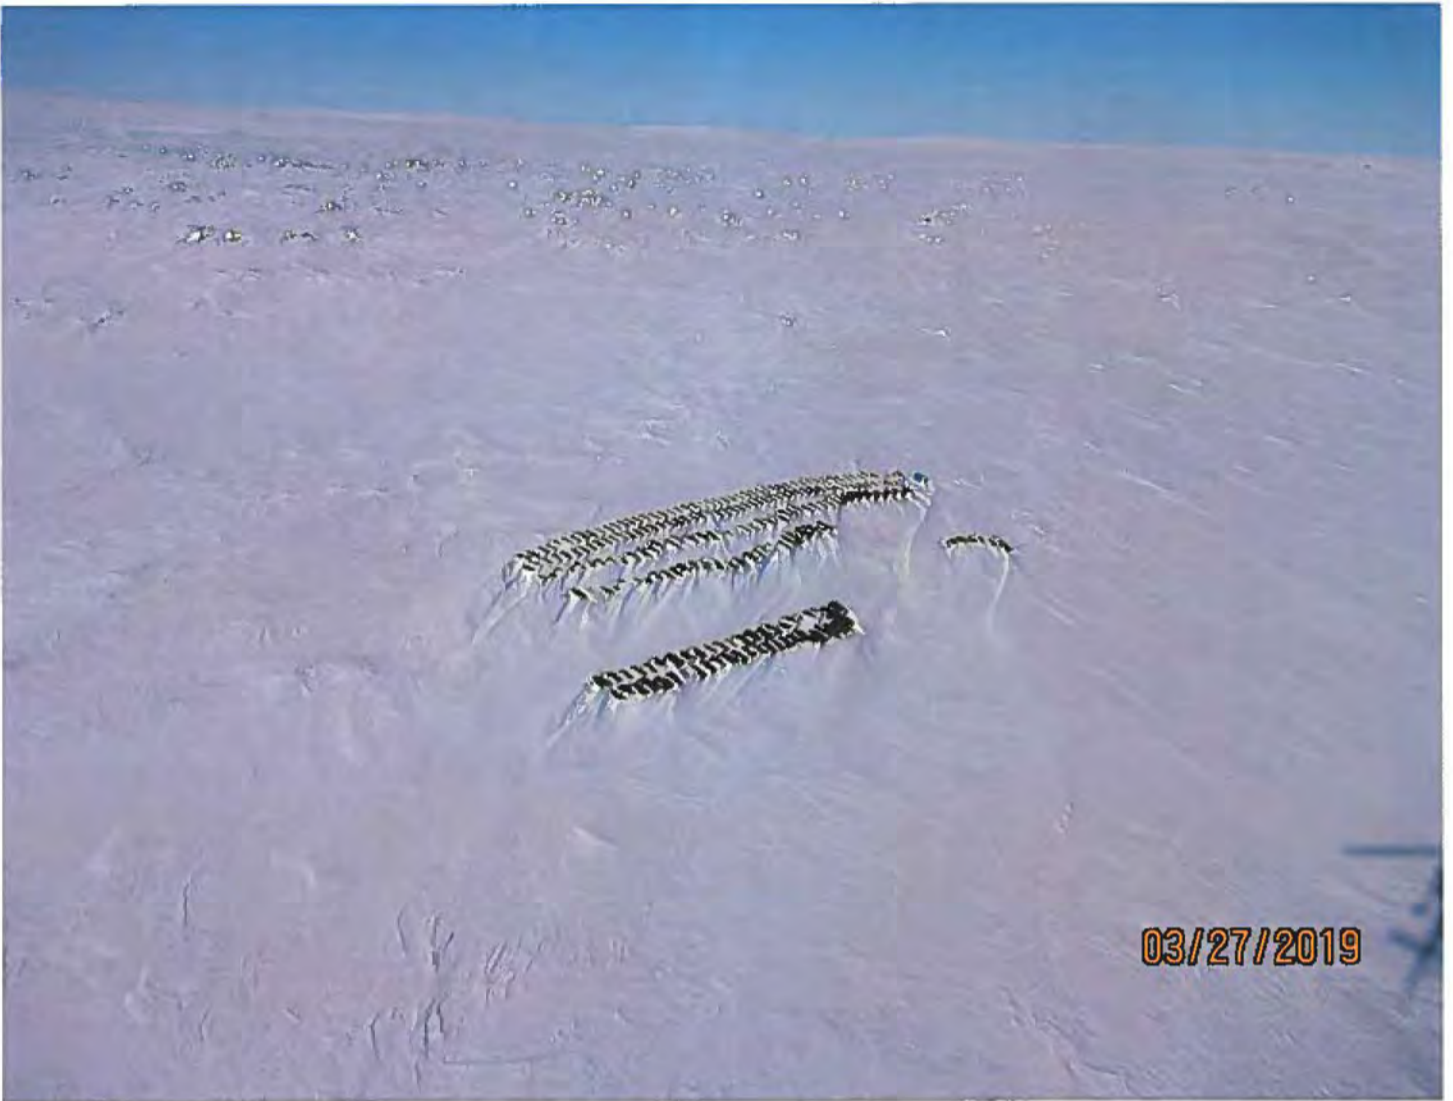
The fuel cache can be viewed in Photo #3 & #4 and consists of 166 drums of jet fuel, 47 drums of diesel, 6 drums of gasoline, and 1 propane cylinder. No concerns were noted with the fuel cache since it appears to have been positioned greater than 100 metres from the ordinary high water mark of Glowworm Lake, wooden stakes are present to mark the fuel location, the majority of the bungs appeared to be at three and nine o'clock, and a spill kit was present.

Photo #3 - MV2017C0022 - Glowworm Lake  
A fuel cache has been established in the land use area.

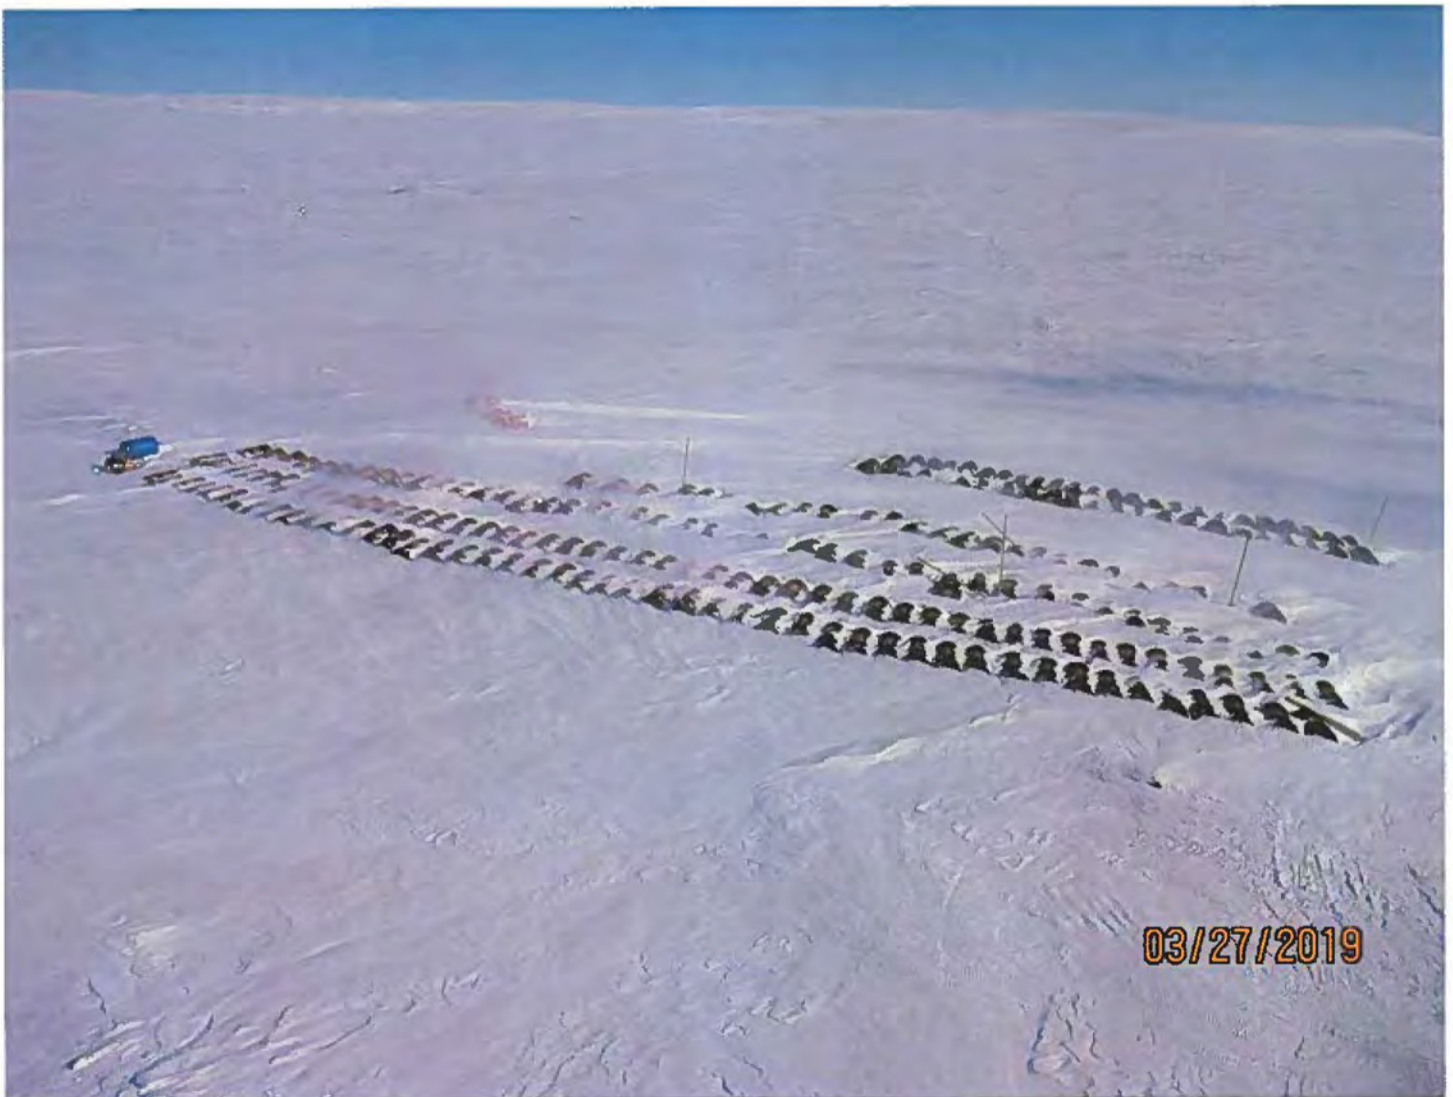
Photo #4 - MV2017C0022 - Glowworm Lake  
Another view of the fuel cache and a spill kit is present.
