**Re: Land Use Permit MV2017X0005
Bluefish Lake Hydro Facility
Bluefish Lake, NT**

ENVIRONMENTAL INSPECTION REPORT

| Location(s) Inspected: | Winter road from McMeekan Bay to the Bluefish Hydro Facility at the north end of Prosperous Lake. |

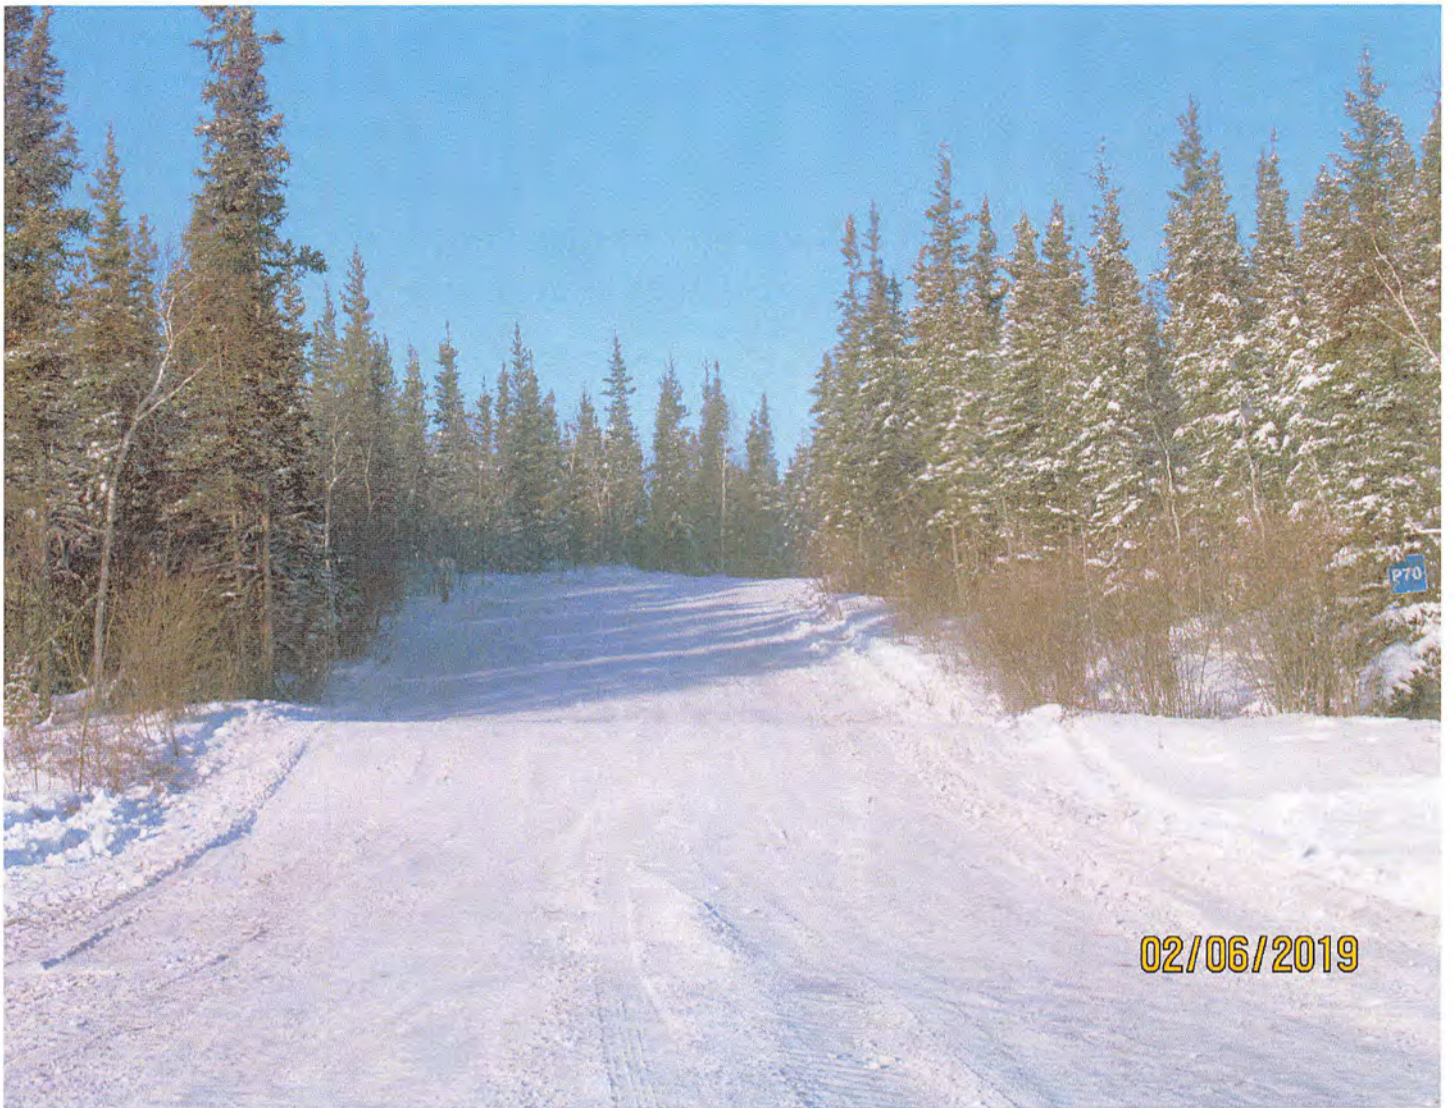
Photo #1 - MV2017X0005 - NTPC - Bluefish Winter Road
Looking north at the first portage along the route. Sufficient icing was present.

It was noted during the February 4th, 2019 inspection that the portages required further icing to meet the requirements of Condition #11 of the land use permit. The Inspector is pleased to report that compliance has now been achieved and the winter road is in an acceptable condition to allow for the movement of vehicles. The Contractor's efforts to continue watering portages after the previous inspection is appreciated.

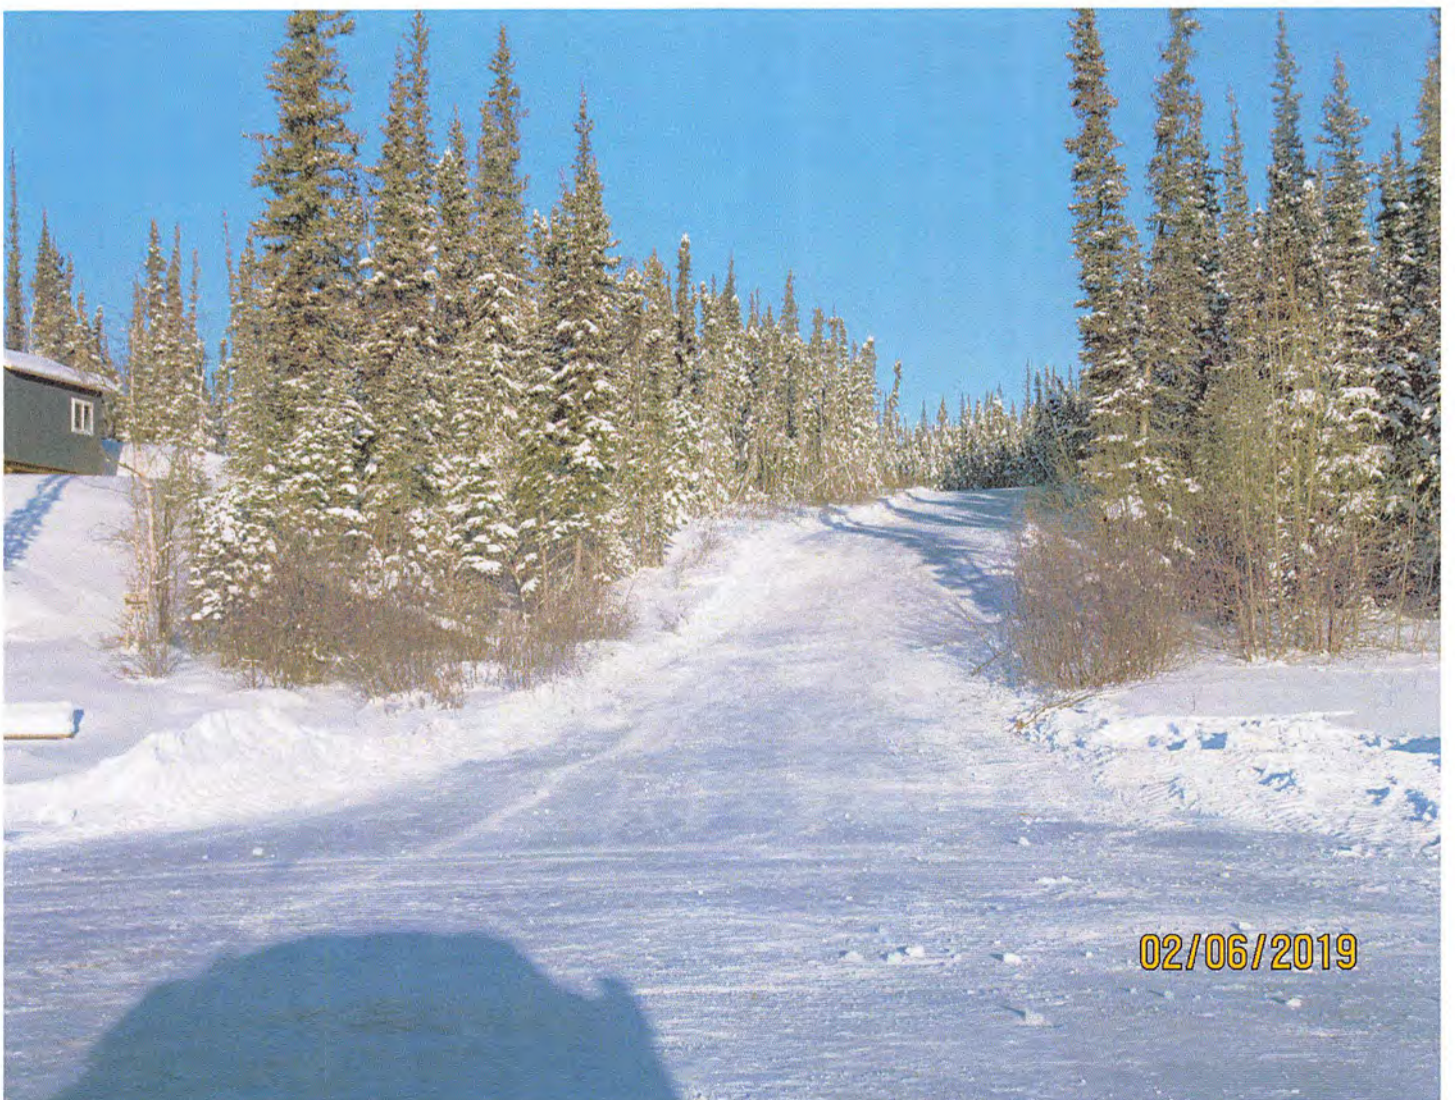
Photo #2 - MV2017X0005 - NTPC - Bluefish Winter Road
Looking north at the portage at the north end of Prosperous Lake. Additional icing occurred since the last inspection.
