November 15, 2017

**File Number** MV2017X0019  
**Type of Operation** HWY MAINTENANCE & OPERATIONS  
**Location** Geotechnical Investigations at Km 243.8, NWT Hwy No. 1

## ENVIRONMENTAL INSPECTION REPORT

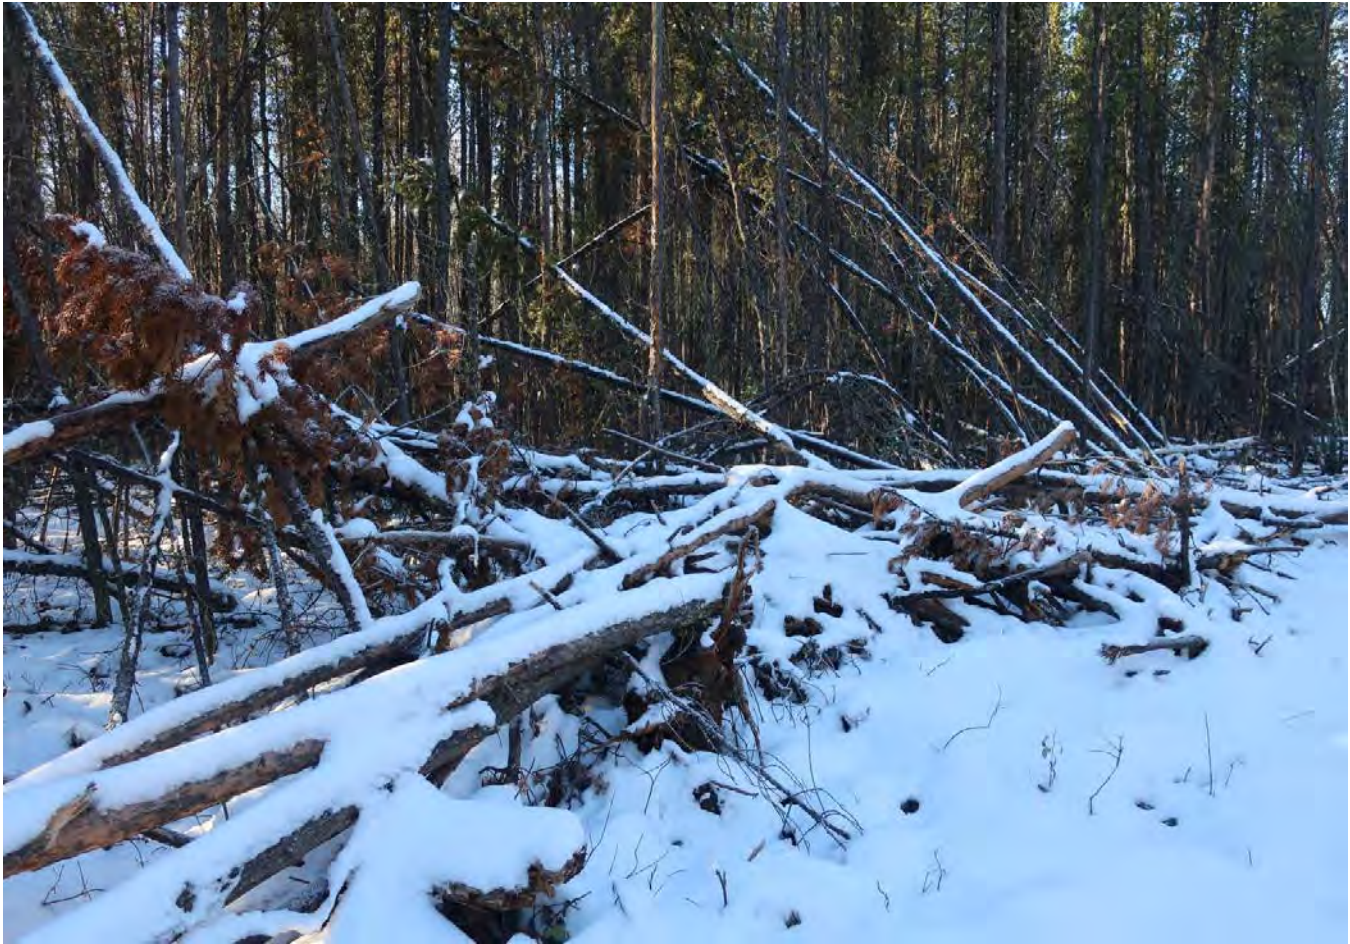
**Figure 1**

adjacent forest when clearing the access line. It was observed that trees were pushed into the adjacent forest during line clearing. This practice makes it more difficult to complete brush disposal during site remediation.

**Trees pushed into the standing timber, windrowed brush has not been made to lay flat.**

2. The Permittee has done a poor job of completing brush and debris disposal. The acceptable method of brush disposal on the lines is a) Windrowing the brush and debris to the side of the line; or b) Spread/scatter the windrows of brush and debris back over the line. All brush and debris that has been windrowed or scattered must be crushed by heavy machinery in order to compact the brush and debris so that all parts of the trees lie flat on the ground surface.

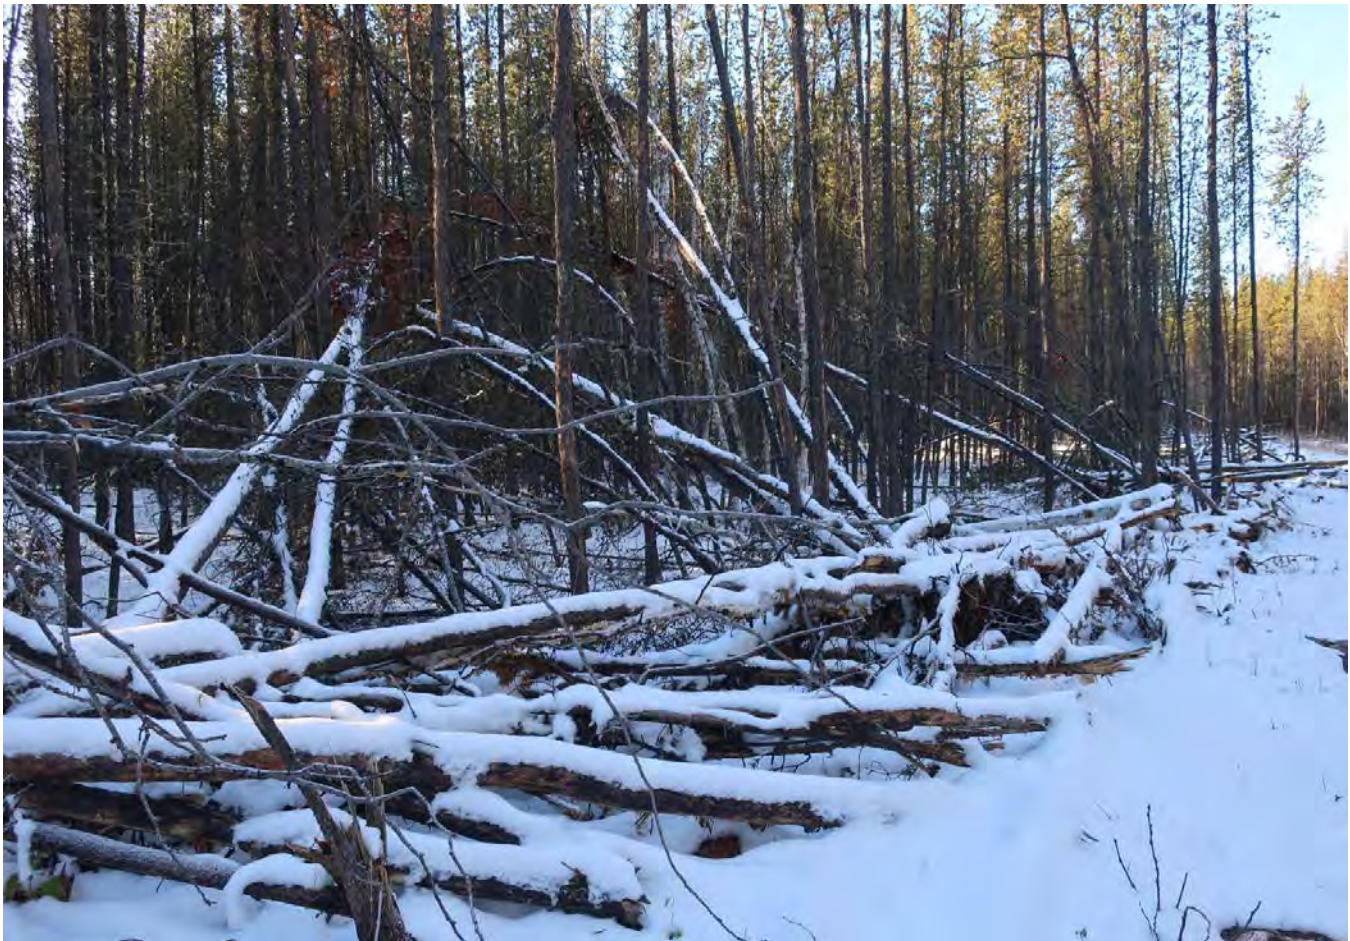
**Figure 2**

**Trees pushed into the standing timber, windrowed brush has not been made to lay flat.**

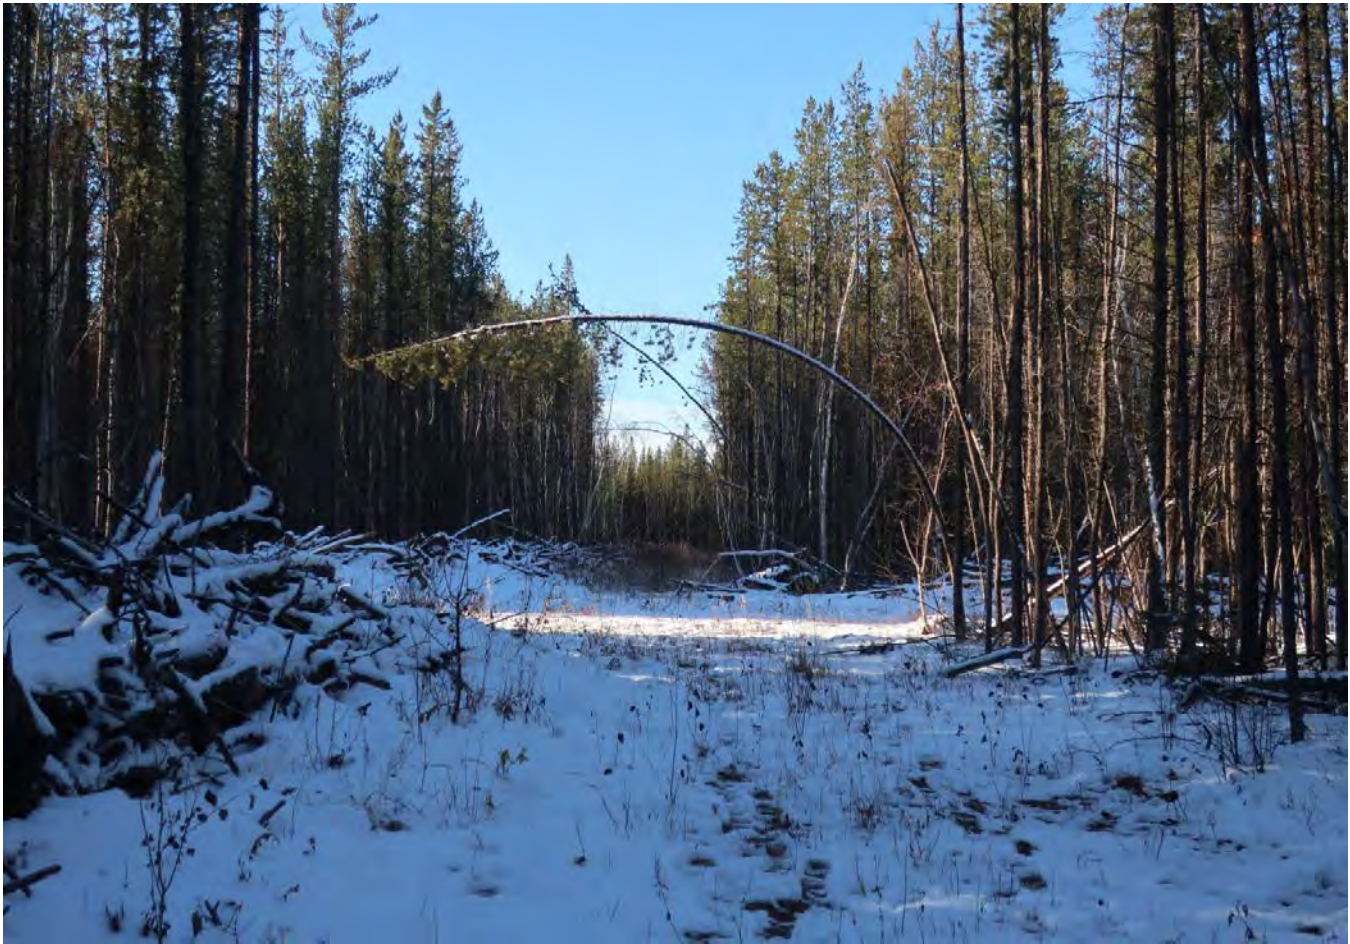
**Figure 3**

**Leaners over the access line must be removed.**

3. The Permittee has not disposed of leaners found along the lines by pushing or felling the trees into the adjacent forest and cutting the tree into lengths so that all parts of the trees felled lie flat on the ground surface
