INAC-CARD Giant Mine UBC Bridge

RE: Land Use Permit MV2017X0030 –Giant Mine UBC Bridge Project

ENVIRONMENTAL INSPECTION REPORT (MV2017X0030)

Current Stage of Operation:	Bridge Reconstruction
-----------------------------	-----------------------

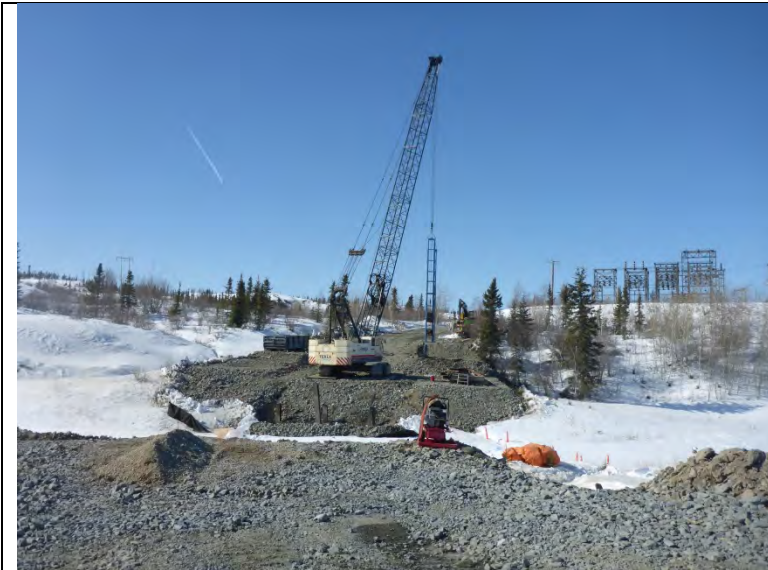
The Inspectors noted at the time of the inspection that site personnel had moved the 110 ton crane (Photo #1) from the east side to the west side of Baker Creek. The contractor was setting up a drill platform on the west side. One ATCO trailer and one portable toilet remained on the east side as well as other support equipment. The Inspectors had no concerns with the waste management onsite as it appeared to comply with conditions #18 and #19 of the land use permit.

Photo #1: 110 Ton Crane moved to the west side of the bridge.

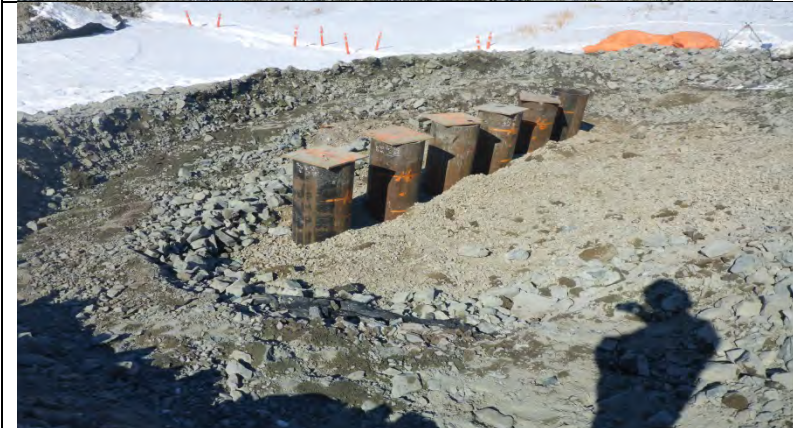
Site personnel explained that the 6 holes were drilled and positioned in place (Photo # 2). These 6 piles are 20 inches in diameter compared to the old piles which were 7 inches. Once the drilling platform is completed on the east side of the creek, the remaining 6 piles will be drilled and placed. The Inspectors explained that mitigation measures should be put in place to prevent any impacts to Baker Creek given the project could possibly run into freshet and ice free conditions.

Photo #2: 6 New 20" piles on the east side of Baker Creek.

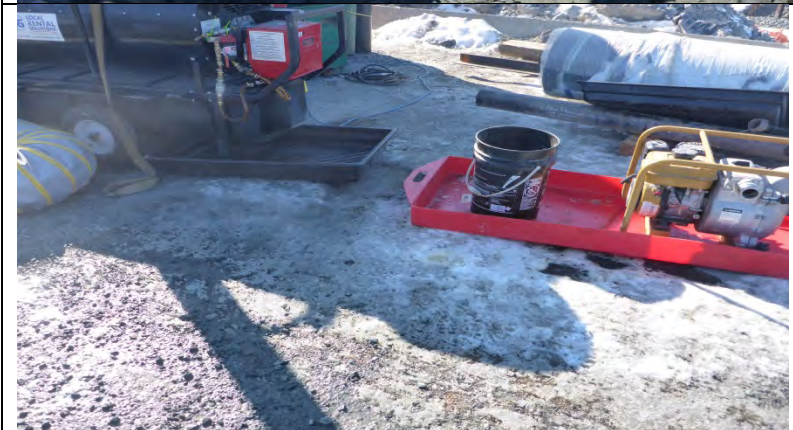
The Inspectors noted that the area was very clean and drip trays were placed under all stationary equipment (Photo #3) in accordance with condition #26 of the land use permit and that no fuel tanks were present within the immediate land use area. One small spill of 0.8L Hydraulic oil was reported (Photo #4) which had been cleaned up and disposed of in accordance with the waste management plan.

Photo #3: Secondary containment under machinery containing fuel.

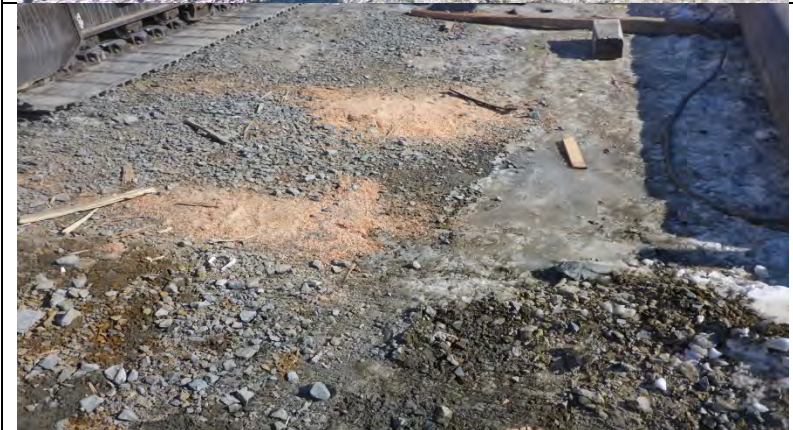
Photo #4: Area where approximately 1L of hydraulic oil spilled and was reported.
