An inspection of the Incorporated Hamlet of Tulita's Water Licence #S16L3-001 was conducted on September 16, 2020. Specifically, the Water Licence was inspected to ensure that the terms and conditions of the licence were met. Enclosed is a copy of the Inspection Report for your review and records.

WATER USE INSPECTION REPORT

Licence #	S16L3-001	Expiry Date	November 01, 2026
Licenece	Incorporated Hamlet of Tulita	Previous Inspection	June 4, 2018
Company Rep	SAO	Inspection Date	September 16, 2020

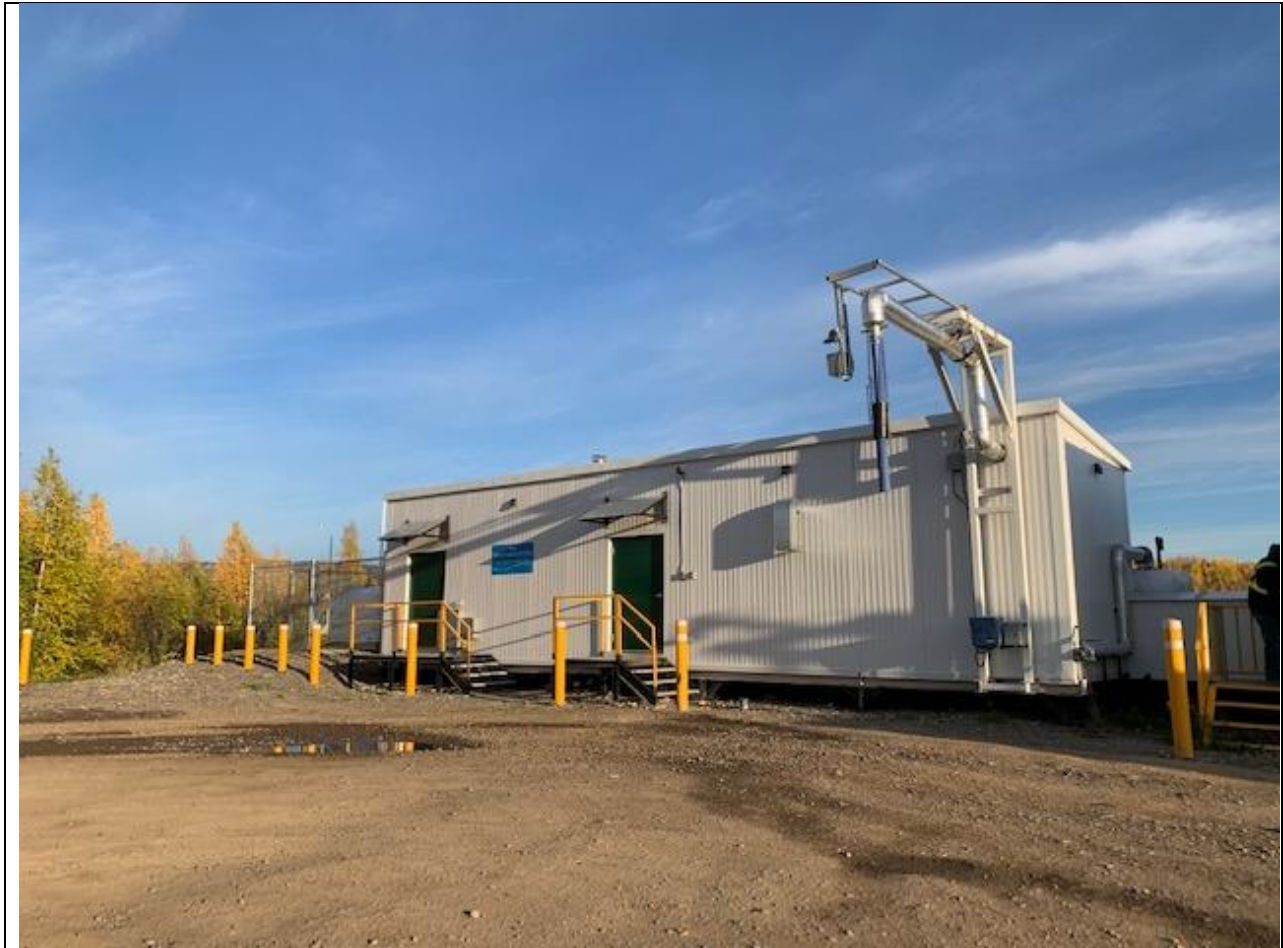
Figure 1: Water Intake Facility

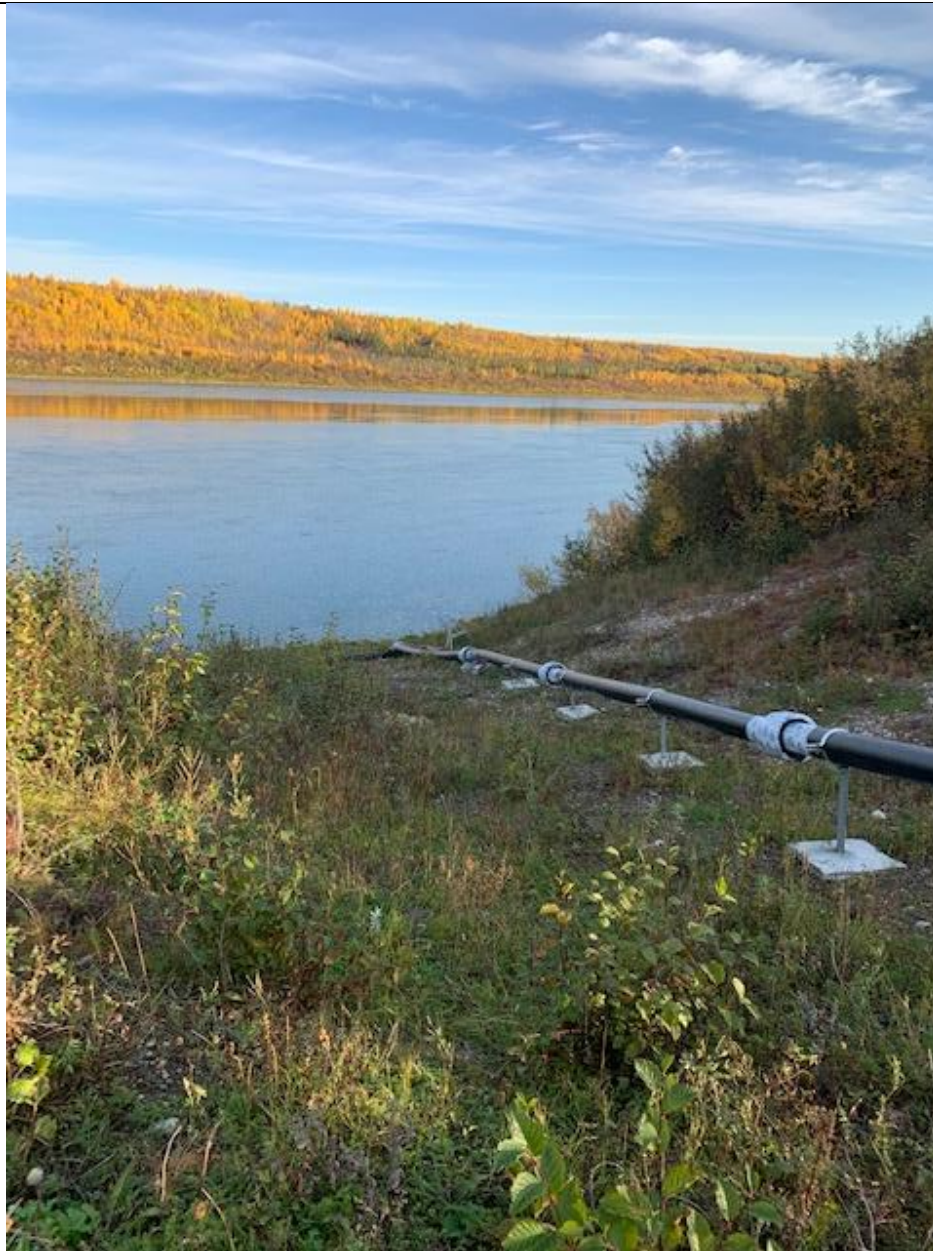
Figure 2: Hose for water flow

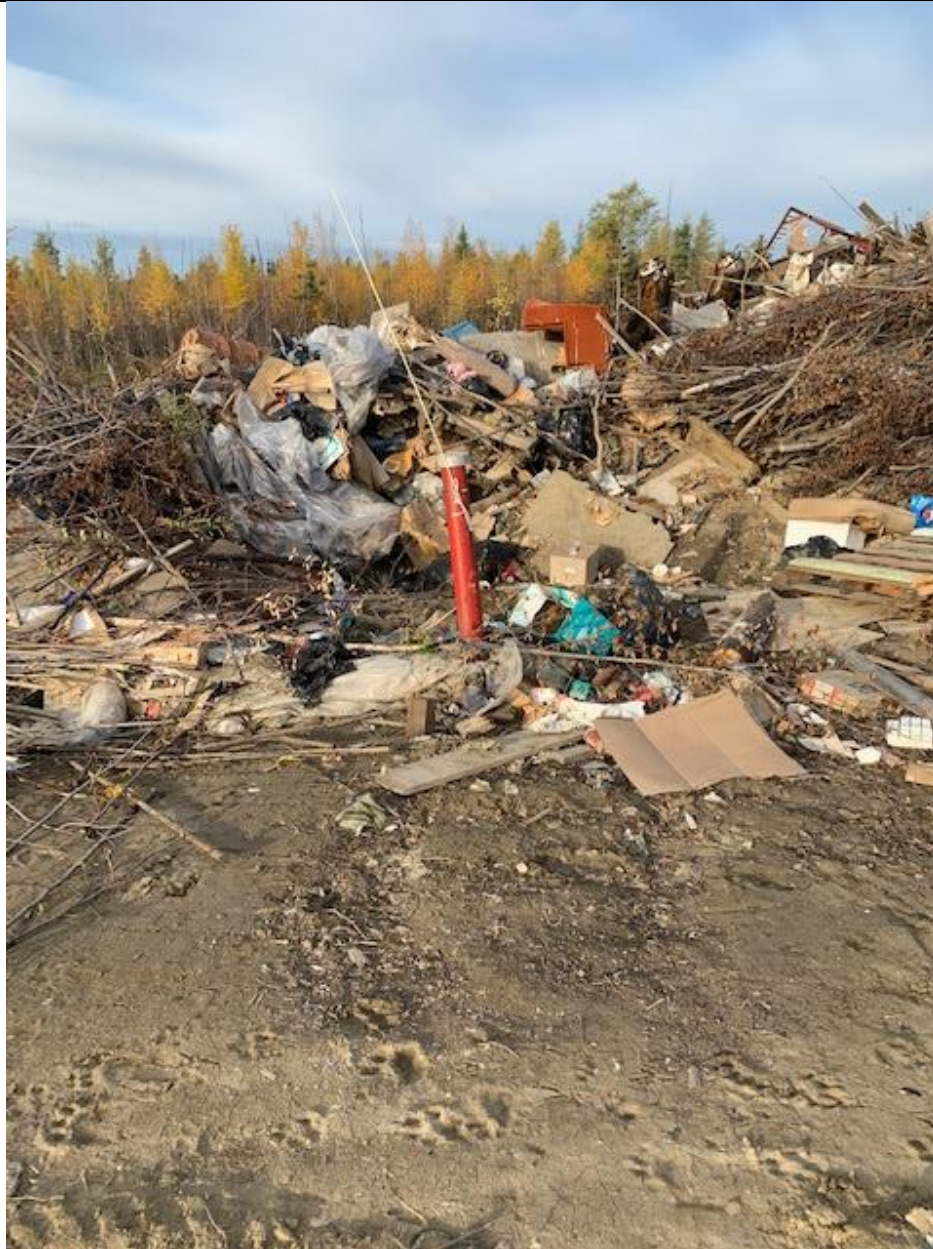
Figure 3: SNP sampling station located at Solid Waste Facility

Since the last report dated June 4, 2018, the signage at the Solid Waste Facility has been updated and it seems to be segregated for the most part, but upkeep and daily monitoring needs to be followed. The entrance could also use more signage for the public as to what can be thrown out and what can be recycled. The SNP sampling stations needs signs with locater numbers as well.

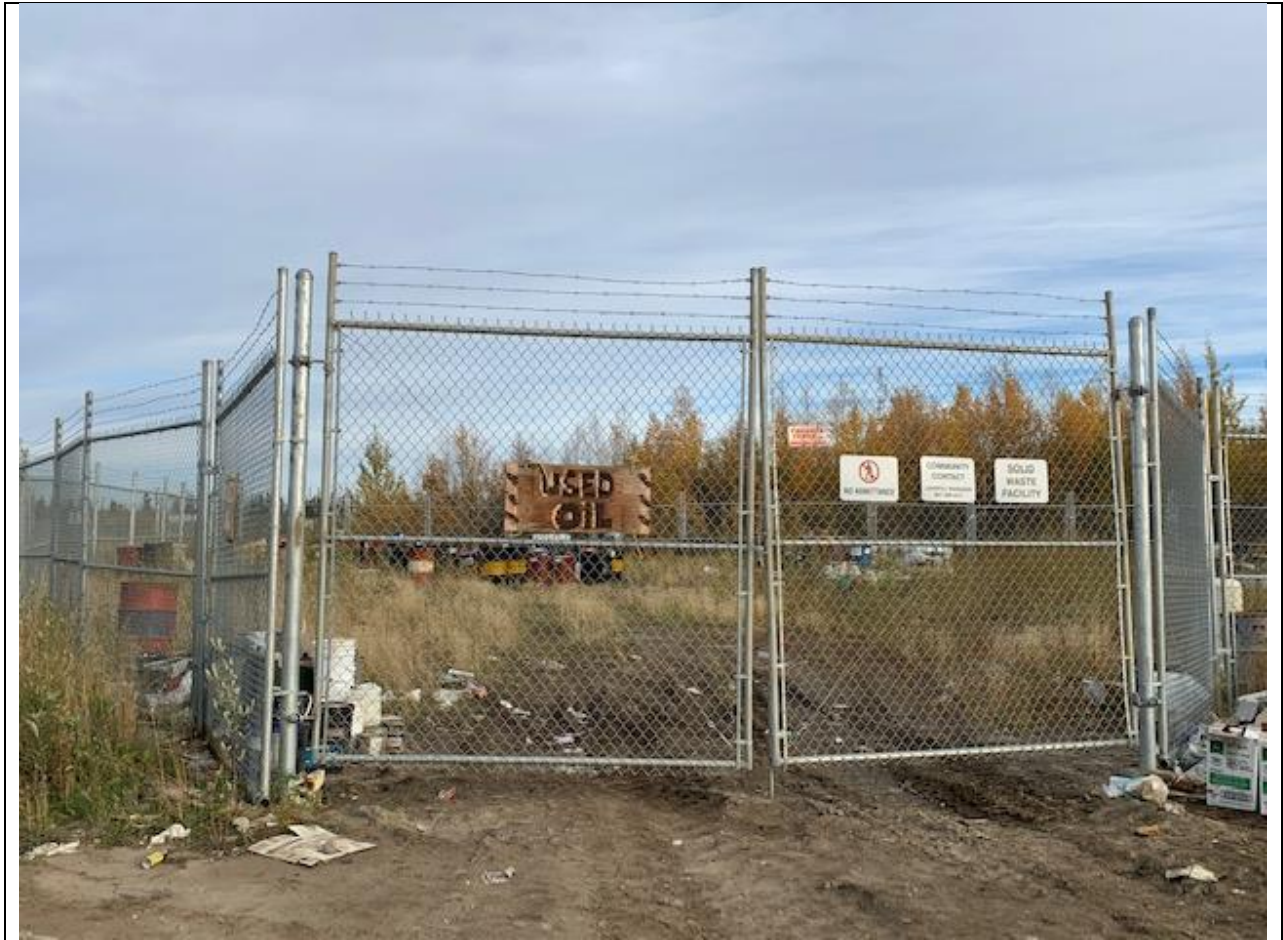
The Solid Waste Facility does have a large amount of hazardous waste that is in a closed fenced off area on the left side entering the facility. Daily maintenance of the facility is required to ensure that the windblown debris is contained.

Figure 4: Temporary Hazardous waste storage located at Solid Waste Facility.

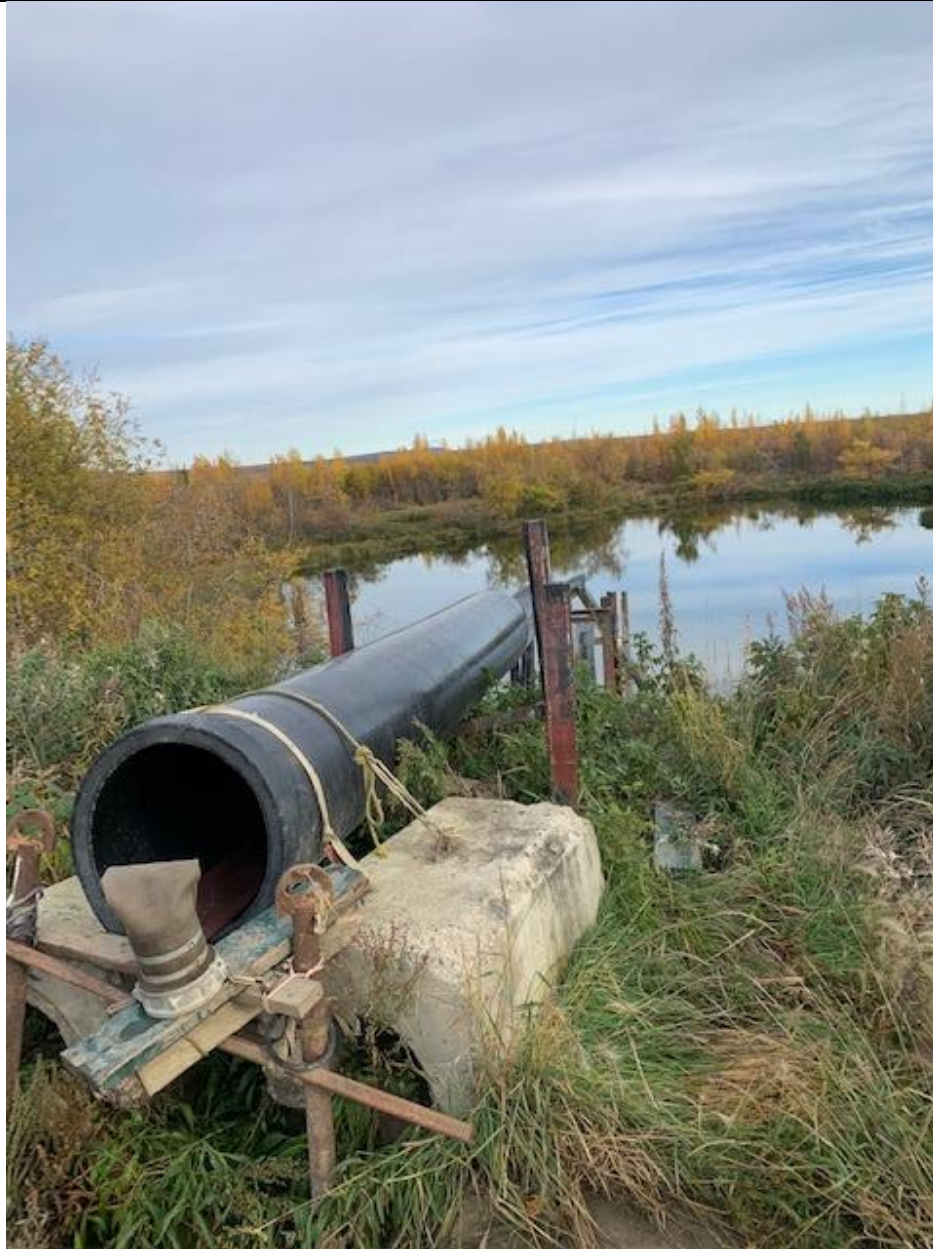
The Sewage Disposal Facility was inspected, there does not seem to be any concern regarding the Water Licence requirements. SNP sampling needs to be done regularly as per the water licence agreement. Highly recommend the update of signage as noted in the previous report.

Figure 5: Sewage Lagoon

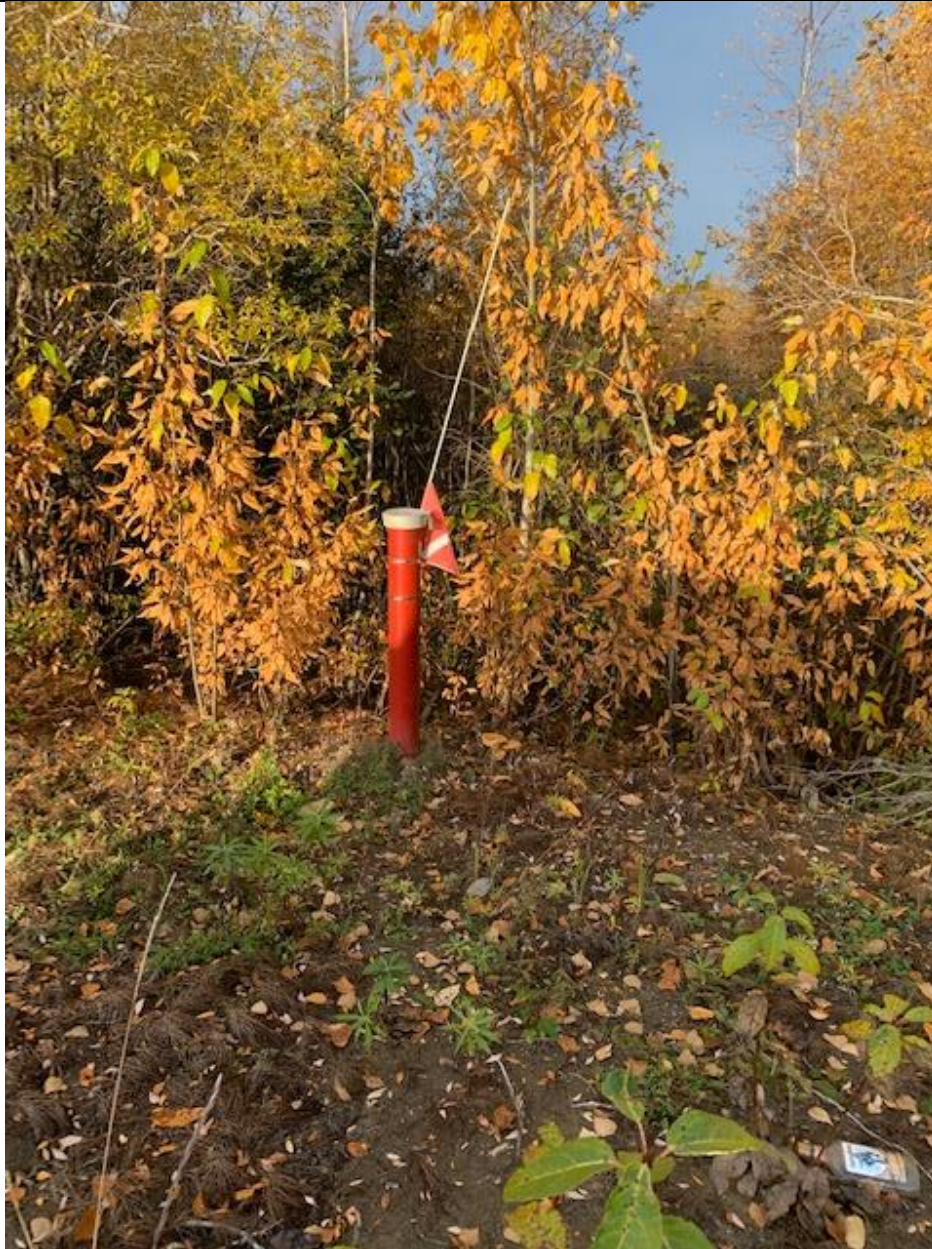
Figure 6: SNP sampling station near Sewage Lagoon, all SNP sampling stations are in need of new signage.
