<b>Attention:</b>	<b>Aldin Jansen</b>
<b>File Number</b>	<b>S16L8-002</b>
<b>Type of Operation</b>	<b>Industrial Type B Water Licence</b>
<b>Location</b>	<b>Canadian Coast Guard Wharf - Norman Wells</b>

An inspection of the repair work taking place at the Canadian Coast Guard Wharf in Norman Wells was conducted on Thursday, March 22<sup>nd</sup>, 2018. Specifically, Water Licence #S16L8-002 was inspected to ensure that the terms and conditions of the licence were met. Enclosed is a copy of the Inspection Report for your review and records.

## WATER LICENCE INSPECTION REPORT

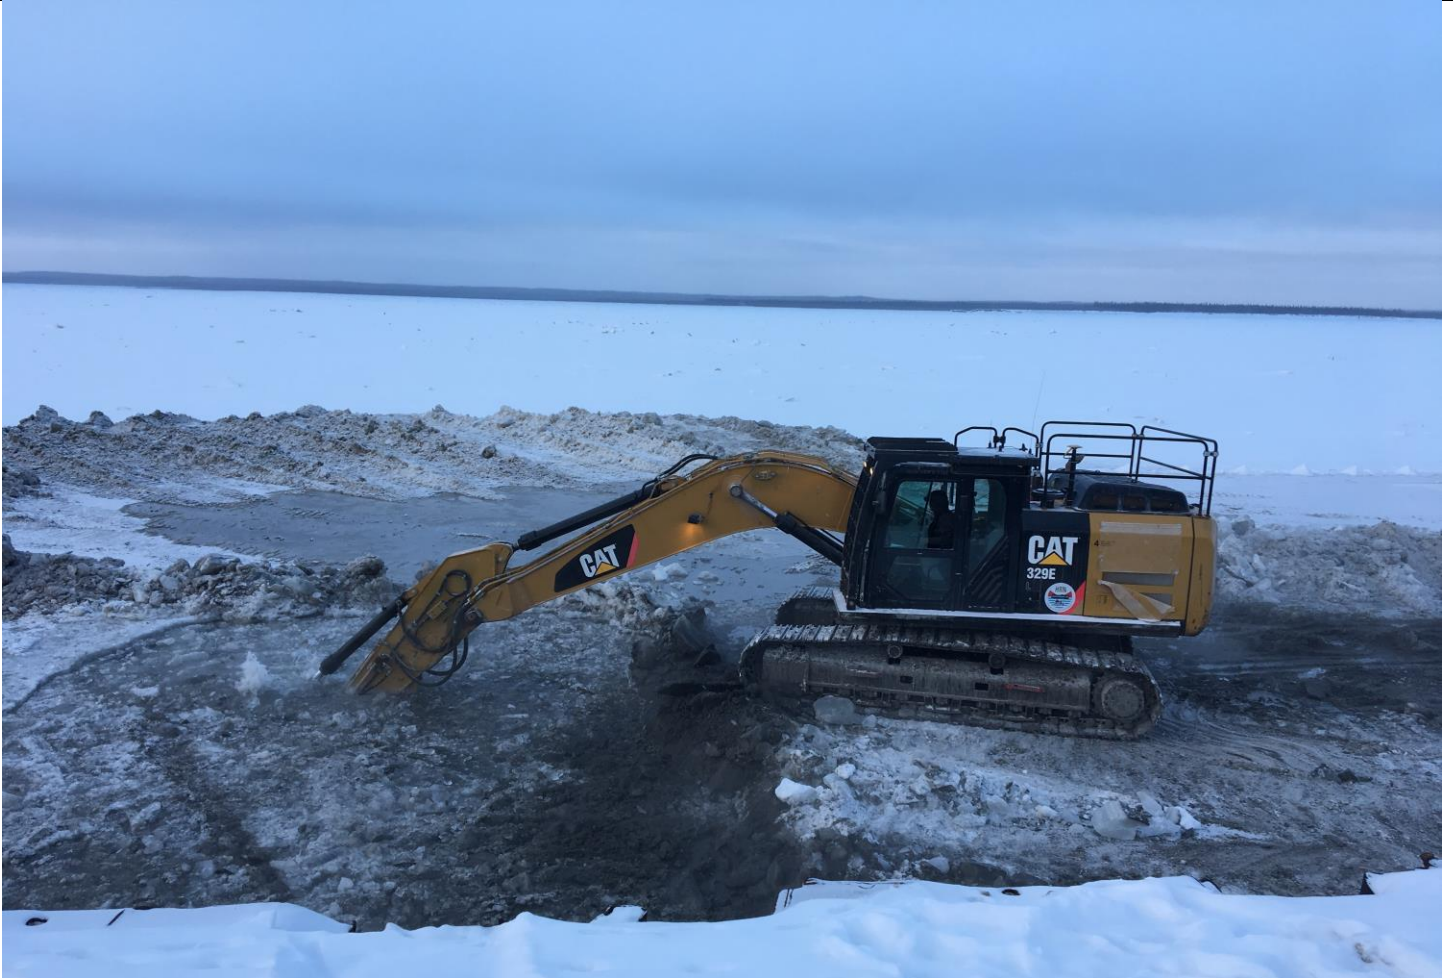
**Figure 1**

On Thursday, March 22<sup>nd</sup>, 2018 Water Resource Officer (Inspector) Alex Lynch, inspected the Canadian Coast Guard Wharf repairs to assess the Water Licence (WL) and associated terms and conditions. The first phase of dredging work had already commenced prior to the inspection (See Figure #1). The Town of Norman Wells will be accepting the dredged materials as landfill cover at the local solid waste facility. Dredged materials are being separated into piles on the wharf where they will be stored temporarily and tested for Total Petroleum Hydrocarbons (TPH), BTEX and Extractable Petroleum Hydrocarbons (EPH) prior to being shipped to the solid waste facility (See Figure #2). It is anticipated that 1500m<sup>3</sup> of material will be dredged during this phase of the project. All equipment on site was inspected and there were no visible leaks or damage to equipment (See Figure #4).

Dredging material in progress

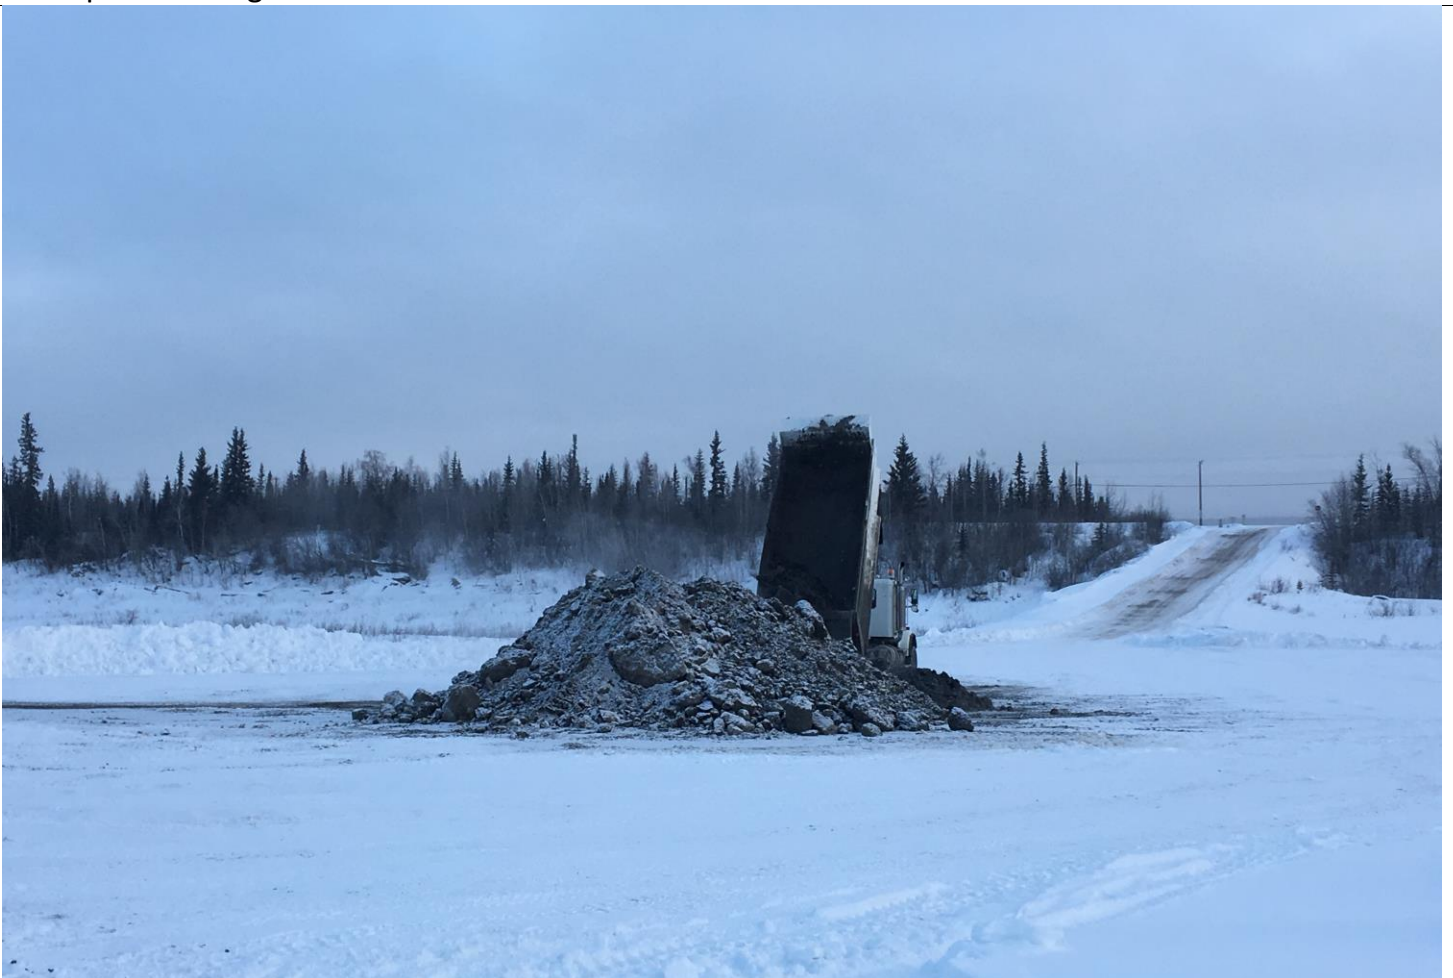
**Figure 2**

Stockpile of dredged material

As per Part D: Waste and Water Management, #6, Prior to the deposit of Waste at a waste facility, an Inspector’s written verification of the facility’s Water Licence compliance and capacity from an Inspector must be submitted to the Board. Please accept this inspection report as written approval from Department of Environment and Natural Resources that dredged material free of contaminants falls within compliance and capacity of the Town of Norman Wells’ Water Licence to accept this material to be used as cover at the local solid waste management facility.

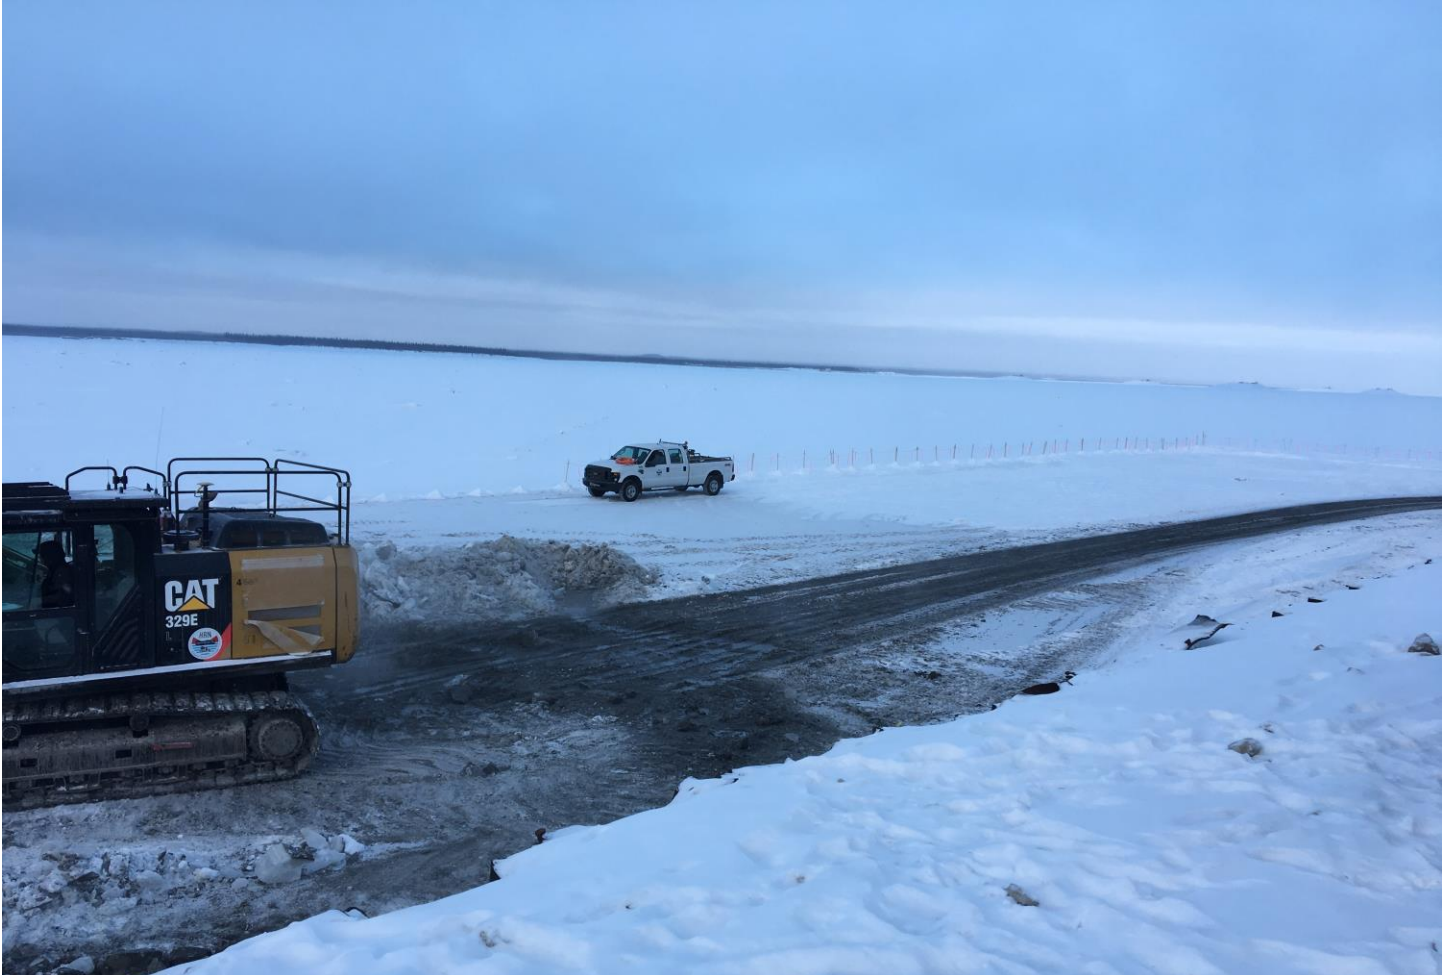
**Figure 3**

Access road to dredging site

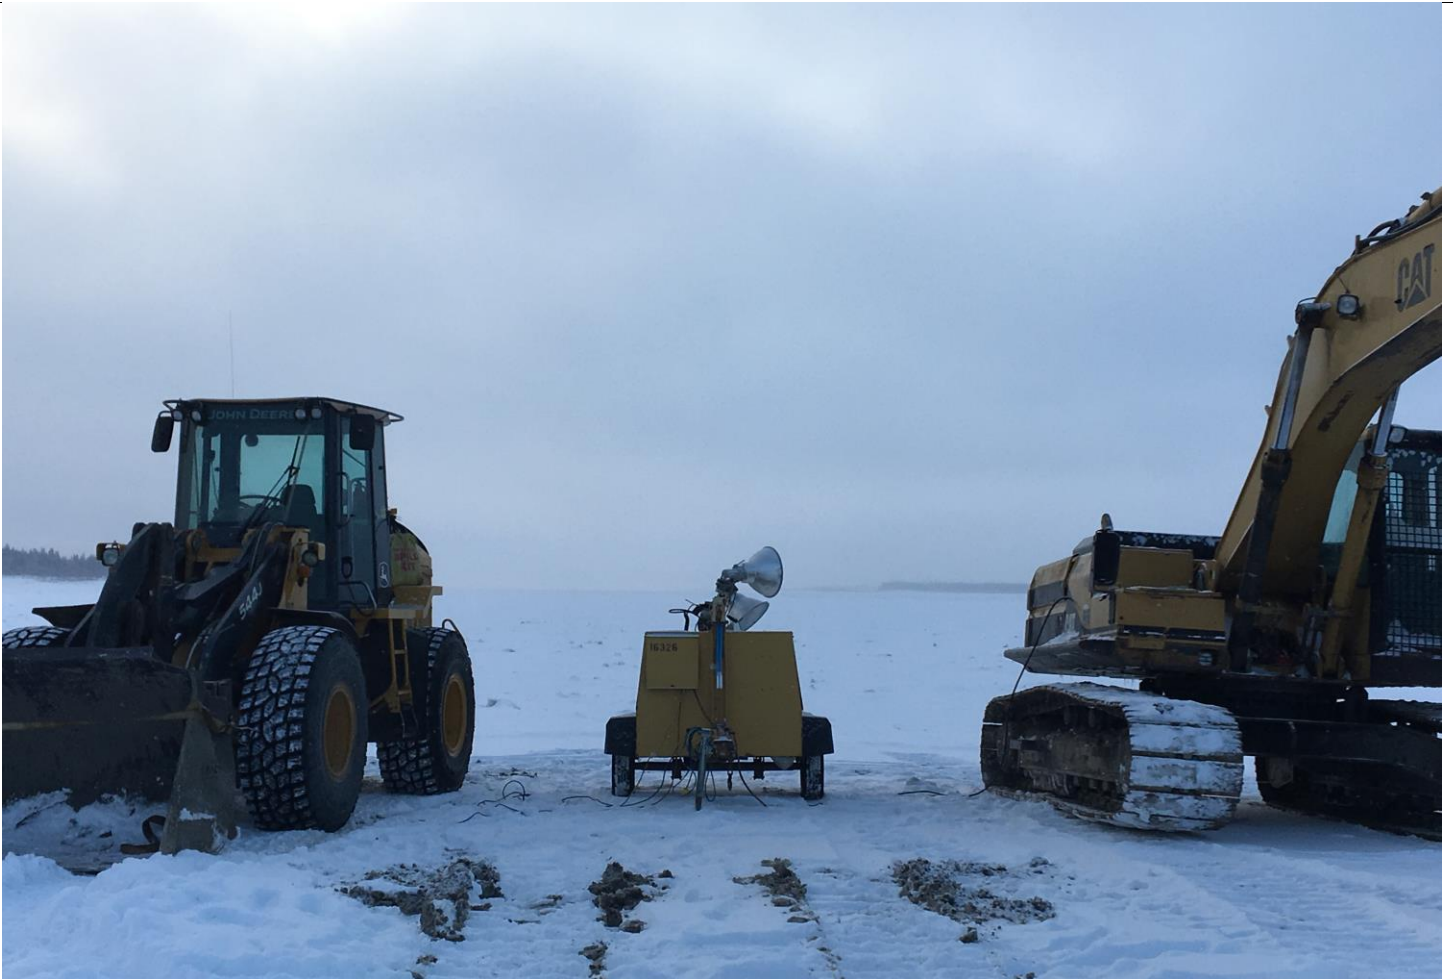
**Figure 4**

Additional equipment on site

As per Part F: Contingency Planning, #3 and #6, please ensure equipment on site is checked on a regular basis for any leaks and ensure all vehicles on site have adequate spill clean-up skits available. Additionally, please ensure that a copy of the Spill Contingency Plan is provided to all persons required to work on this site.
