**Re: Land Use Permit W2014F0002
Winter Road
Snare Forks to Whati/Gamètì Winter Road Junction, NT**

ENVIRONMENTAL INSPECTION REPORT

Location(s) Inspected:	The winter road from the Whati/Gamèti junction to the Snare Forks Hydro Facility.
------------------------	---

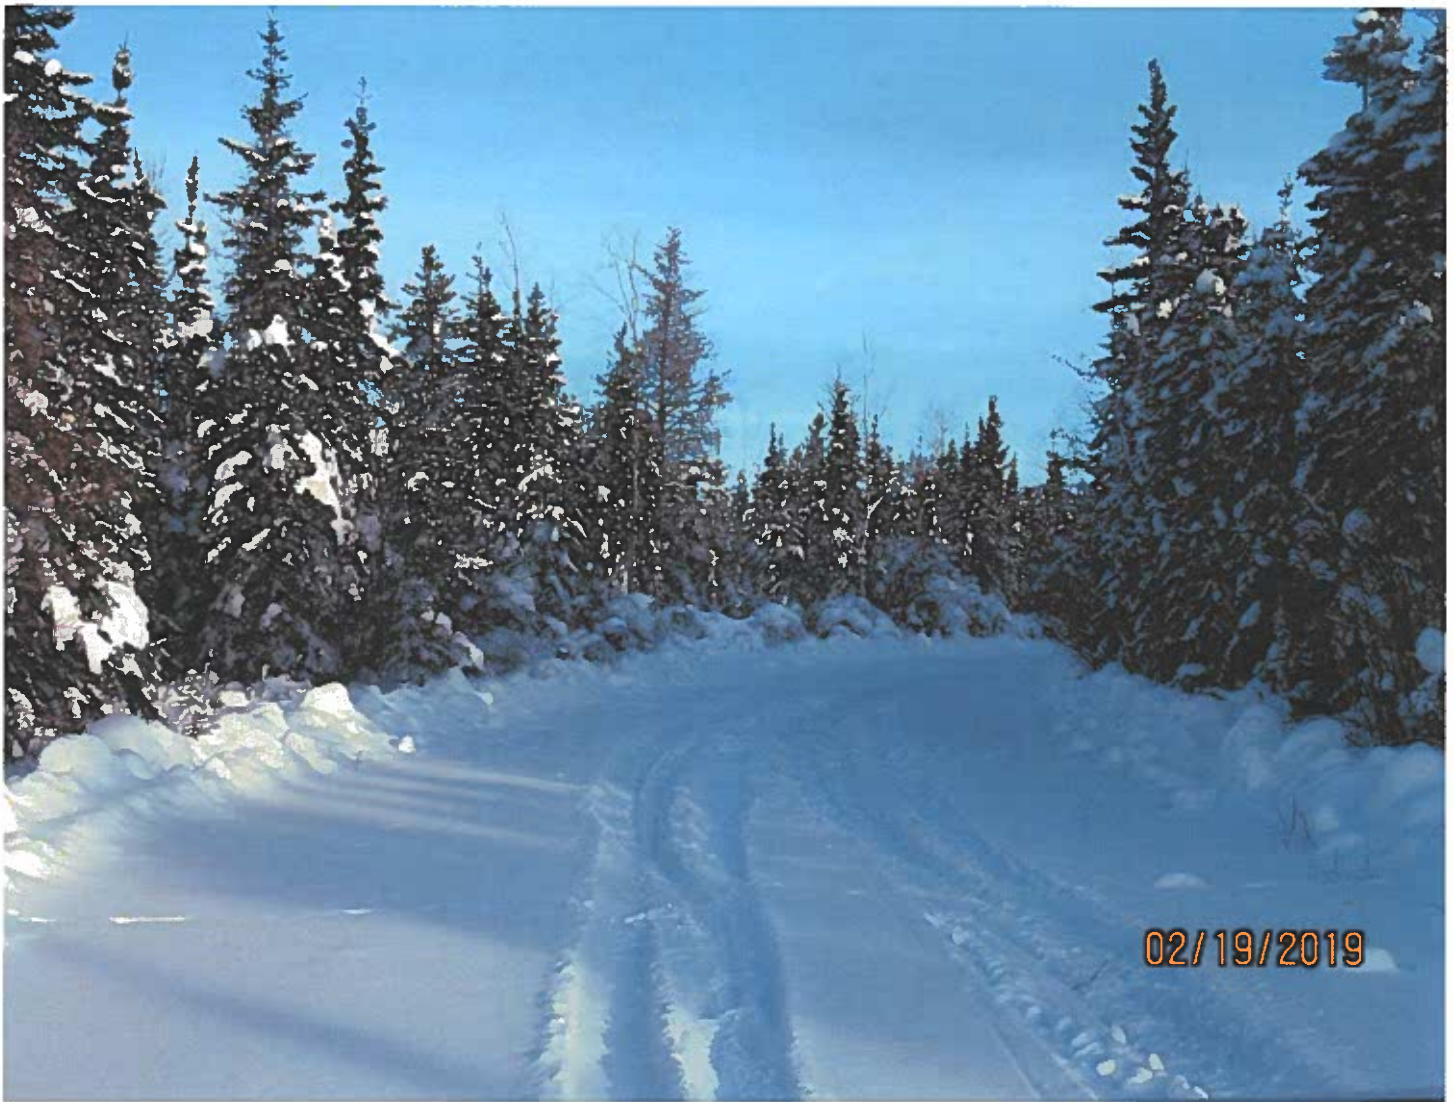
Unfortunately sufficient icing and/or snow pack (10 cm) wasn't present along the entire route (Photo #1 & #2) which is a requirement of Condition #8 of the land use permit. This concern was discussed with Mr. Robert Sunderland (Permittee) upon completion of the inspection and the Inspector was informed that the Contractor is currently making arrangements to bring a water truck into the land use area to finish construction of the winter road prior to use by the Permittee.

Photo #1 - W2014F0002 - NTPC - Share Hydro Winter Road
Looking north at the winter road alignment.

This cooperation to comply with all operating conditions of the permit is appreciated and once the water truck is actively working, the Inspector must be notified so that another inspection can be scheduled.

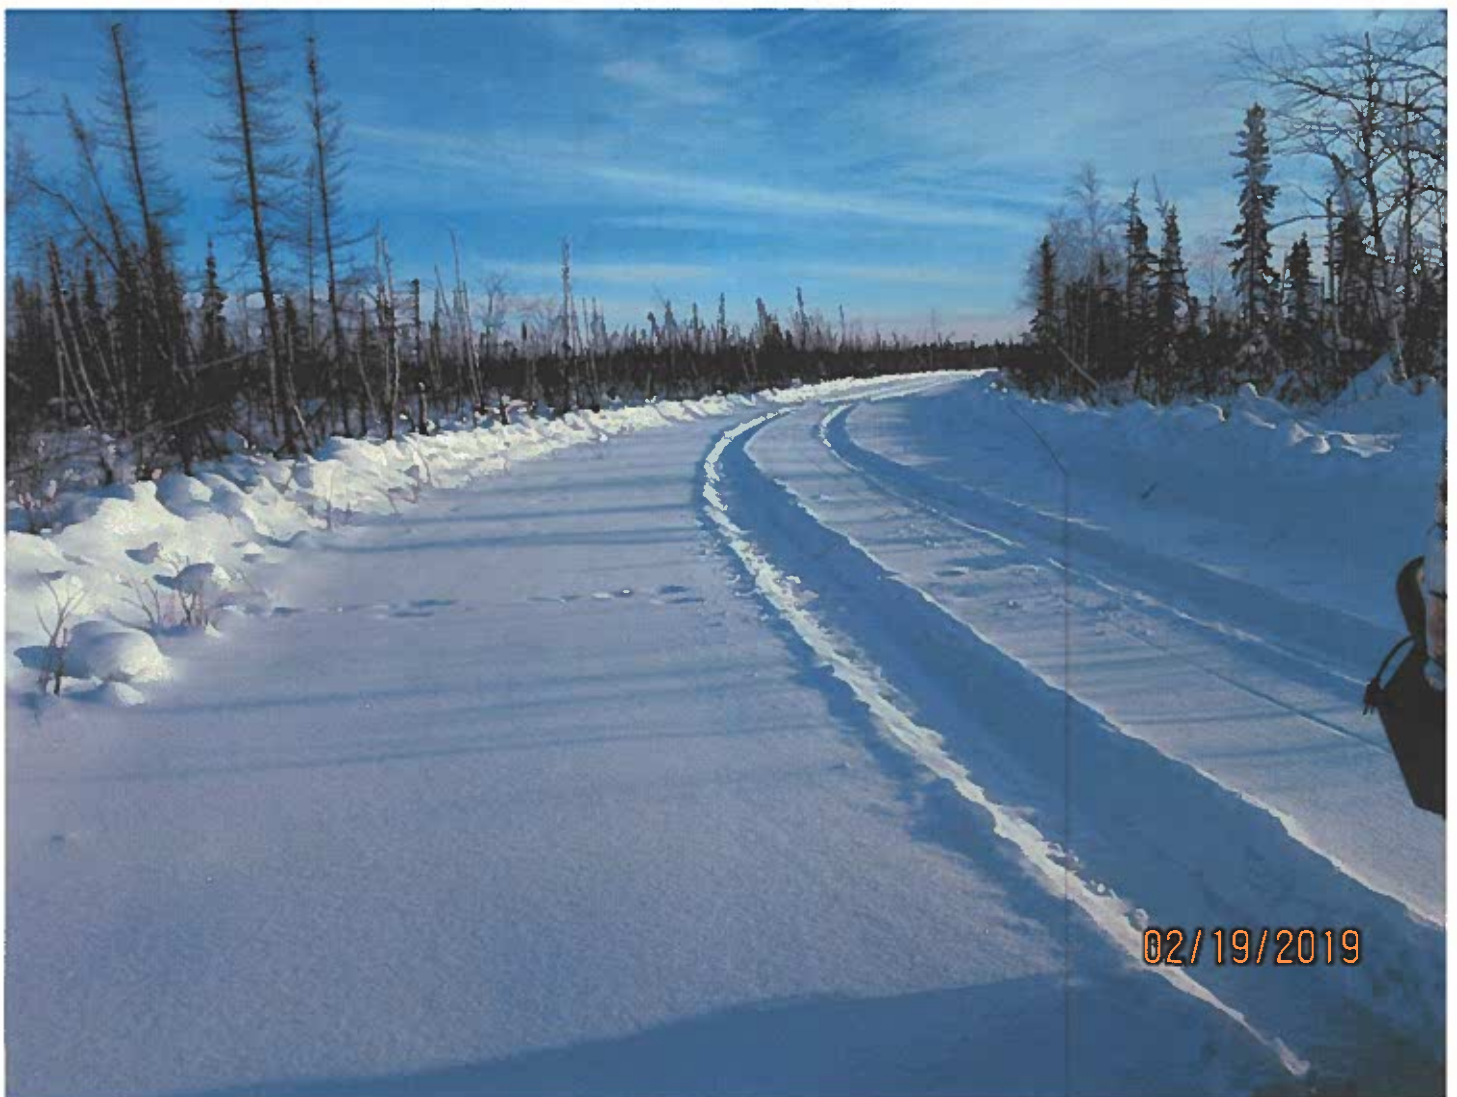
Photo #2 - W2014F0002 - NTPC - Share Hydro Winter Road
Although snow was present, requirements of Condition #8 of the land use permit have not been met.
