**RE: Land Use Permit M2013Q0017
QUARRY SITE - New
NWT Highway No. 5, Km 34.1 Site A & Site C**

ENVIRONMENTAL INSPECTION REPORT

Permittee:	ProCore Drilling Ltd.	Permit Expiry Date:	May 21, 2019
Land Use Permit No.	M2013Q0017	Previous Inspection:	New
Quarrying Permit No.	2013QP0083	Inspection Date:	August 12, 2014
Contractor:		Subcontractor:	
Location(s) Inspected:	NWT Highway No. 5, Km 34.1 Site A & Site C		
Current Stage of Operation:			
Program Modifications Approved:

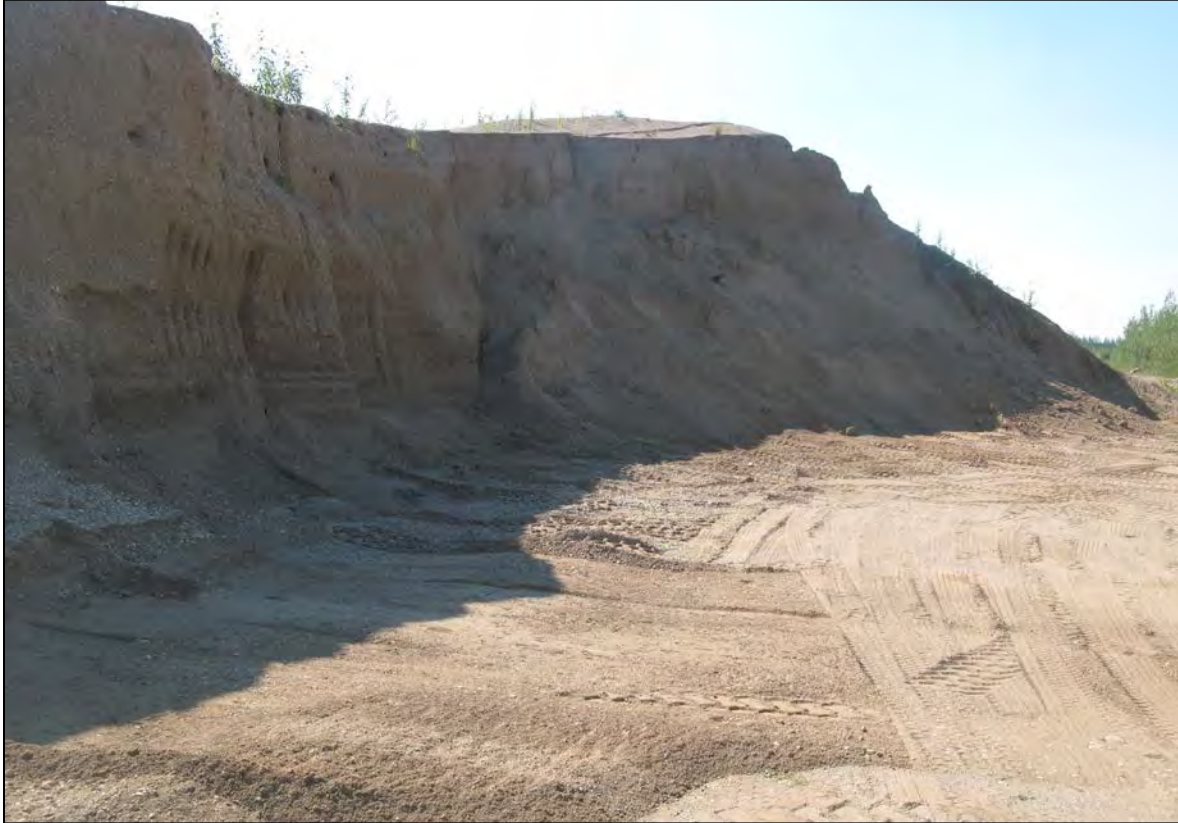
Figure 1

Stockpile must be sloped to a 2:1 horizontal/vertical ratio. Material has been removed from the stockpile recently.

The large stockpile of material must be sloped to a minimum of 2:1 horizontal/vertical ratio as per Condition 16 of your land use permit. The old dryer that is located at the west end of the pit (Site C) must be removed from federal lands and taken to an authorized facility for disposal (Condition 25).

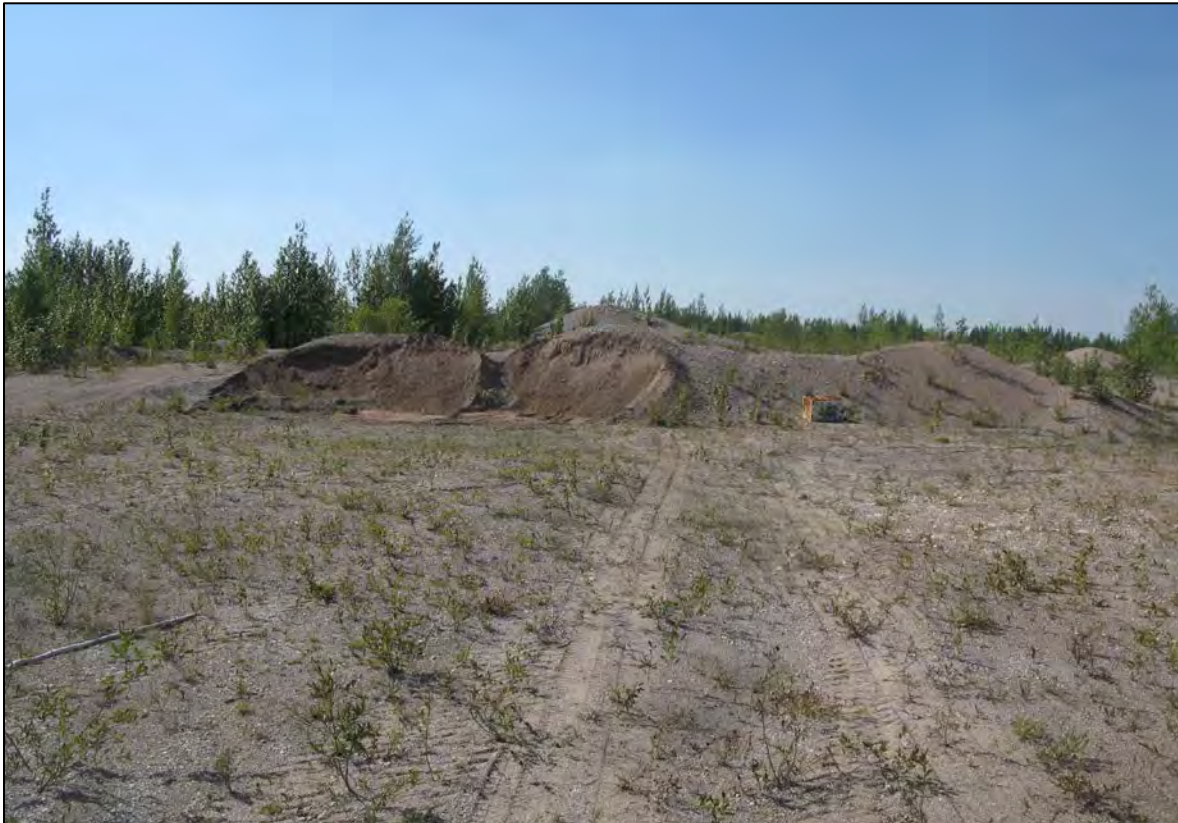
Figure 2

Material has been removed recently from the west end of Site C. Note the old dryer to the right in the picture must be removed.

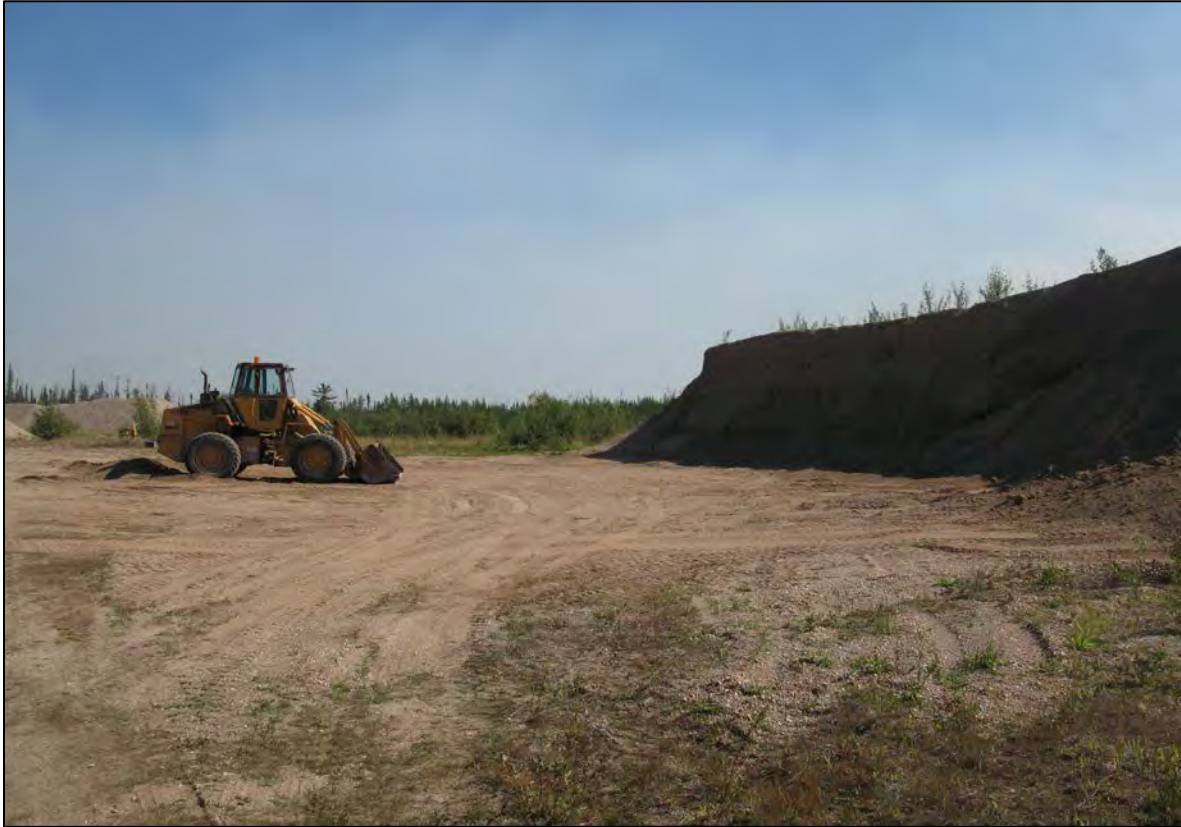
Figure 3

Loader parked near the stockpile at Site C.

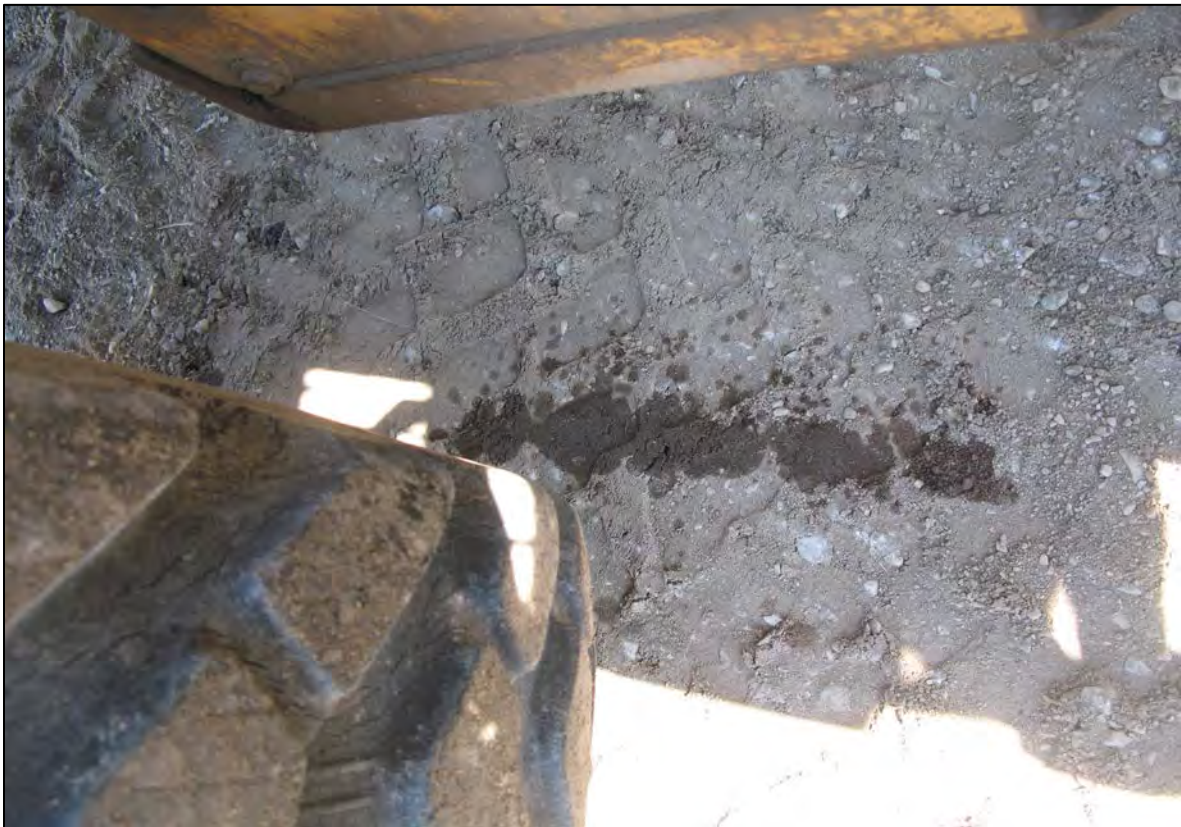
Figure 4

Loader is leaking oil on to the ground. Haz-mat/drip trays are not being used and the loader is not diapered.

It was noted during the inspection that the loader parked at Site C was leaking oil onto the ground. As per Condition 35 of your land use permit "All equipment that may be parked for two hours or more should have a haz-mat/drip tray under it or be sufficiently diapered. (Leaky equipment should be repaired immediately.)" Please ensure that the loader is repaired immediately and Condition 35 is being followed. All contaminated soil must be cleaned up and taken to an authorized facility for disposal (Condition 32 and 36).
