File Number	MV2013Q0017
Type of Operation	QUARRY SITE - New
Location	Km 34.1, NWT Highway No. 5, Sites A & C

ENVIRONMENTAL INSPECTION REPORT

Permittee:	ProCore Drilling Ltd.	Permit Expiry Date:	May 21, 2019
Land Use Permit No.	MV2013Q0017	Previous Inspection:	October 26, 2017
Quarrying Permit No.	2017QP0025	Inspection Date:	June 20, 2018
Contractor:		Subcontractor:	
Location(s) Inspected:	Km 34.1, NWT Highway No. 5, Sites A & C		
Current Stage of Operation:	Quarrying has taken place at Site C this season.		
Program Modifications Approved:

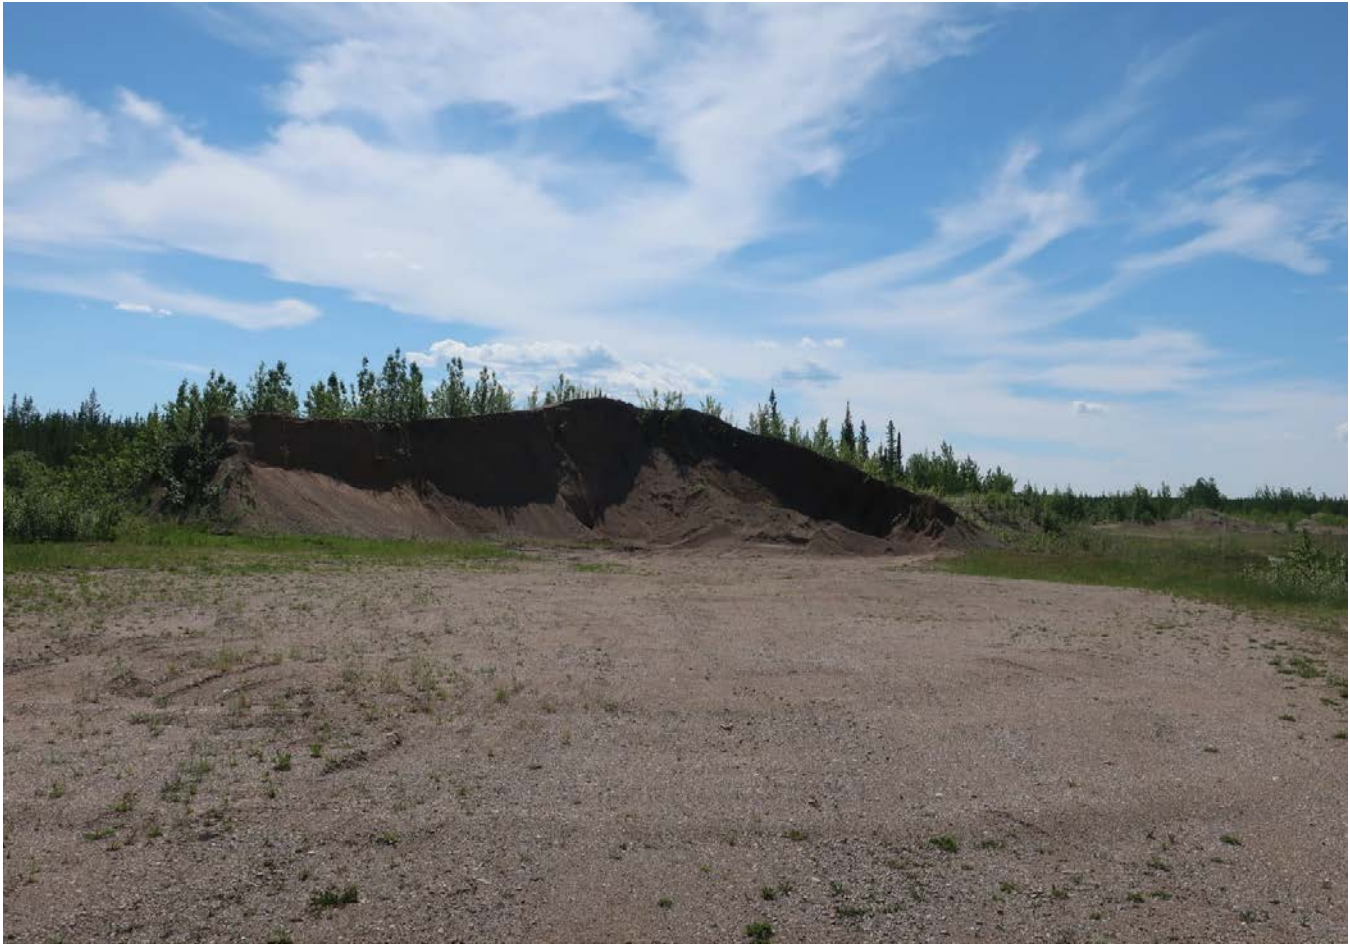
Figure 1

There was no equipment in the pit at the time of inspection however quarrying has taken place at Site C this season under the authority of quarry permit #2017QP0025. Granular material has been removed from the large stockpile.

Site C: Large stockpile where quarrying has taken place this season.

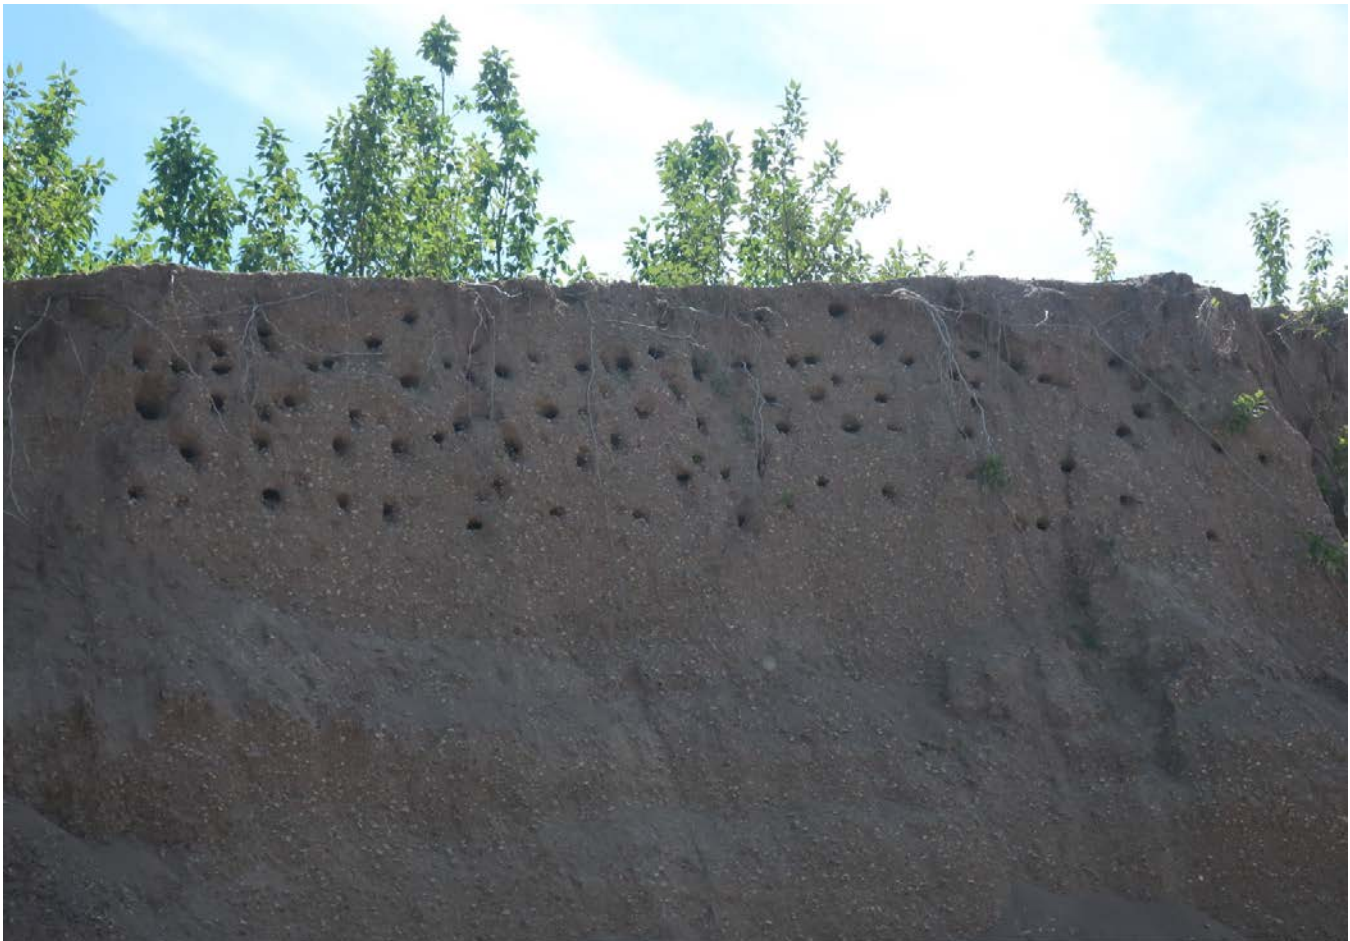
Figure 2

Site C: Swallows nesting in the stockpile.

The Inspectors observed swallows nesting in the stockpile. No further material can be removed from this stockpile until the eggs have hatched and the birds have left the nests to avoid disturbing them in accordance with **Condition 23** of your LUP. Once the birds have left the nests, the stockpile should be contoured to a 2:1 horizontal/vertical slope (**Condition 16**) to avoid having the birds nest in the pile next year and potentially disrupting your operation.

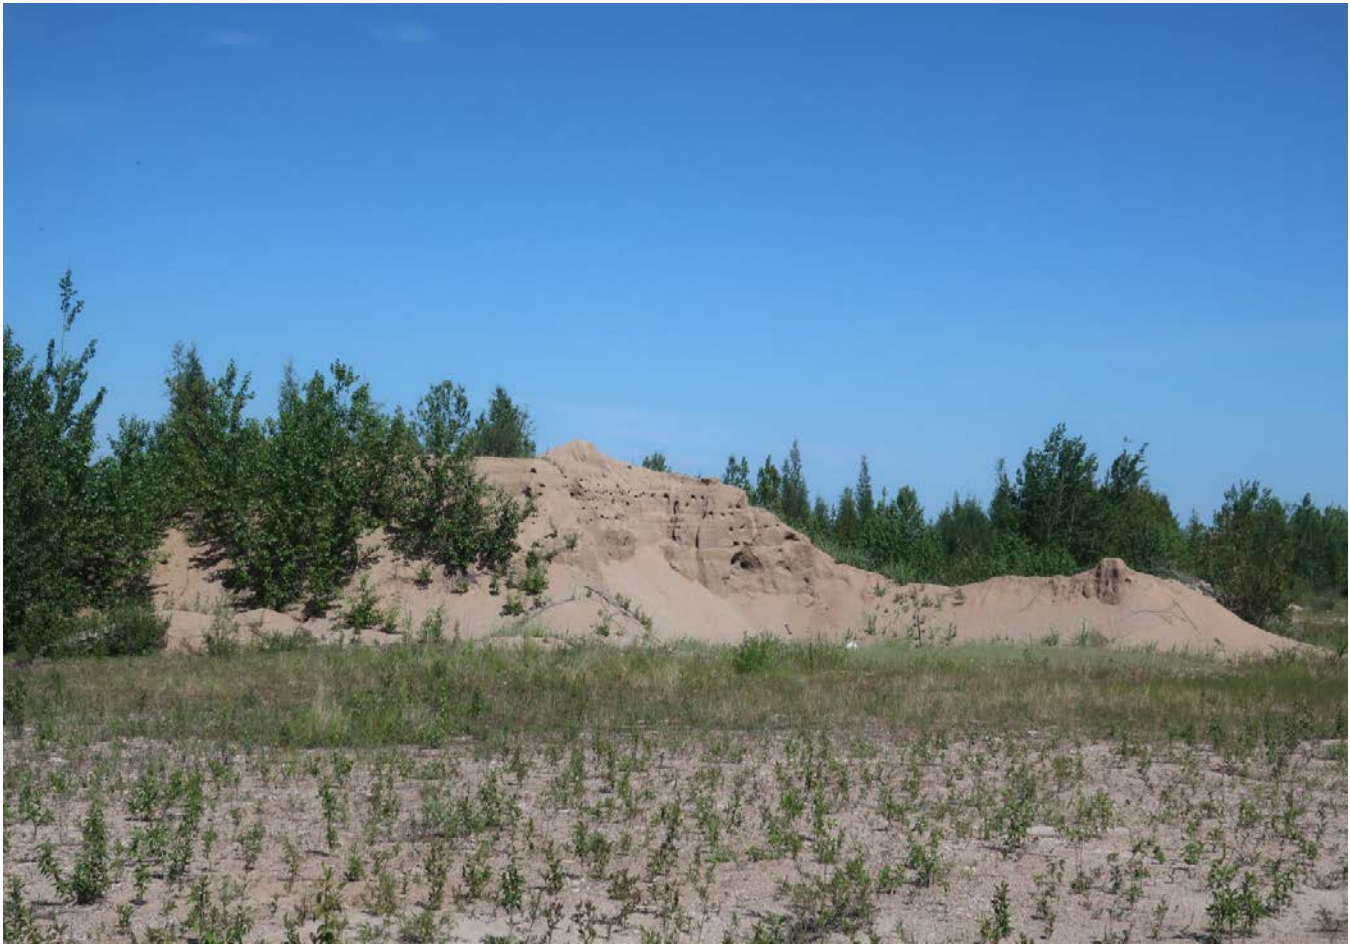
Figure 3

There was no sign of recent activity.

Site A: No sign of recent activity.
