File Number MV2015Q0022
Type of Operation QUARRY SITE - Existing
Location NWT Highway No. 1, Km 191.6

ENVIRONMENTAL INSPECTION REPORT

Permittee:	Rowe's Construction	Permit Expiry Date:	February 17, 2021
Land Use Permit No.	MV2015Q0022	Previous Inspection:	July 16, 2019
Quarrying Permit No.	20/0008	Inspection Date:	August 07, 2020
Contractor:		Subcontractor:	
Location(s) Inspected:	NWT Highway No. 1, Km 191.6		
Current Stage of Operation:	No sign of recent activity.		
Program Modifications Approved:

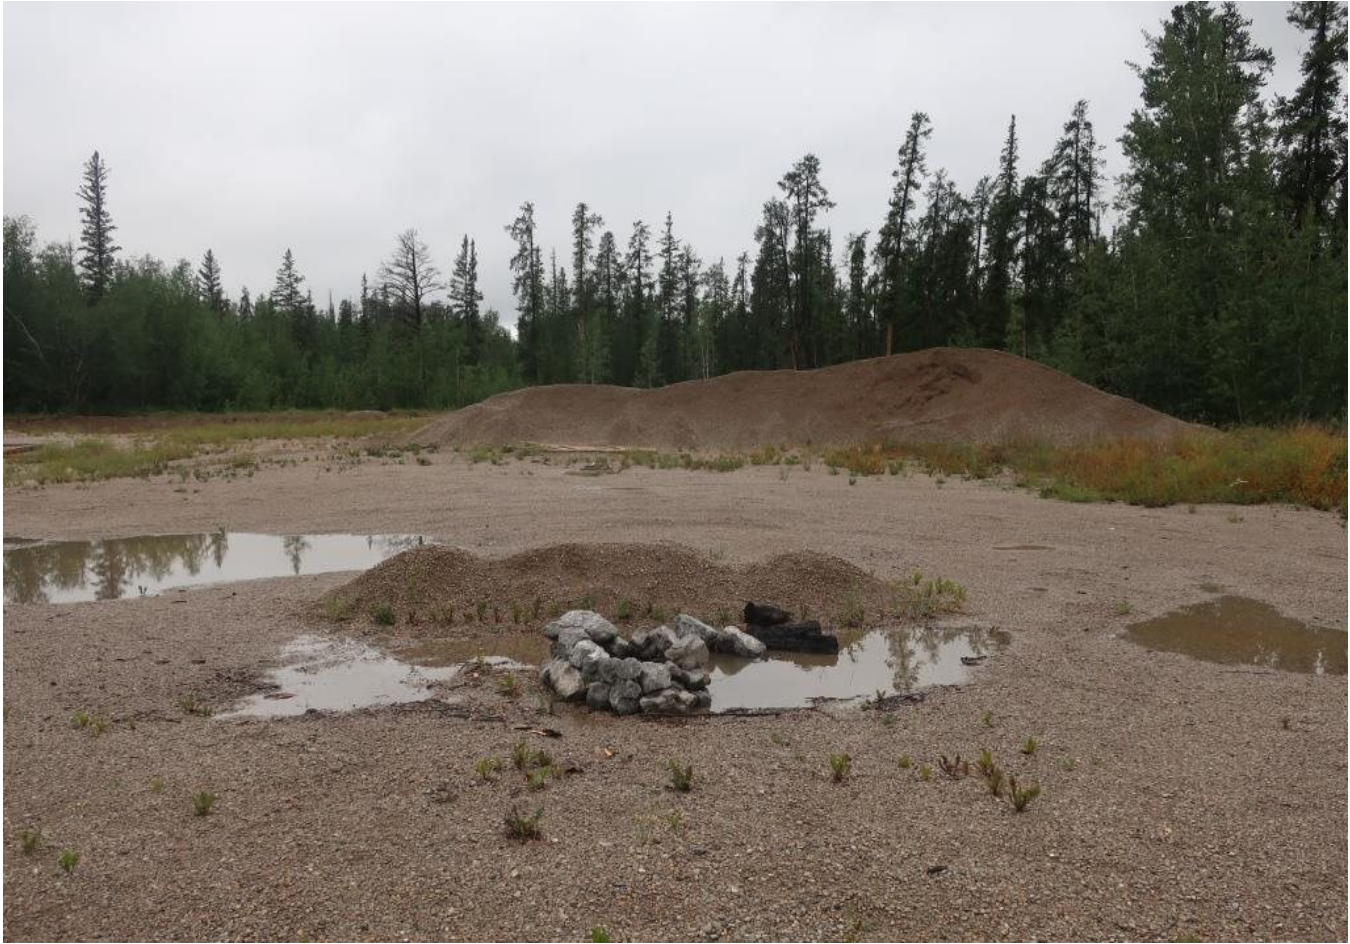
Figure 1

No sign of recent activity. One of the open excavations is barely visible in the background due to the vegetation.

As seen in the attached photos, vegetation is starting to grow up making it difficult to see the two excavations on site. As a measure of public safety, the Inspector is requesting that Rowe's Construction place a berm around the two excavations on site. Alternatively, the sides of the excavations can be sloped to a 2:1 ratio as required by Condition 12 of your Land Use Permit.

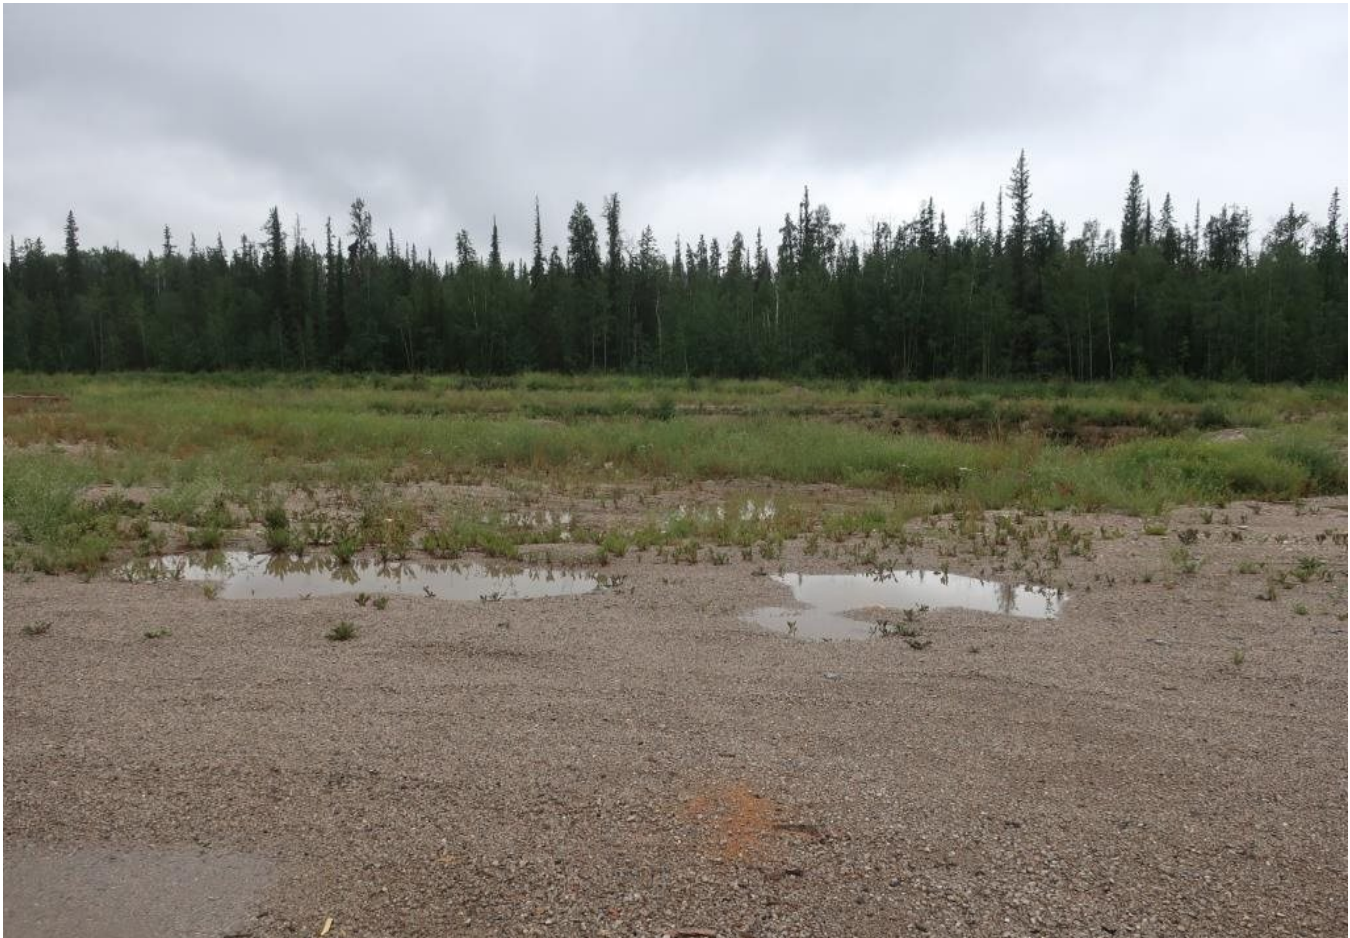
Figure 2

Vegetation has reduced the visibility of the second excavation on site.
