INAC-CARD Bullmoose/Ruth Remediation Project

RE: Land Use Permit MV2016X0013 – Bullmoose/Ruth Remediation Project

ENVIRONMENTAL INSPECTION REPORT (MV2016X0013)

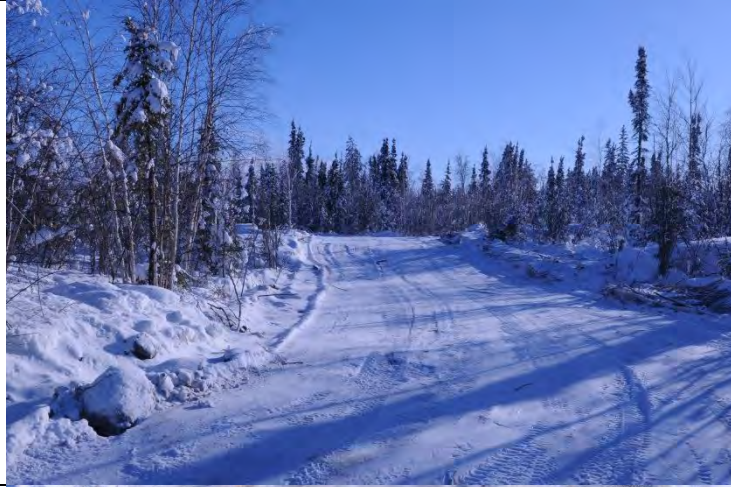
At the time of the inspection access roads were pushed into Ruth, Bullmoose, Beaulieu, Spectrum, and Joon Mines. The portages were very fresh in many locations and as the site contractors were using water tankers and heavy equipment to achieve a minimum of 10 cm's of snow/ice pack as stated in condition #15 of the land use permit.

Photo #1: The portage on the North End of Beaulieu Mine.

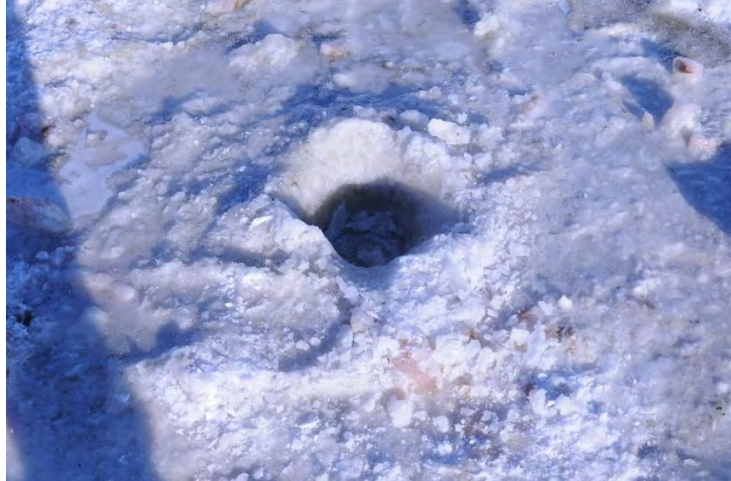
One small spill of an unidentified substance was discovered at one of the ice auger drill hole at **62°24'51.19⁰ N , 112°53'34.12⁰W**. The remains of this spill are illustrated in Photos # 2 and 3. The material should be removed from site and disposed of according to the waste management plan.

Photo #2: Small unidentified spill around ice auger drill hole at $62^{\circ}24'51.19^{\circ}$ N , $112^{\circ}53'34.12^{\circ}$ W

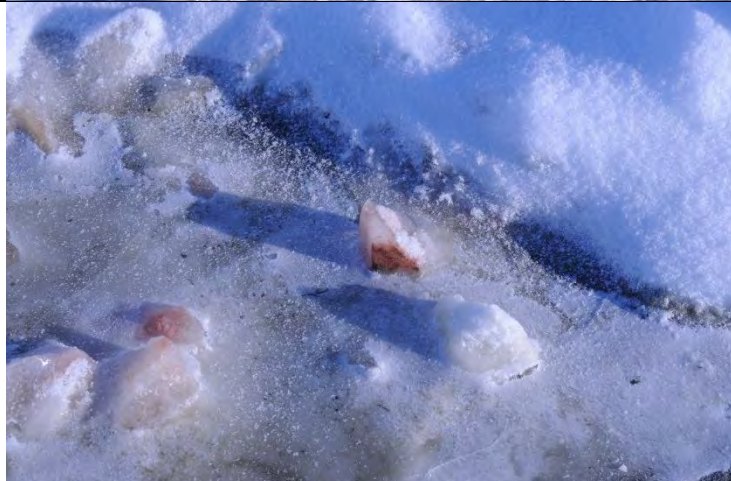
Photo #3 A close up of the spill noted in the above photo.

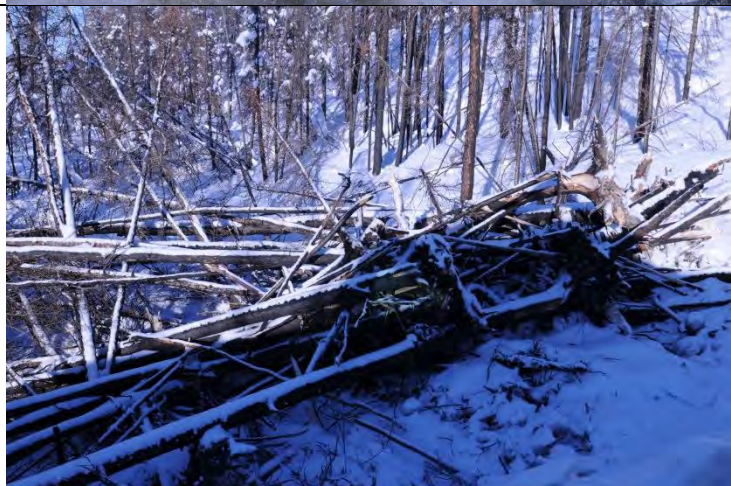
Trees and other brush were piled up in multiple locations along the access roads as displayed in Photo #4. As indicated in condition #66 the permittee shall progressively dispose of all brush and trees and complete all brush disposal: all disposal shall be completed prior to the expiry date of this Permit.

Photo #4: An example of trees/brush piled along the side of the portages.

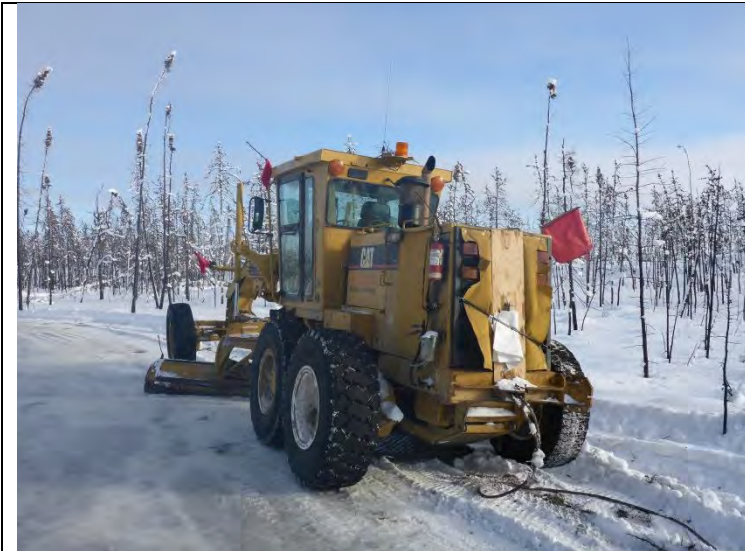
Several pieces of heavy equipment were parked along the access roads with drip trays placed underneath to catch any minor leaks as required by condition #64 of the land use permit (Photo #5).

Photo #5. Heavy Equipment parked with spill tray placed underneath.
