DE BEERS GROUP

Re: Snap Lake Mine
Land Use Permit – MV2017D0032, Water License MV2019L2-0004
Follow-Up Report for Spill # 2022133 – April 16, 2022

FIGURE 1: SPILL REPORT 2022133

FIGURE 2: PHOTOS

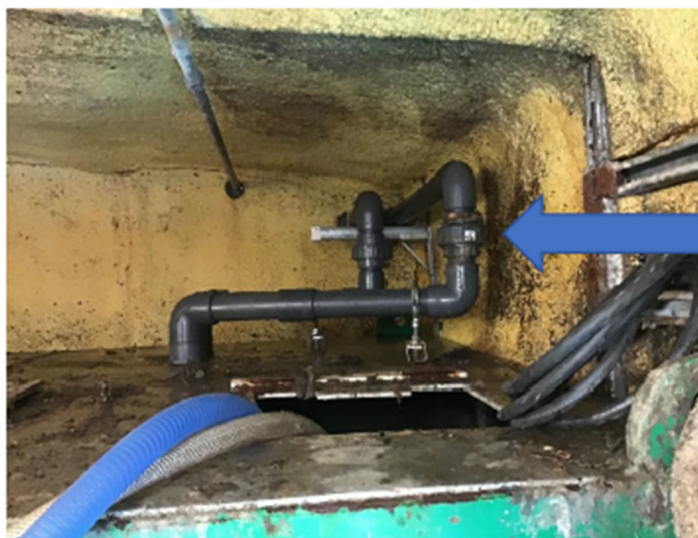
The crack in the plumbing line was in an obscure spot, which made it difficult to detect during the initial inspection. The damage was most likely the result of the line freezing or occurred during the transit to site.

The cracked line located behind a tank in a difficult area to assess

The incident was discussed at a toolbox meeting, highlighting the importance of expecting the unexpected; to look for hidden hazards while performing inspections and always to have the mindset to be prepared to mitigate.

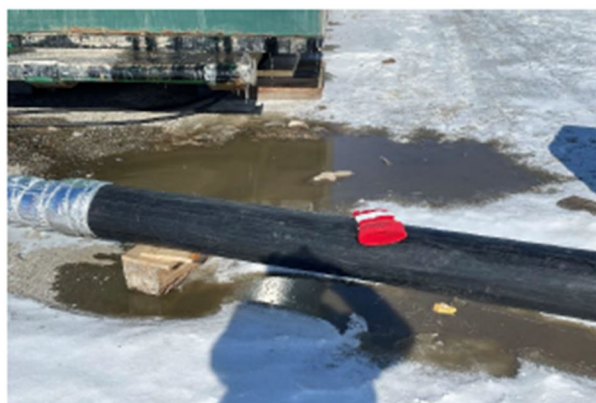
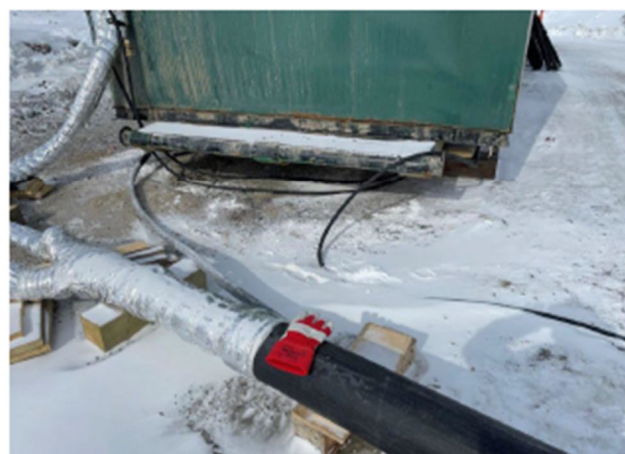
On April 16, 2022, during the start-up of the newly commissioned modular sewage treatment plant, a cracked pipe was undetected, resulting in approximately 20L of greywater to be released to the ground.

Upon noticing the leak, the operator immediately stopped the operation and investigated the cause of the spill. This led to the discovery of the crack in the plumbing line. The spill was immediately neutralized with lime, sealed in a barrel and transferred to the hazardous waste area for proper disposal
