Re: Snap Lake SNP Station Discontinuance (MV2019L2-0004)

De Beers is writing to seek discontinuance of seven of the SNP stations at the Snap Lake Mine.

Introduction

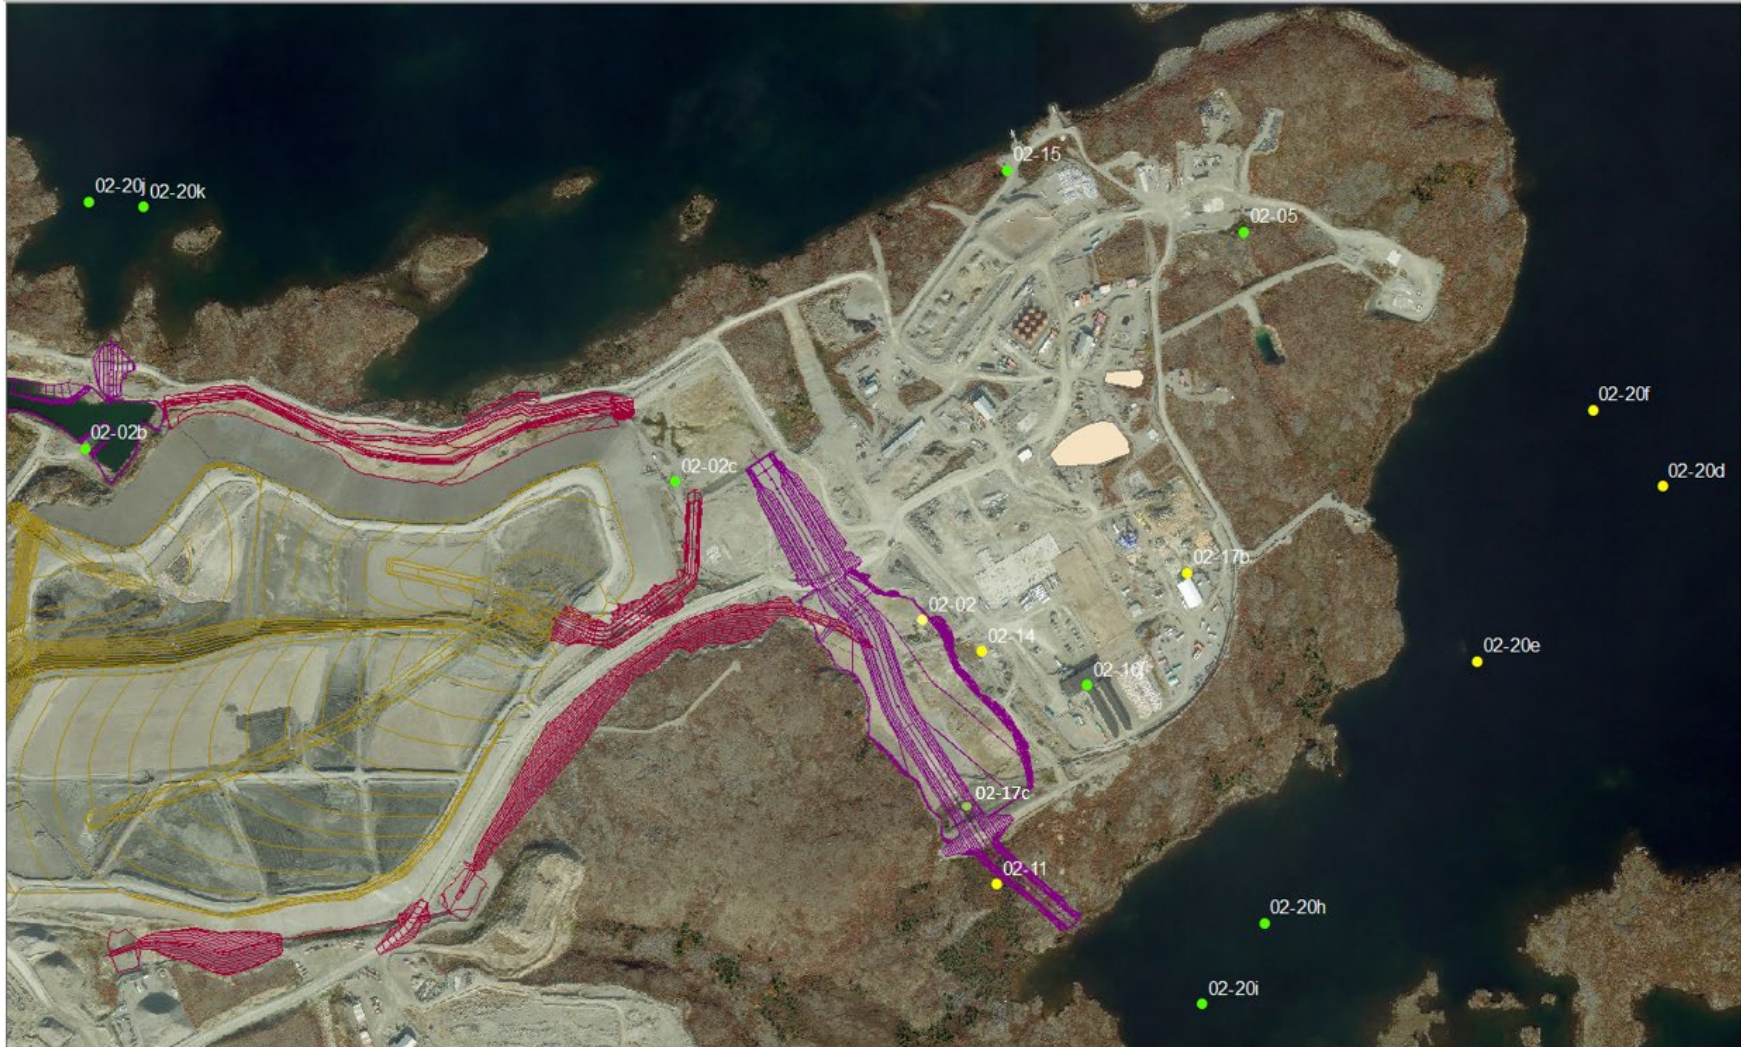
Figure 1: SNP Stations overlaid onto a 2023 satellite image of Snap Lake Mine with the design drawings for closure features. Yellow circles indicate stations to be discontinued. Green circles indicate stations to be retained .

Table 1 describes the current monitoring requirements at each of the stations that De Beers is seeking to discontinue. Figure 1 illustrates the locations of the SNP stations De Beers is seeking to discontinue as well as the stations that De Beers will retain. A detailed rationale for the discontinuance of each station is provided in the following sections for the Mackenzie Valley Land and Water Board's (MVLWB) consideration.
