Re: Snap Lake Mine  
Land Use Permit – MV2017D0032, Water License MV2019L2-0004  
Follow-Up Report for Spill # 2023186 – May 7, 2023

ATTACHMENT 1: SPILL REPORT 2023186

ATTACHMENT 2: PHOTOS

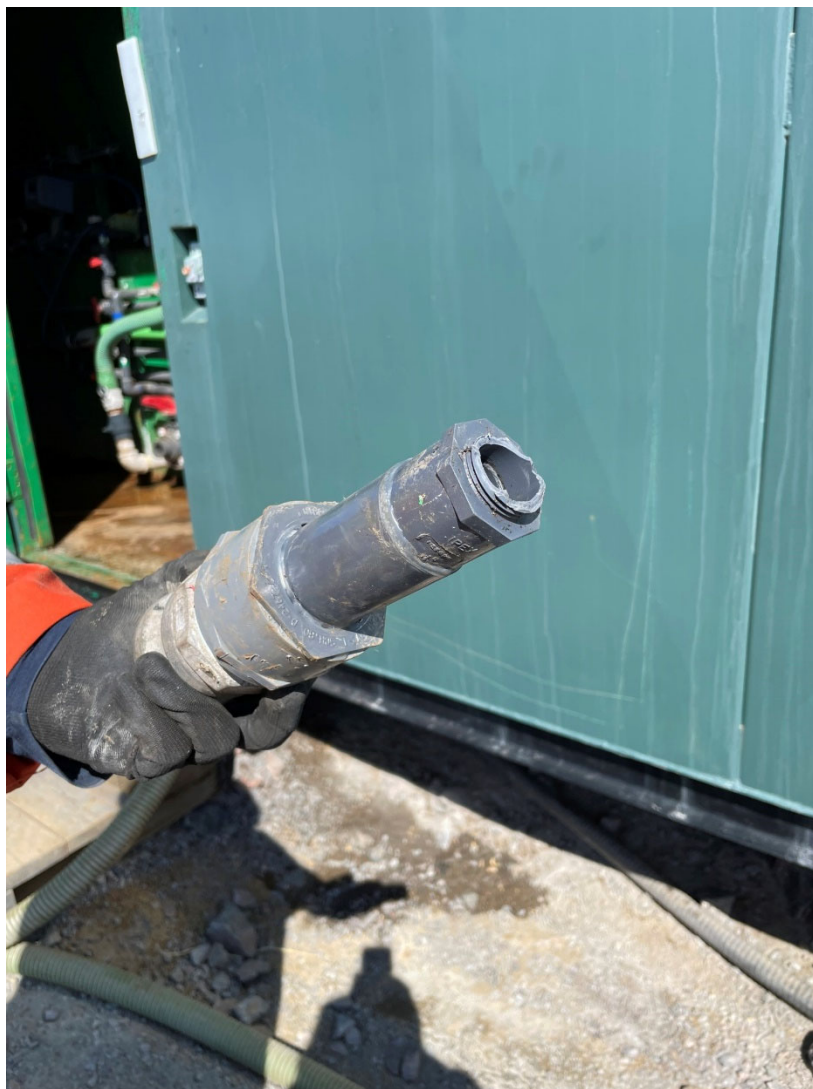
The fitting is supported by a wood tie providing it some protection up/down but not side to side. During the transfer, as a result of the weight of the hose moving side to side, broke a grey PVC fitting positioned lower on the tank.

Broken PVC Fitting:

The damaged PVC fitting was replaced with a new fitting, with a higher strength rating and would be able to withstand inadvertent impacts from the hose.

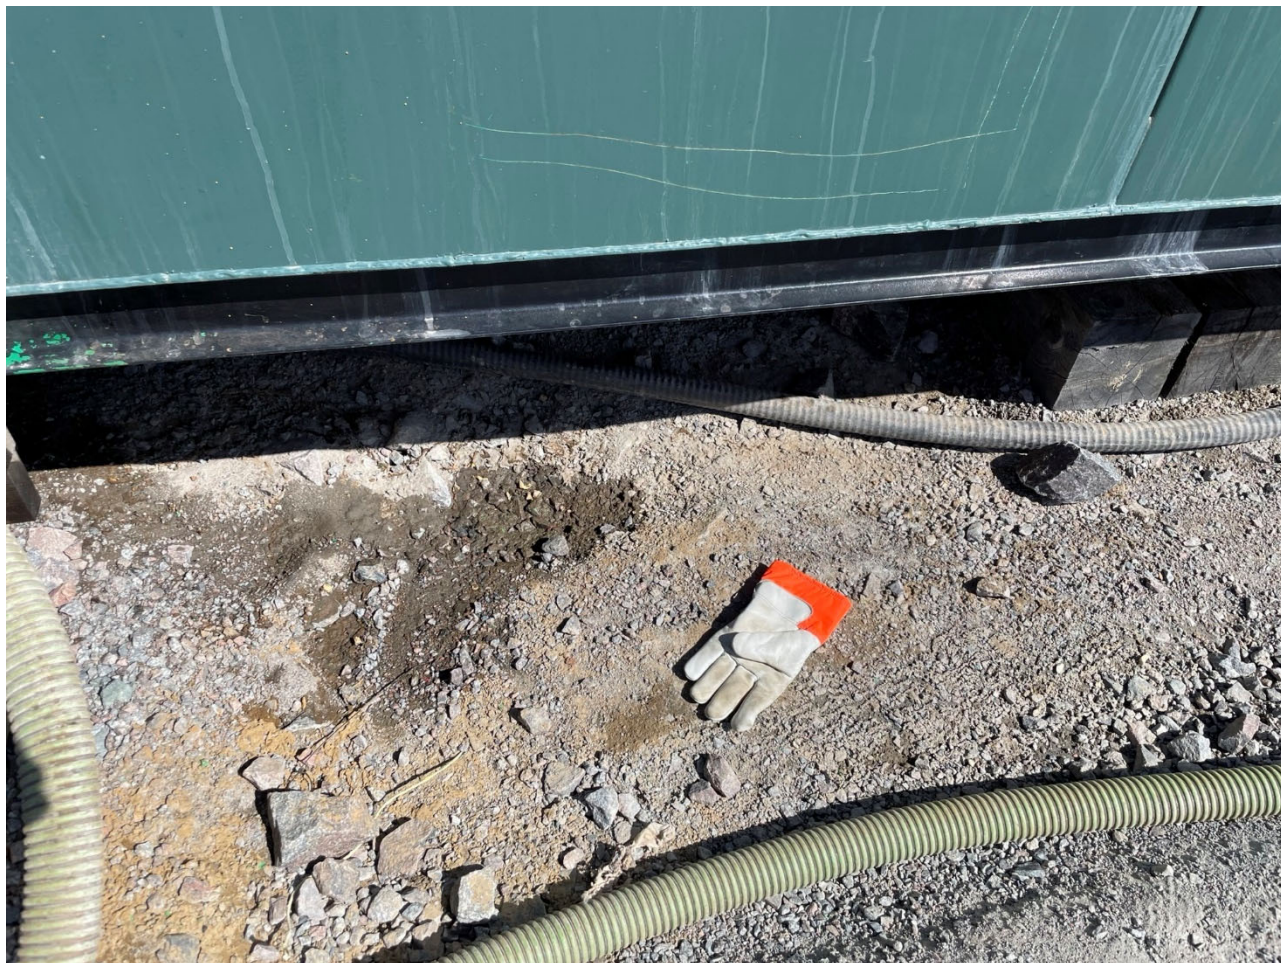
At approximately 13:20 on May 7, 2023, a spill of approximately 3 liters of sewage water was released outside the Sewage Treatment Plant. The Wastewater Plant Operator was in the process of transferring sludge from the mobile unit to the hydro-vac truck. During the transfer, the weight of the hose thrashing from the sludge moving through the 2 inch suction hose, broke a grey PVC fitting positioned lower on the tank. The Operator shut the valve off immediately, ending and minimizing the loss of sewage water. The broken fitting located close to the entrance door enabled a 3 litre loss outside the Sewage Treatment Plant.

Spill Outside Sewage Treatment Plant:

Spill was immediately reported to the supervisor and cleaned up using a hydro-vac truck and the ground material was bagged into a “Mega Bag” and disposed of safely using all the required personal protective equipment.
