# DE BEERS GROUP

**Subject: Follow-Up Spill Report – Hydraulic Oil – Gahcho Kué Mine – February 23, 2022 (GNWT Spill #2022047)**

Pursuant to Part H Condition 3(d) of Water License MV2005L2-0015, De Beers Canada Inc. (De Beers) is submitting this follow-up spill report for GNWT Spill #2022047, which occurred at the Gahcho Kué Mine at 01:00 on February 23, 2022.

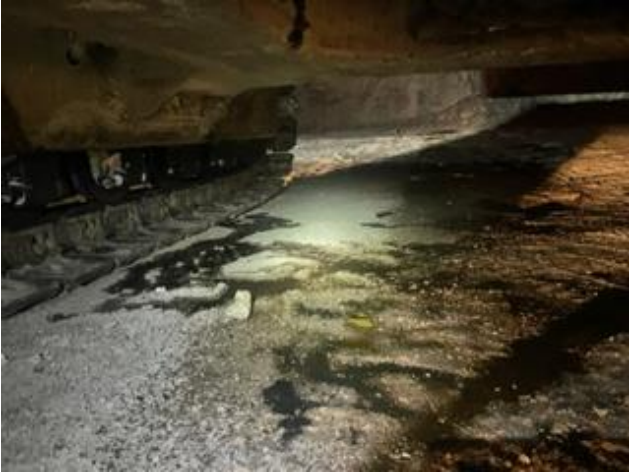
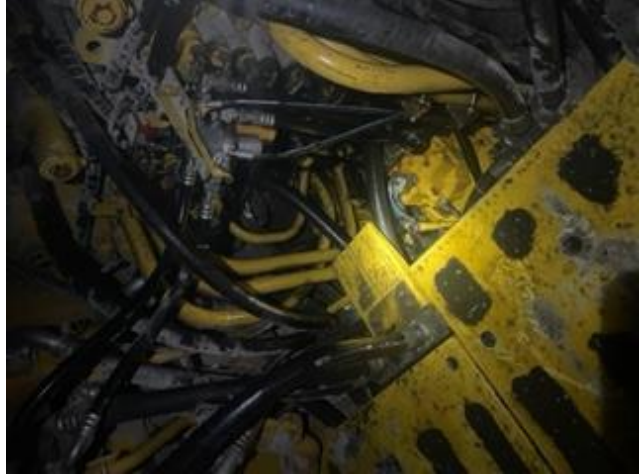
*Figure 2. Photos GNWT Spill #2022047*

Mine operations were travelling a PC2000 Shovel (TV-003) from the pit maintenance pad to the Hearne Pit, when the operator smelled hydraulic oil. He proceeded to shut the unit down and investigated what was causing the smell. The operator found a hydraulic filter had come loose and detached from the housing. He then called the shovel technician for assistance. The shovel technician went to the scene and placed spill pads, installed new filters, continued to cleaned up oil on machine and coordinated with the Mine Operations and Environment team for help with the ground clean up. TV-003 had recently undergone a 2000 hour maintenance service. It was determined that the hydraulic filter canisters came loose due to improper installation, resulting in 150 liters of AST 20 hydraulic oil to spill onto the ground.

TV-003 had recently undergone a 2000 hour maintenance service. It was determined that the hydraulic filter canisters came loose due to improper installation, resulting in 150 liters of AST 20 hydraulic oil to spill onto the ground.

1. Proper hydraulic cylinder installation procedure to be reviewed by all maintenance technicians.
2. Hydraulic cylinder installations to be signed off by senior technician prior to recommissioning.

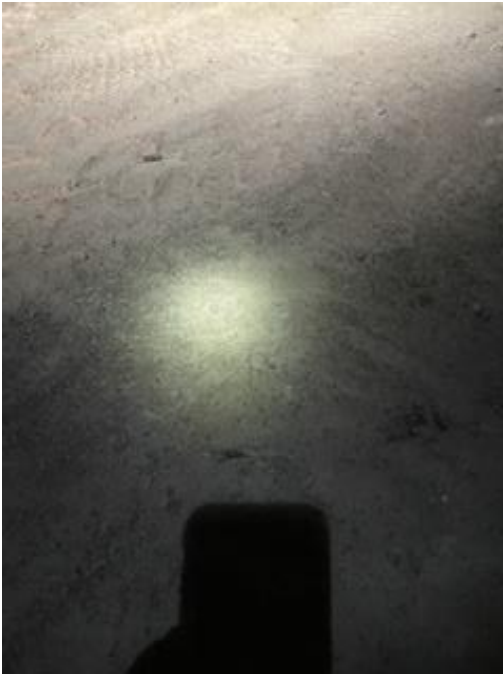
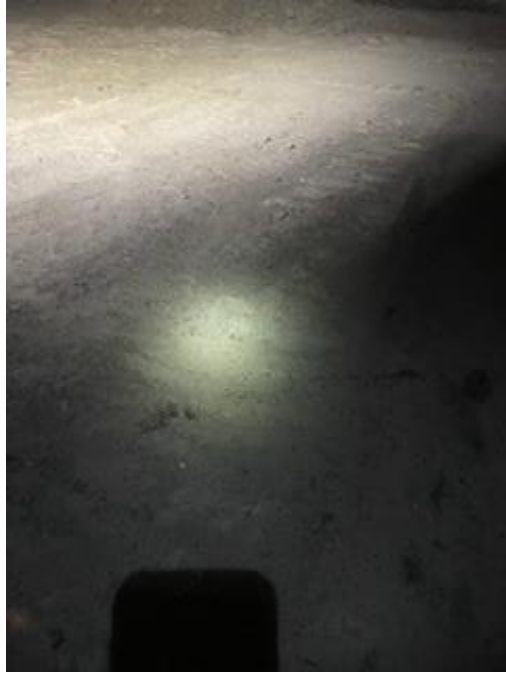
*Figure 3. Clean Up Photos GNWT Spill #2022047*

Once the operator was aware of the odour of hydraulic oil, the equipment was shut down and both their supervisor and mobile maintenance were notified. The maintenance technician then deployed spill pads, while the mine operations supervisor coordinated the cleanup of contaminated materials and remediation of the area.

The spill occurred in the Hearne Pit and all contaminated material was removed and loaded out to the Type 3 Area of the West Mine Rock Pile.
