# DE BEERS GROUP

**Subject: Follow-Up Spill Report –Sewage – Gahcho Kué Mine – July 22, 2021 (GNWT Spill # 2021309)**

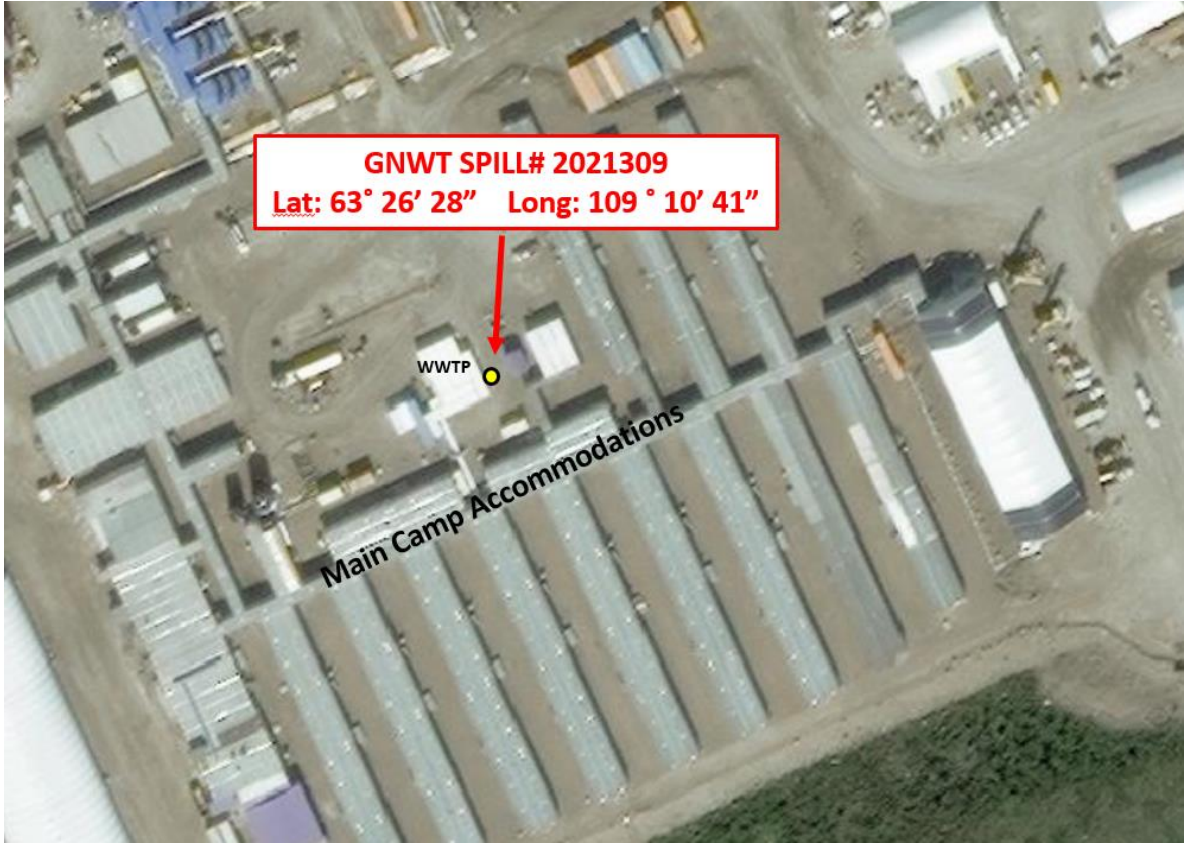
Figure 1. Location of GNWT Spill #2021309

At approximately 08:00 on July 22, 2021, while off-loading sewage into the Waste Water Treatment Plant (WWTP), sewage was released from the intake overflow valve. The operator immediately turned off the discharge from the tanker truck (LV-001). Approximately 200 litres of sewage was discharged onto the gravel camp pad and was contained within close proximity of the WWTP.

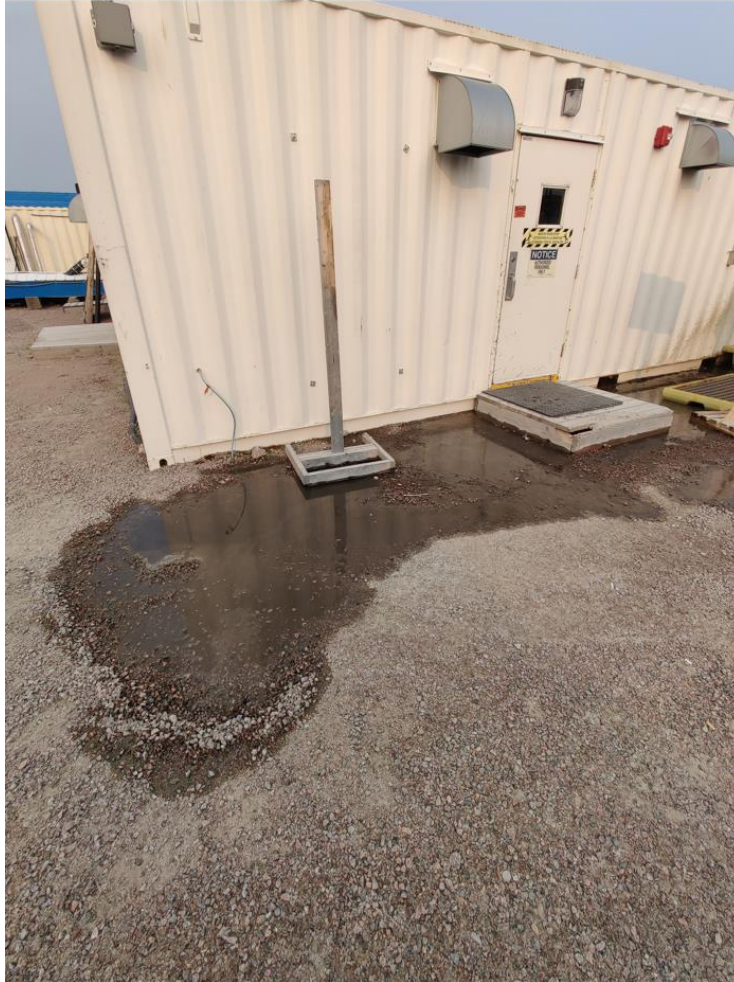
Figure 2. Photo of initial spill of GNWT Spill #2021309

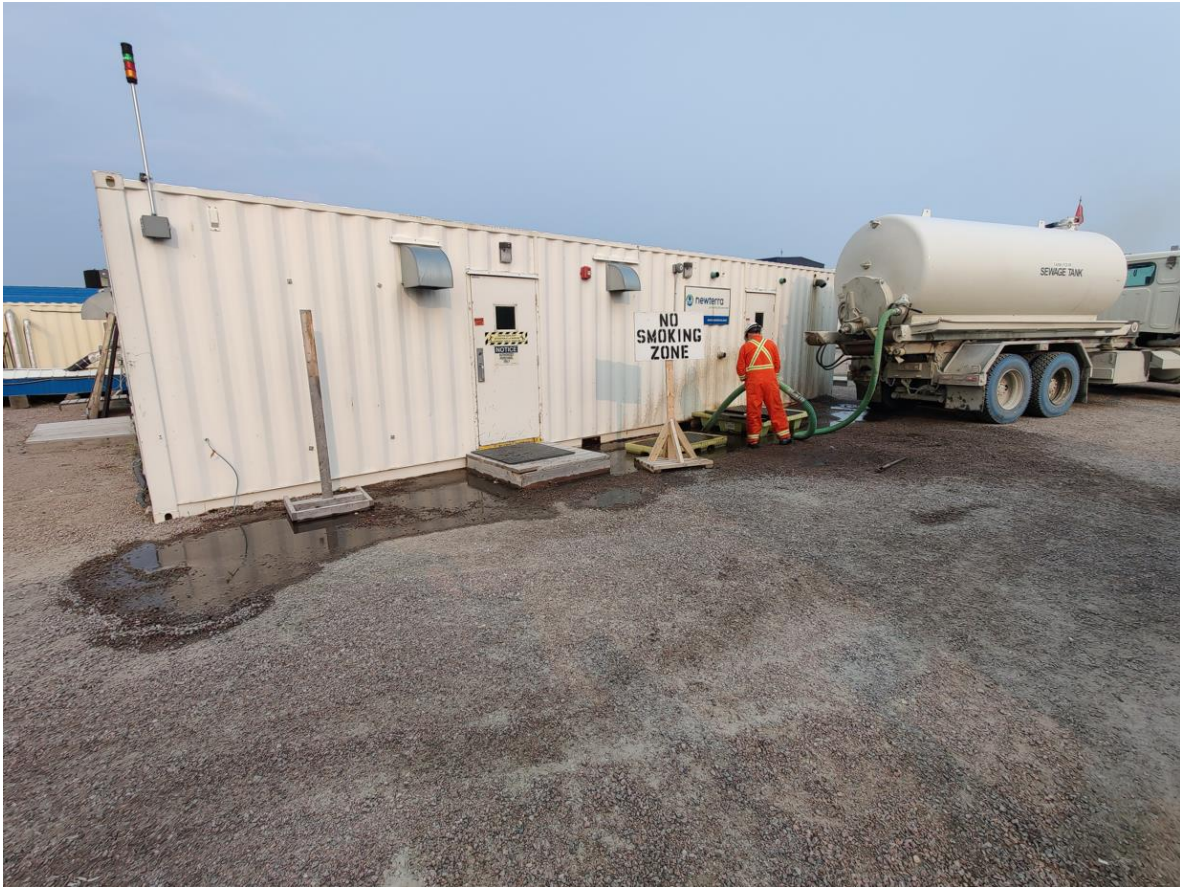
Figure 3. Photo of ongoing clean-up of GNWT Spill #2021309

Clean up of the contaminated gravel was initiated immediately, with both the area supervisor and the Environment department being contacted. The contaminated gravel was disposed of in the Type 3 Waste Dump, with fresh material being placed within the affected area. The investigation as to cause of failure was completed prior to the continuing the offload of sewage from LV-001.

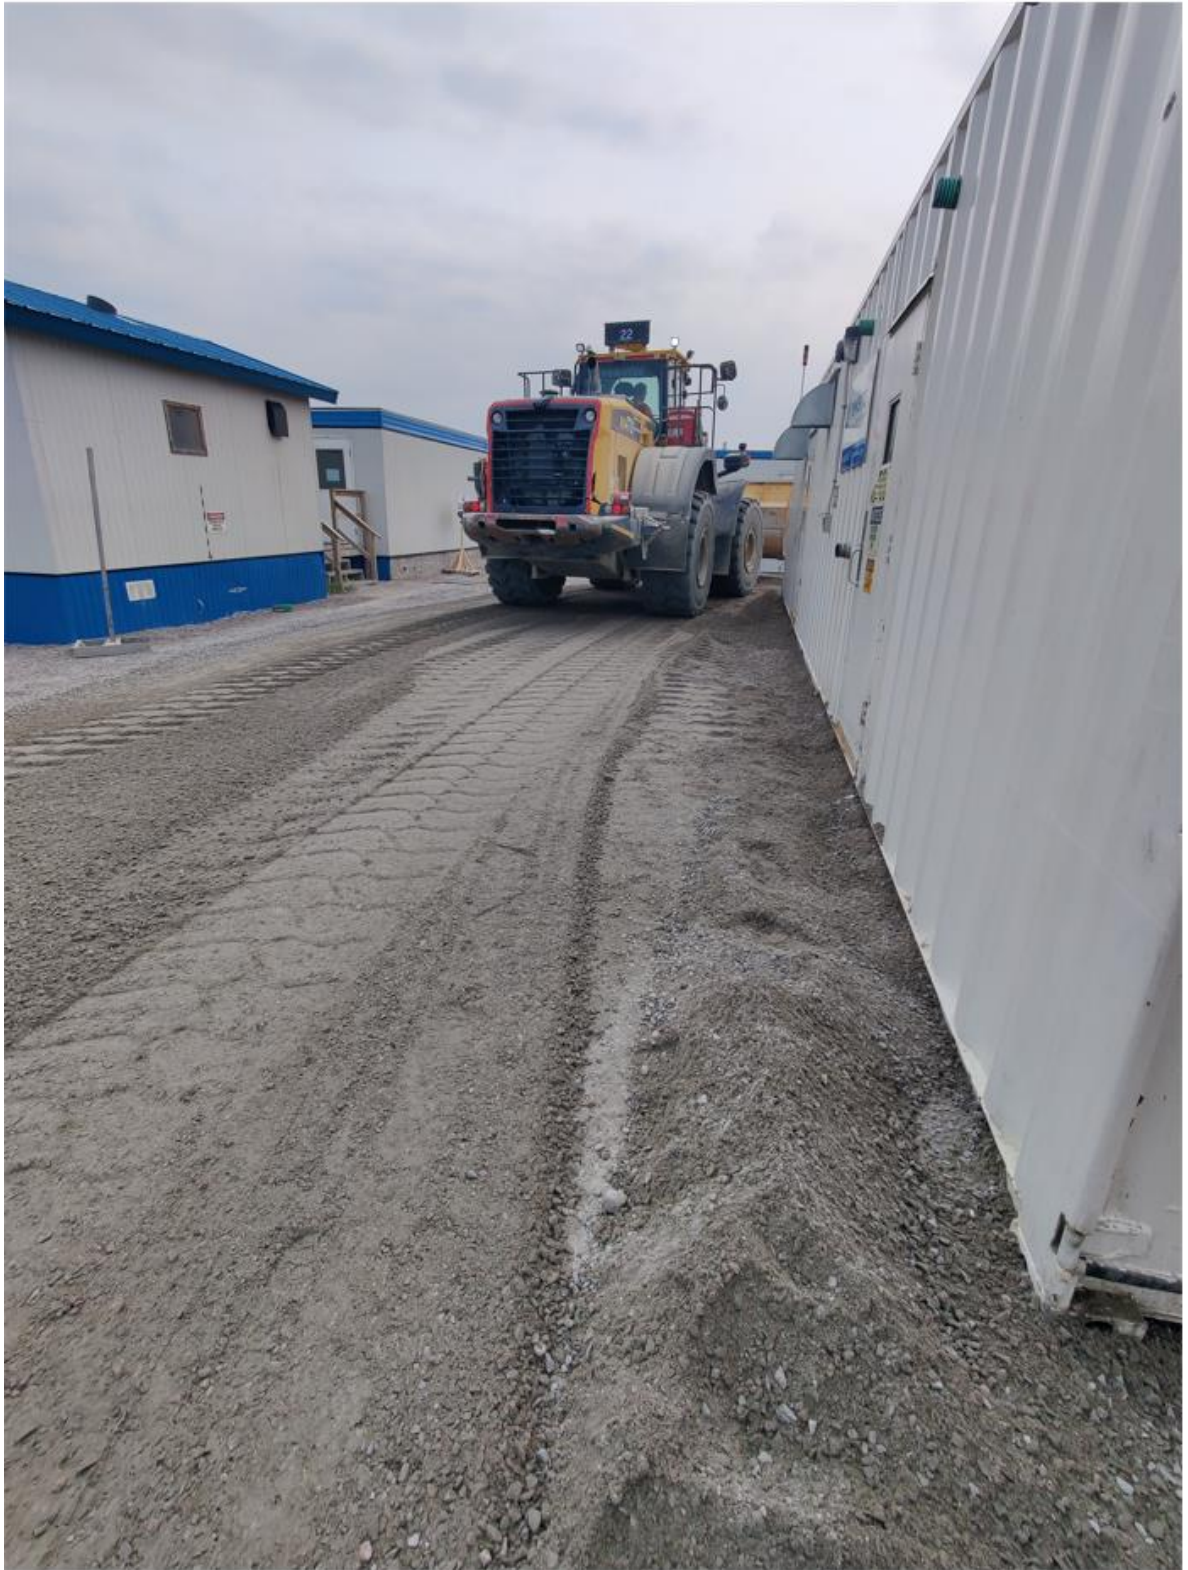
Figure 4. Photo of the affected area once remediated GNWT Spill #2021309
