**Re: Land Use Permit MV2016C0030  
Mineral Exploration (Advanced)  
Kennady Lake area, NT**

## ENVIRONMENTAL INSPECTION REPORT

Location(s) Inspected:	Kelvin Camp.
------------------------	--------------

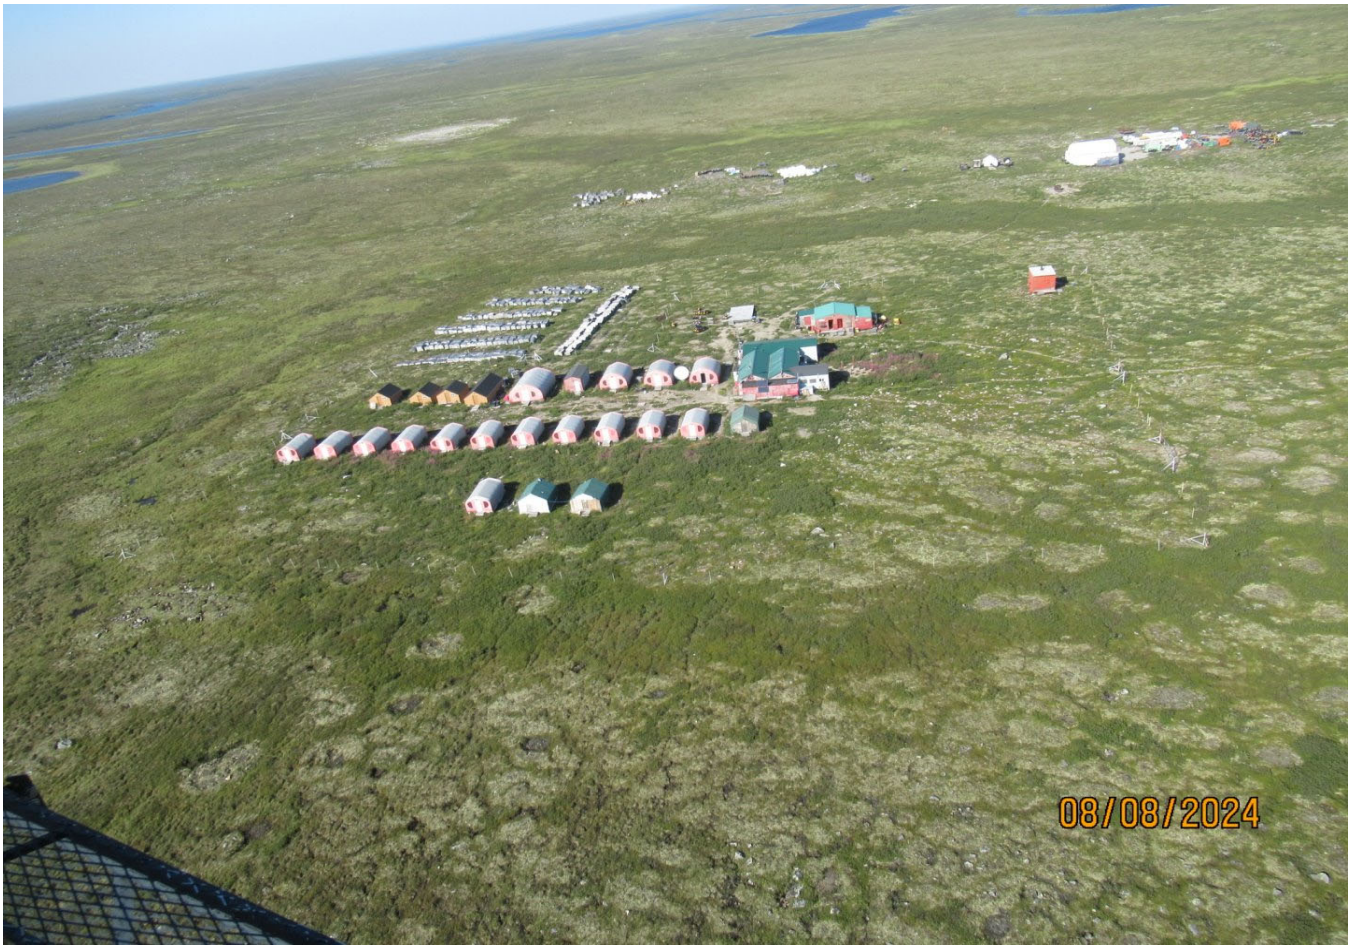
**Figure 1**  
**Looking north at Kelvin Camp.**

Notification of camp occupancy was provided to the Inspectors prior to personnel mobilizing on July 24<sup>th</sup>, 2024 and Kelvin camp (Figure 1 through 4) was occupied with eight (8) people at the time of the inspection. Overall, the camp continues to be well managed and the following observations were documented during the inspection;

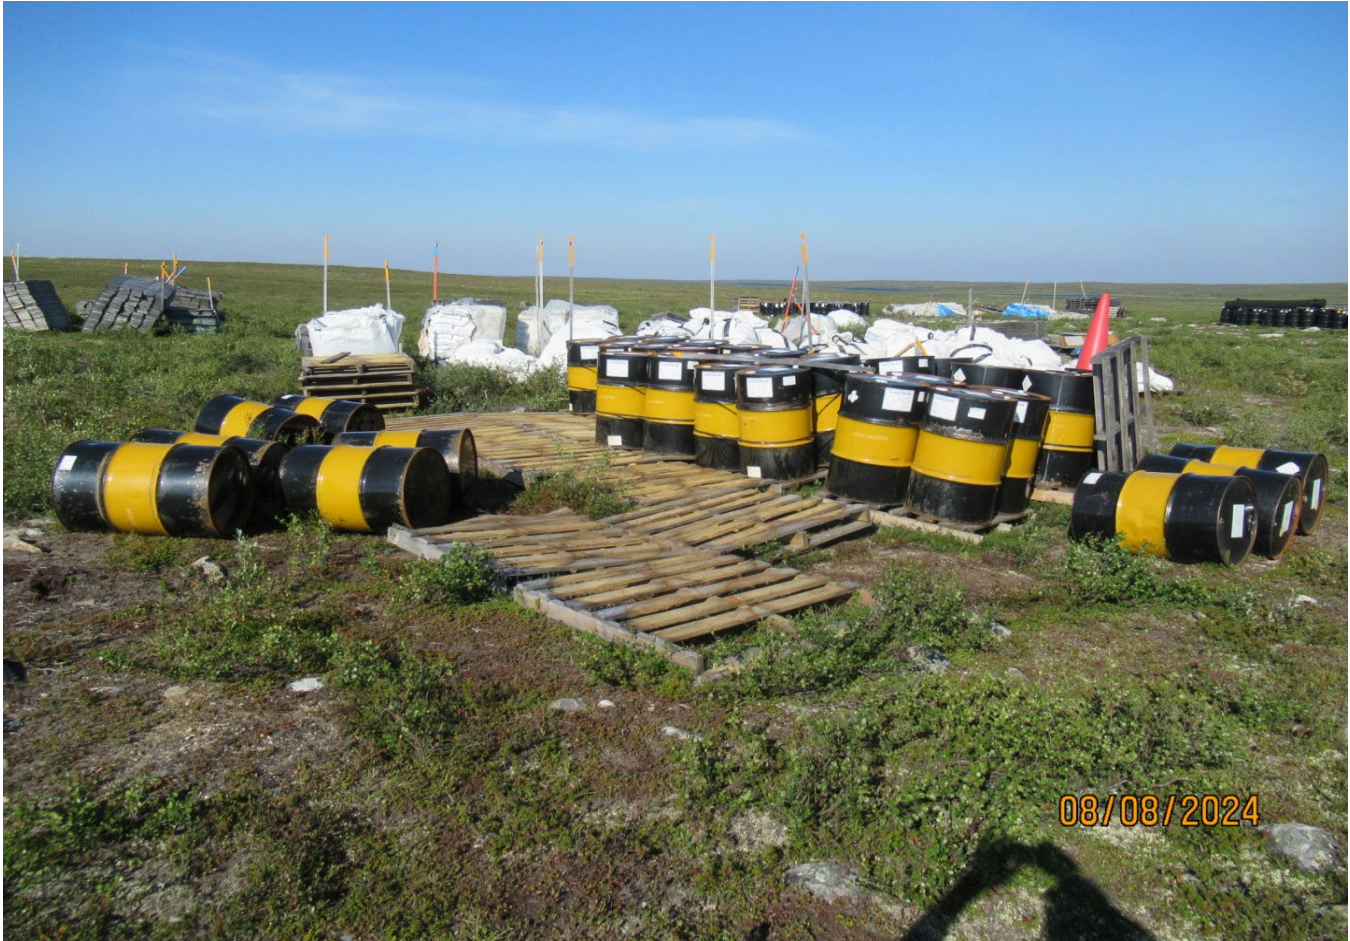
**Figure 5**

- There are various types & quantities of drummed fuel in the land use area and these caches can be viewed in Figure 5 through 9. Proper storage is occurring, drums are upright & banded together on pallets and stored greater than 100 metres from the nearest watercourse.

**Jet fuel cache. Laid down drums are being slung to the helicopter fuel rack at the camp. Other drums are being stored upright and banded on pallets.**

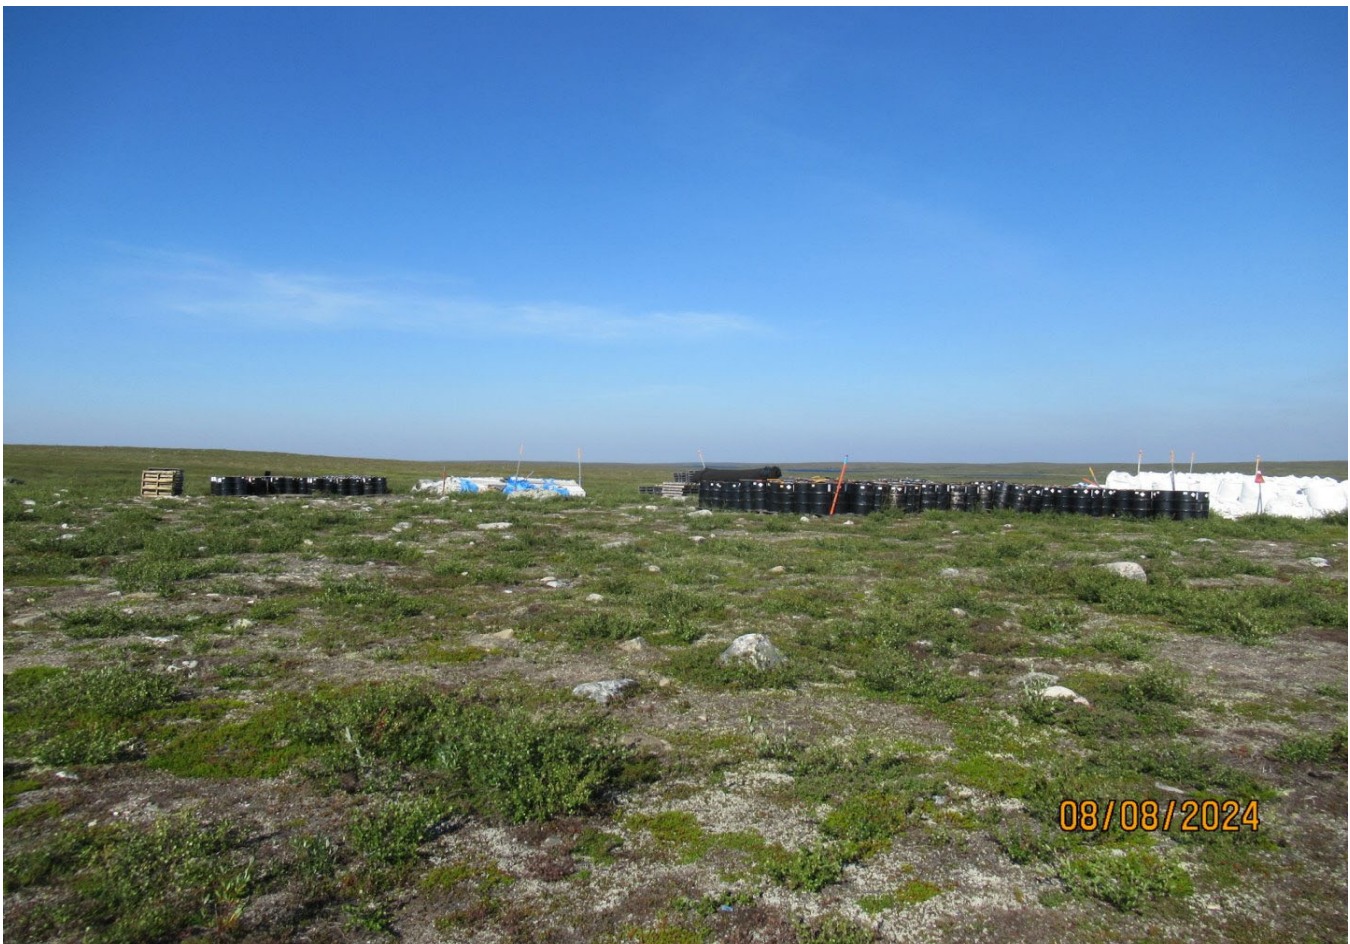
**Figure 6**

**Diesel fuel cache in the consumables laydown.**

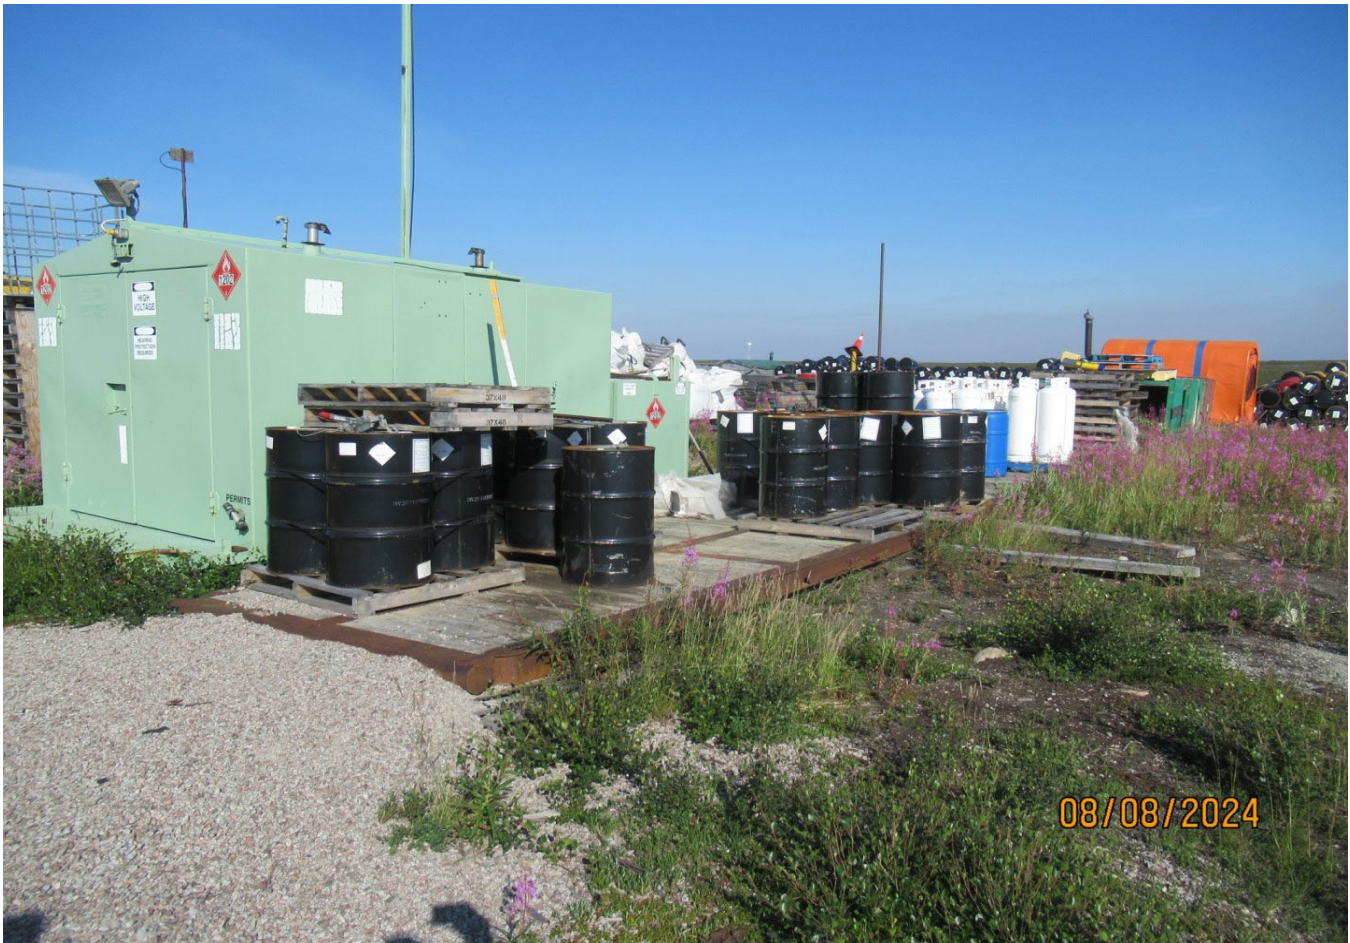
**Figure 7**

**Diesel drums are stored upright adjacent to the shop generator.**

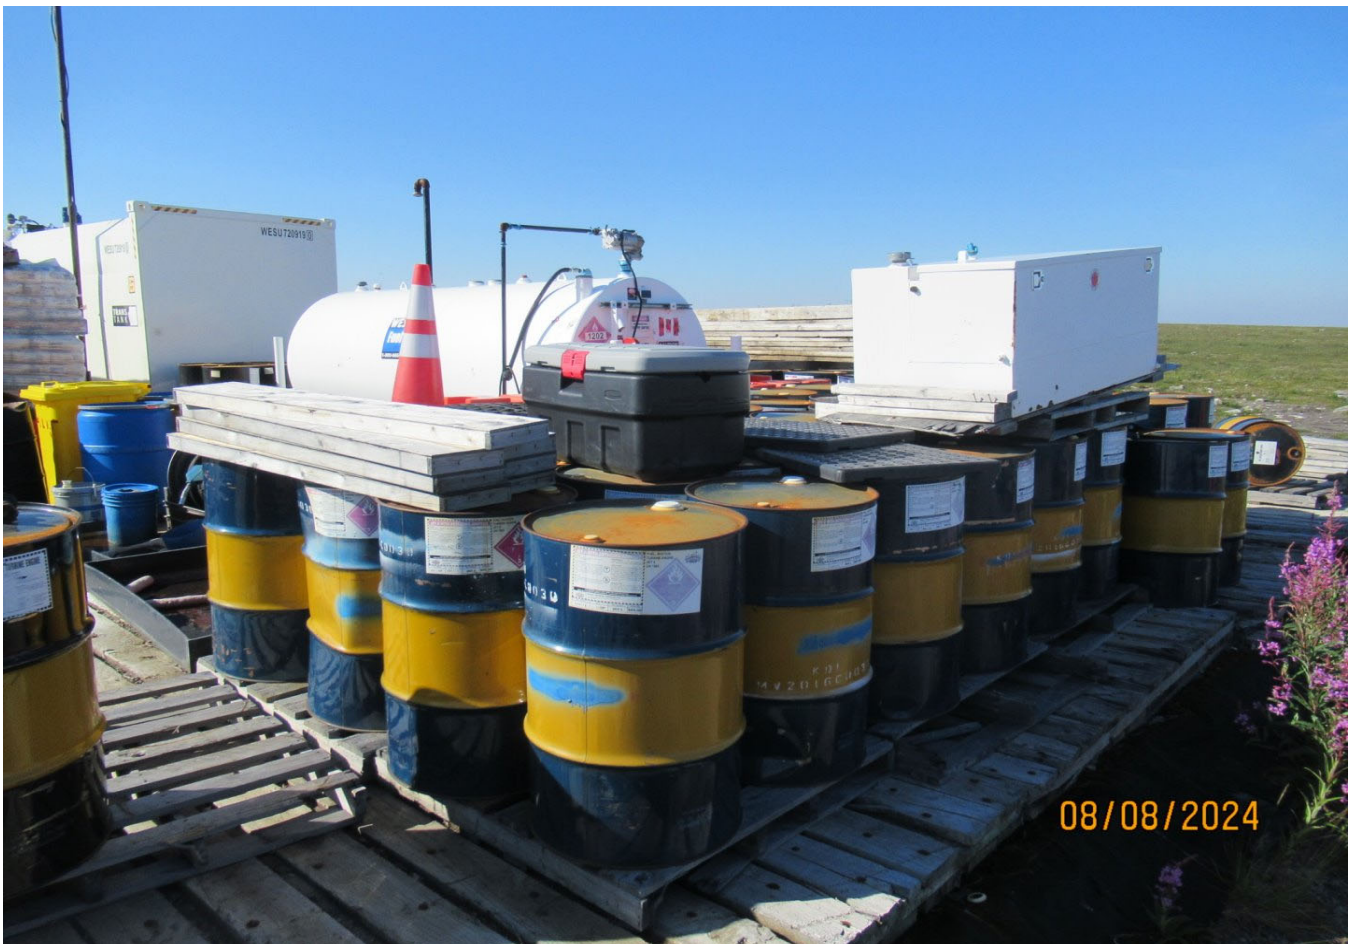
**Figure 8**

**Drums of jet fuel at the Shop Laydown. If this fuel no longer serves a purpose on site it must be removed from the land use area for proper offsite disposal.**

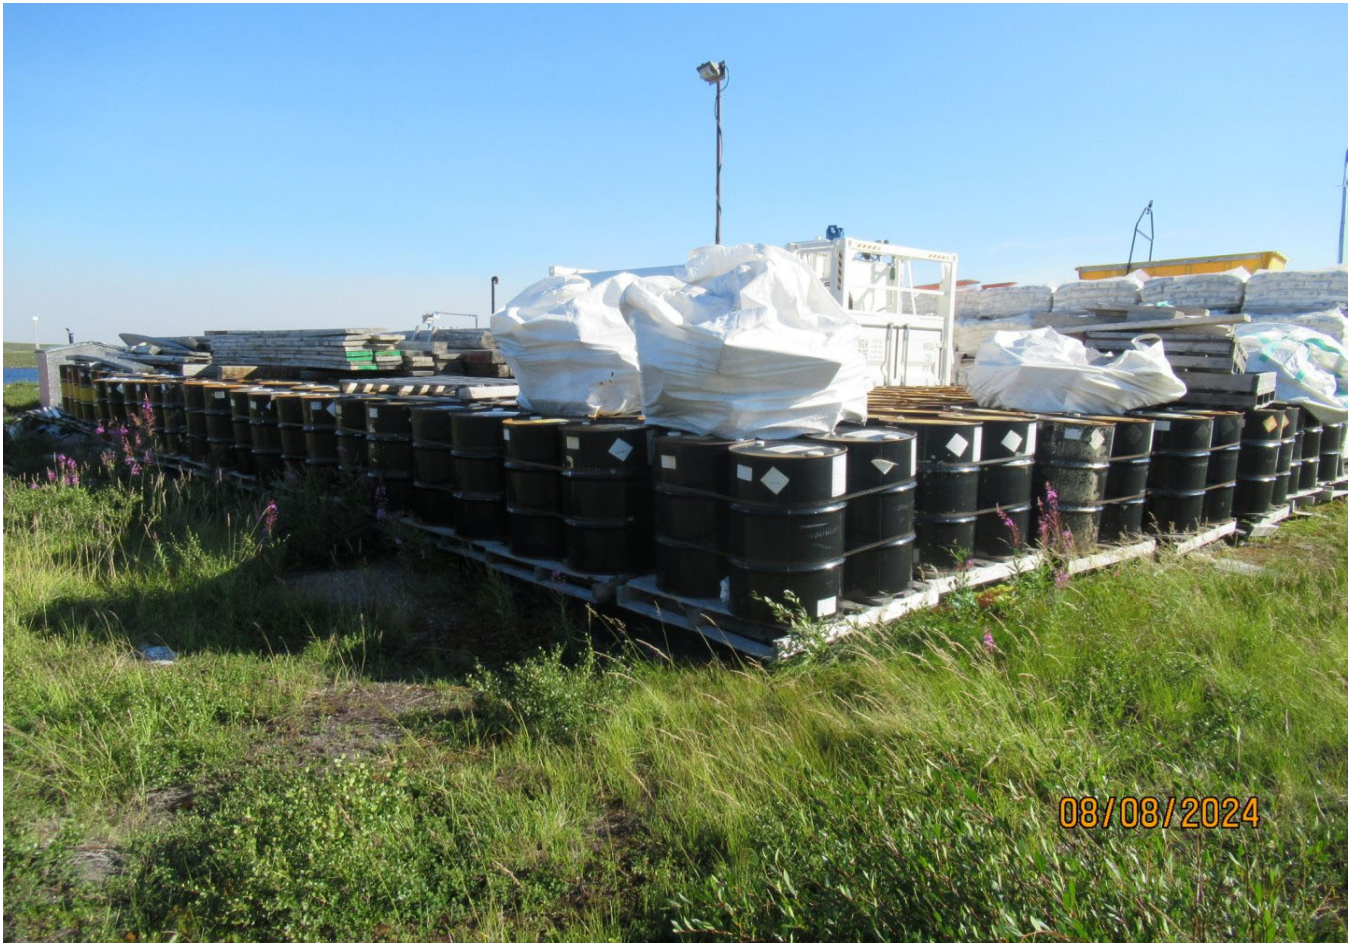
**Figure 9**

**Another diesel fuel cache in the shop laydown. If the pallets of concrete in the background no longer serve a purpose on site they must be removed at the very earliest opportunity.**

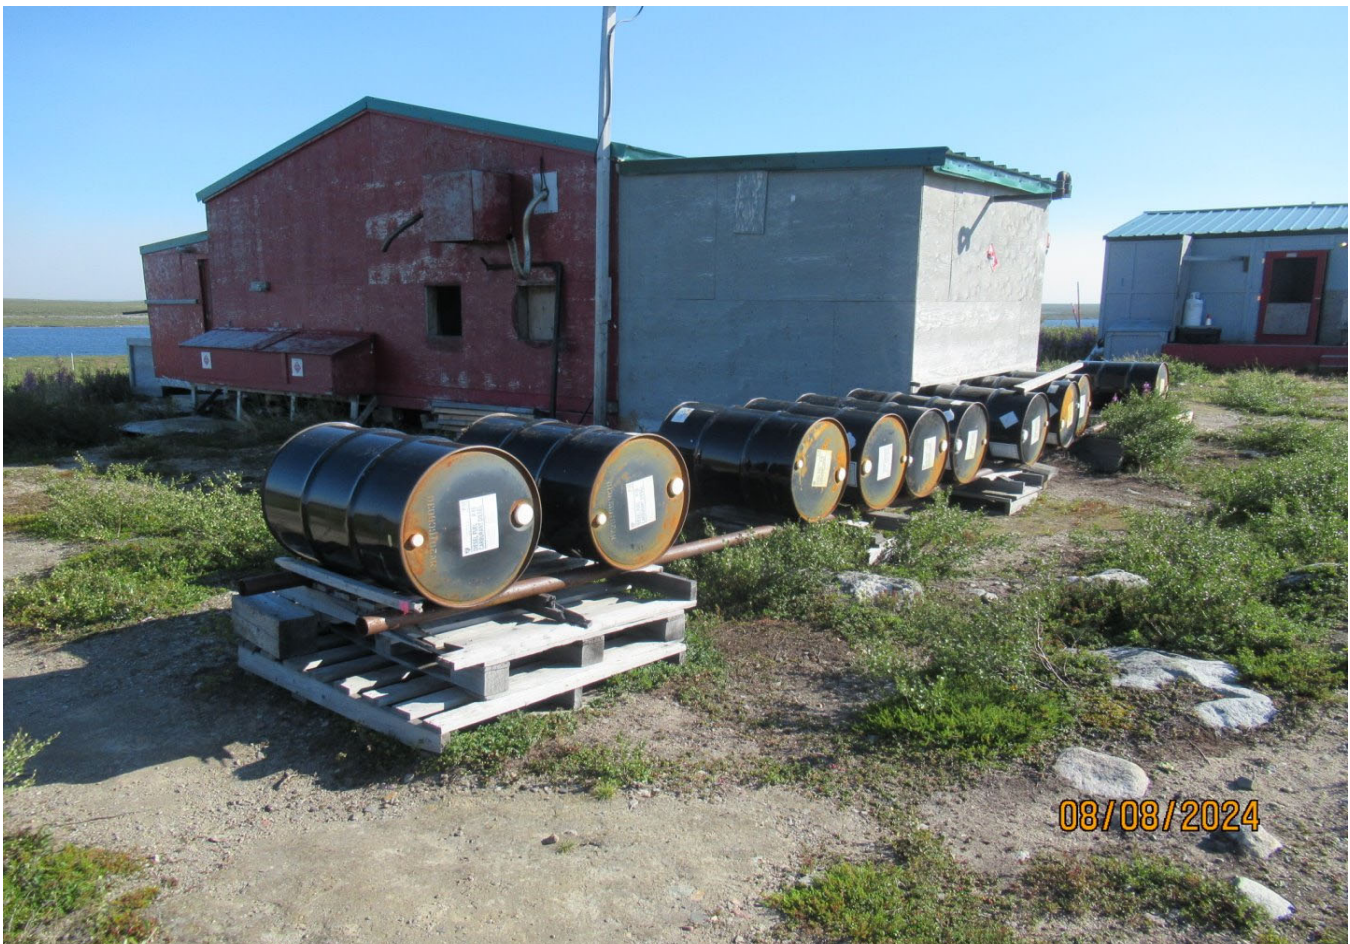
**Figure 10**

- Forty-five gallon drums of fuel at the generator building are being stored with their bungs at 3 & 9 o'clock or upright on spill pallets (Figure 10).

**Fuel drums at the camp generator are stored on a rack with the bungs positioned at 3 and 9 o'clock.**

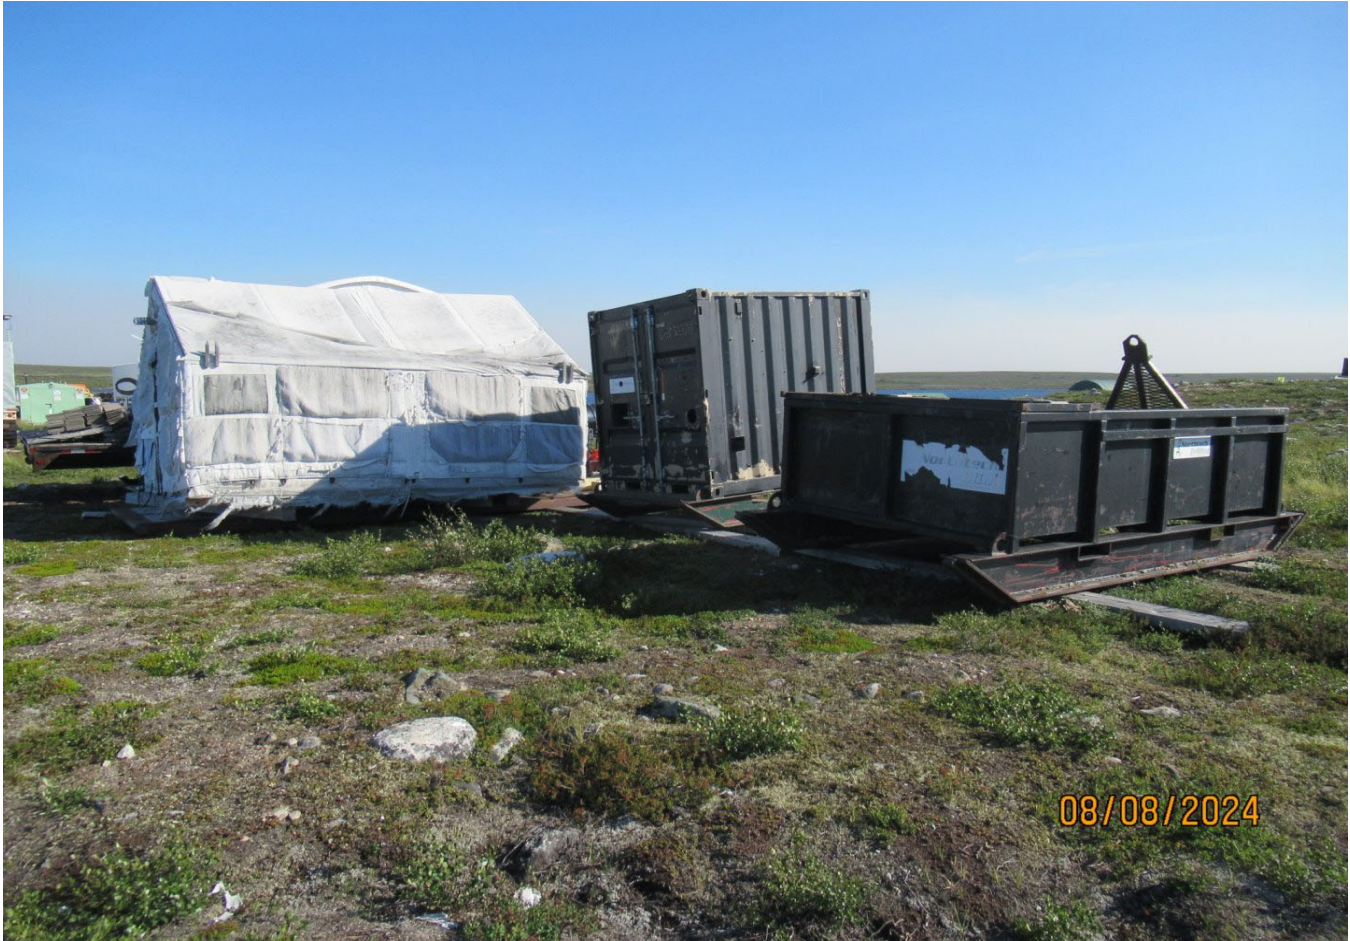
**Figure 11**

**If any of these items no longer serve a purpose on site they must be removed at the very earliest opportunity.**

- The burn bin that is used for open burning only contained acceptable items and when fire & weather conditions permit, the contents will be burnt.
- If equipment like that viewed in Figure 11 no longer serves a purpose for this land use operation, it must be removed from the land use area at the very earliest opportunity.

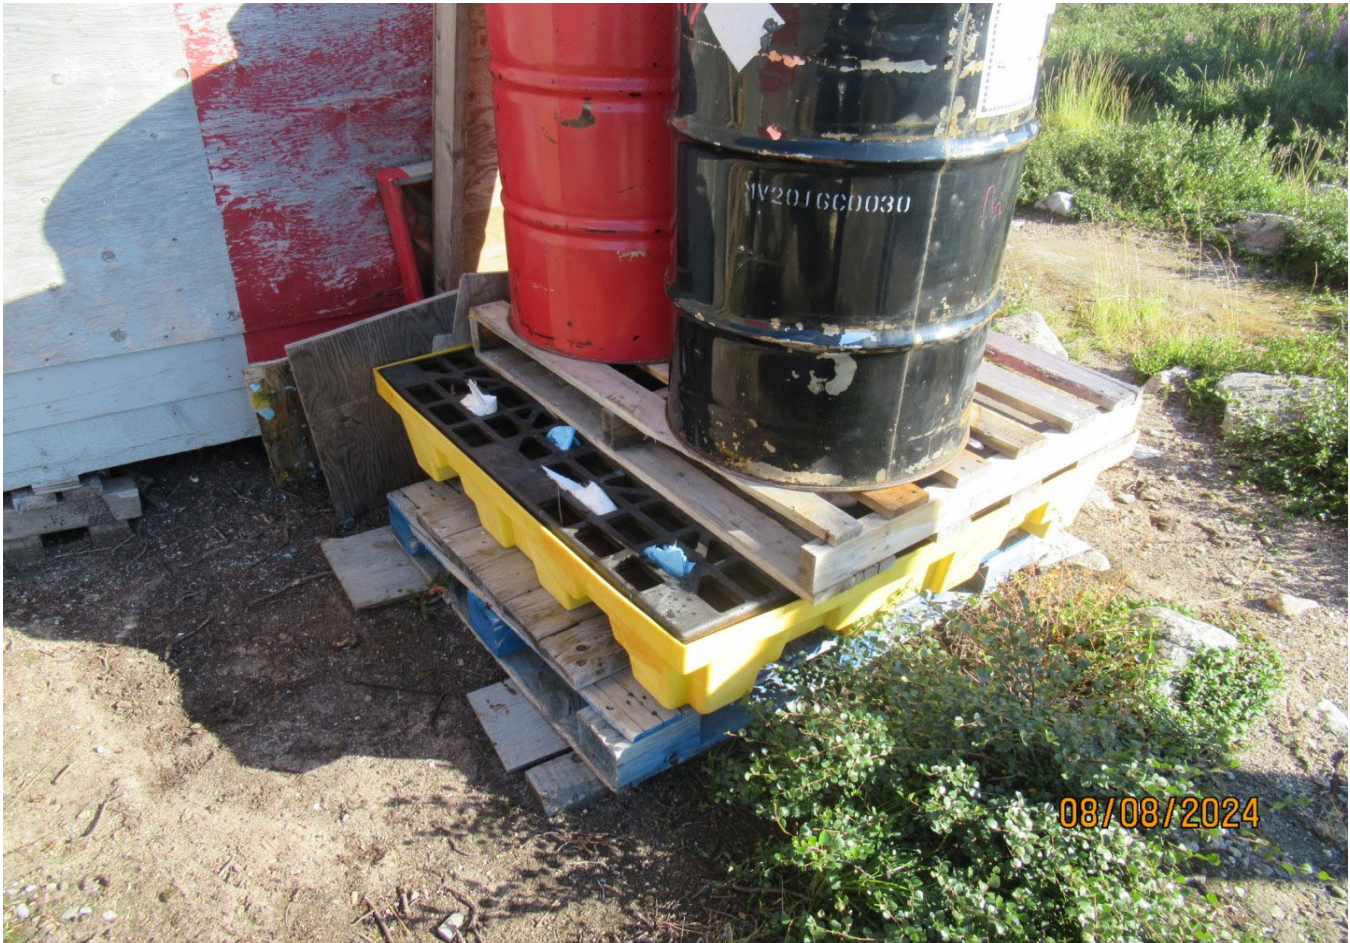
**Figure 13**

- Spill pallets (Figure 13) are being actively used throughout the land use area and the majority were quite full of water, but no hydrocarbon sheens were observed. Maintenance is anticipated to occur with proper treatment of water by mopping it with hydrocarbon absorbent matting or treating it through a rain drain.

Water in containment structures will be mopped for hydrocarbons or put through a rain drain prior to discharge.

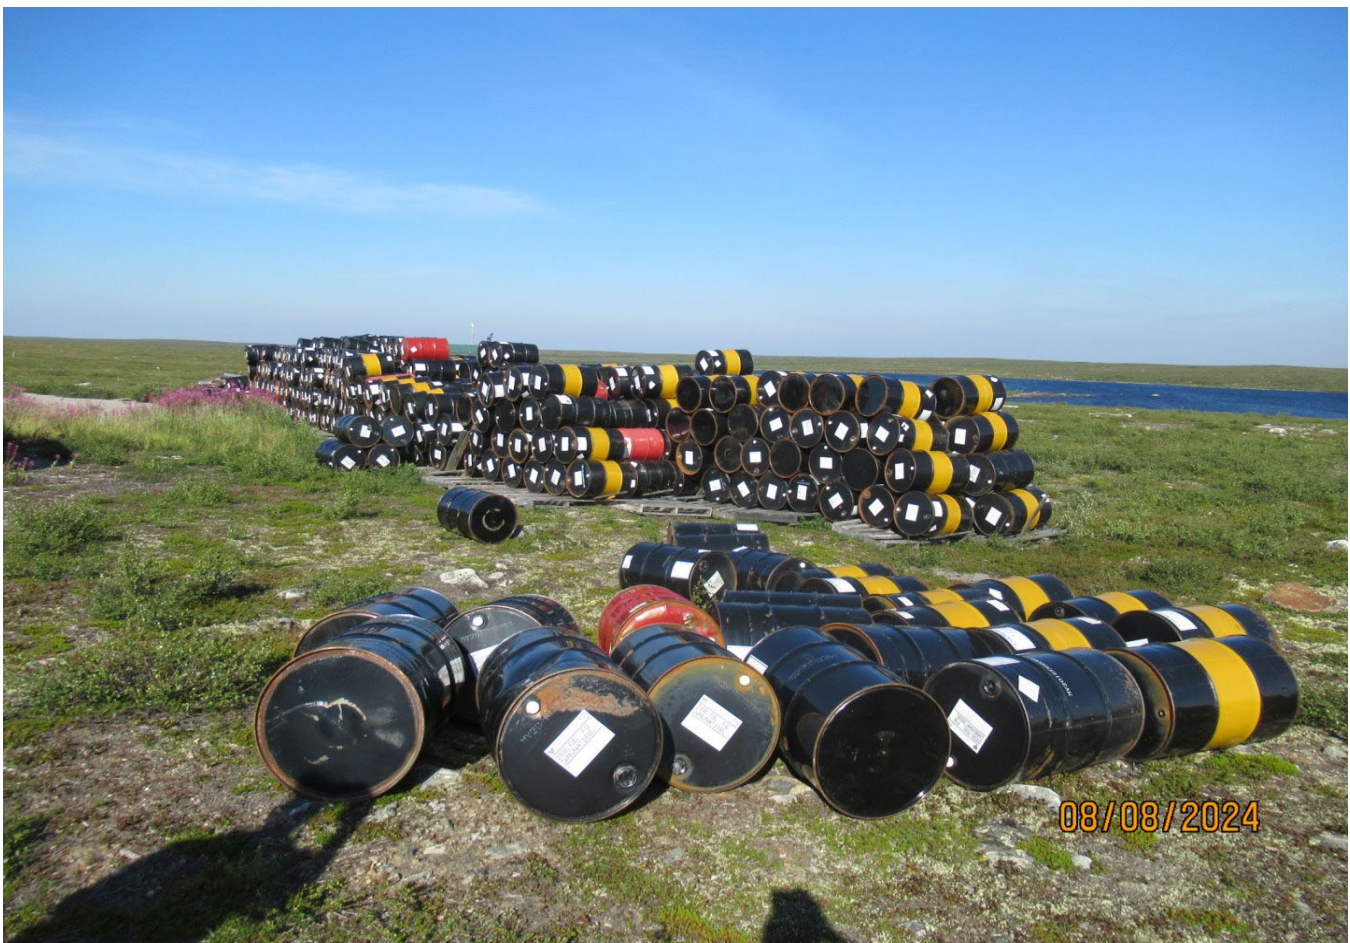
**Figure 14**

Since the camp has only been accessed by air for the last few land use operations that have occurred, there is limited room on small aircraft for the removal of empty fuel containers (45 gallon drums) and therefore stacking east of the old KDI shop has occurred (Figure 14). The Inspectors appreciate that since drums "bulk out" an aircraft they have accumulated in the land use area.

Empty fuel drums have accumulated at the Shop Laydown. Drums must be removed from the land use area at the very earliest opportunity.

It is assumed that most of the drums, if not all, would have been decanted leaving minimal product in them. This would reduce the potential for a spill or environmental concern to arise but it is imperative that when opportunities arise, drums are removed for proper offsite recycling or disposal. It is anticipated that this will occur and if a future winter road is constructed into the land use area, the scheduling of drum removal must be made a priority.
