**Subject: W2016D0003: Spill 2022547 Report**

Pursuant to Part C Condition 18(c) of Land Use Permit W2016D0003, Arctic Canadian Diamond Company Ltd. (Arctic Canadian) is providing a detailed report on Spill 2022547 which occurred on December 5, 2022, at the Koala tailings line between the process plant and south end of the truck shop.

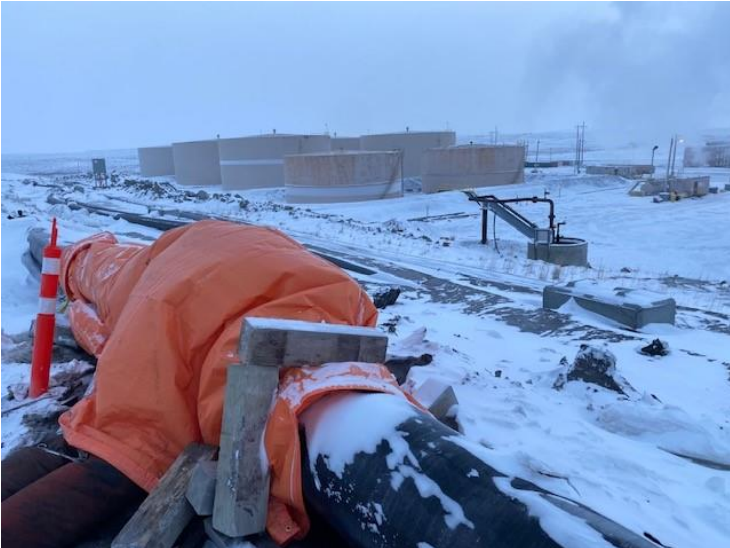
The section of the tailings line that cracked did not appear to have a heat trace system. This suggests that the tailings material likely froze in the pipe causing a pressure build up which ultimately resulted in the crack in the line.

*Photo 1: Facing E Spill 2022547 immediately after spill occurrence placed a cover over the damaged area of Koala tailings line.*

Upon discovery the pumping of the line was immediately stopped thereafter all remaining discharge was moved along the backup line into Cell C of the LLCF. Following this the area of the leak was identified and the component replaced. The spill is located proximal to a series of electrical lines and therefore any significant excavation of the spill will risk damaging these lines. Any of the spill that is accessible at a safe distance from the electrical lines has been excavated and deposited in the appropriate waste stream. Further clean up of the area will be conducted in springtime when the spill melts.

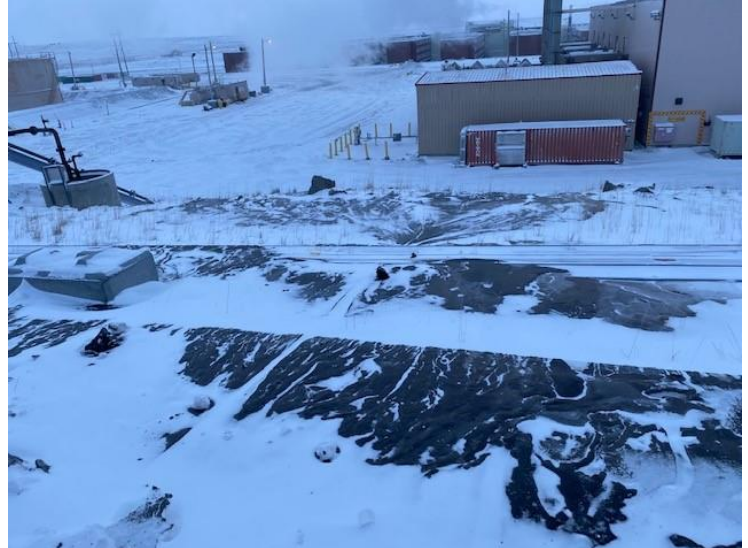
At 16:30 PM on December 5, 2022, it was identified that the Koala Tailings line had spilt an approximate 12,000 L of diesel onto disturbed ground on the berm between the truck shop and the process plant. The spill covers an approximately 50m<sup>2</sup> area (see photos).

*Photo 2: facing S Spill 2022547 flow from the affected pipe heading down the berm towards the process plant building.*

A detailed clean up strategy will be proposed early in the new year. The site will be inspected on a weekly basis until any signs of thawing are apparent upon which the cleanup program will commence.
