**Land Use Permit
W2016D0003
Sable Development**

Re: April 4th 2017 Land Use Permit Inspection W2016D0003

ENVIRONMENTAL INSPECTION REPORT

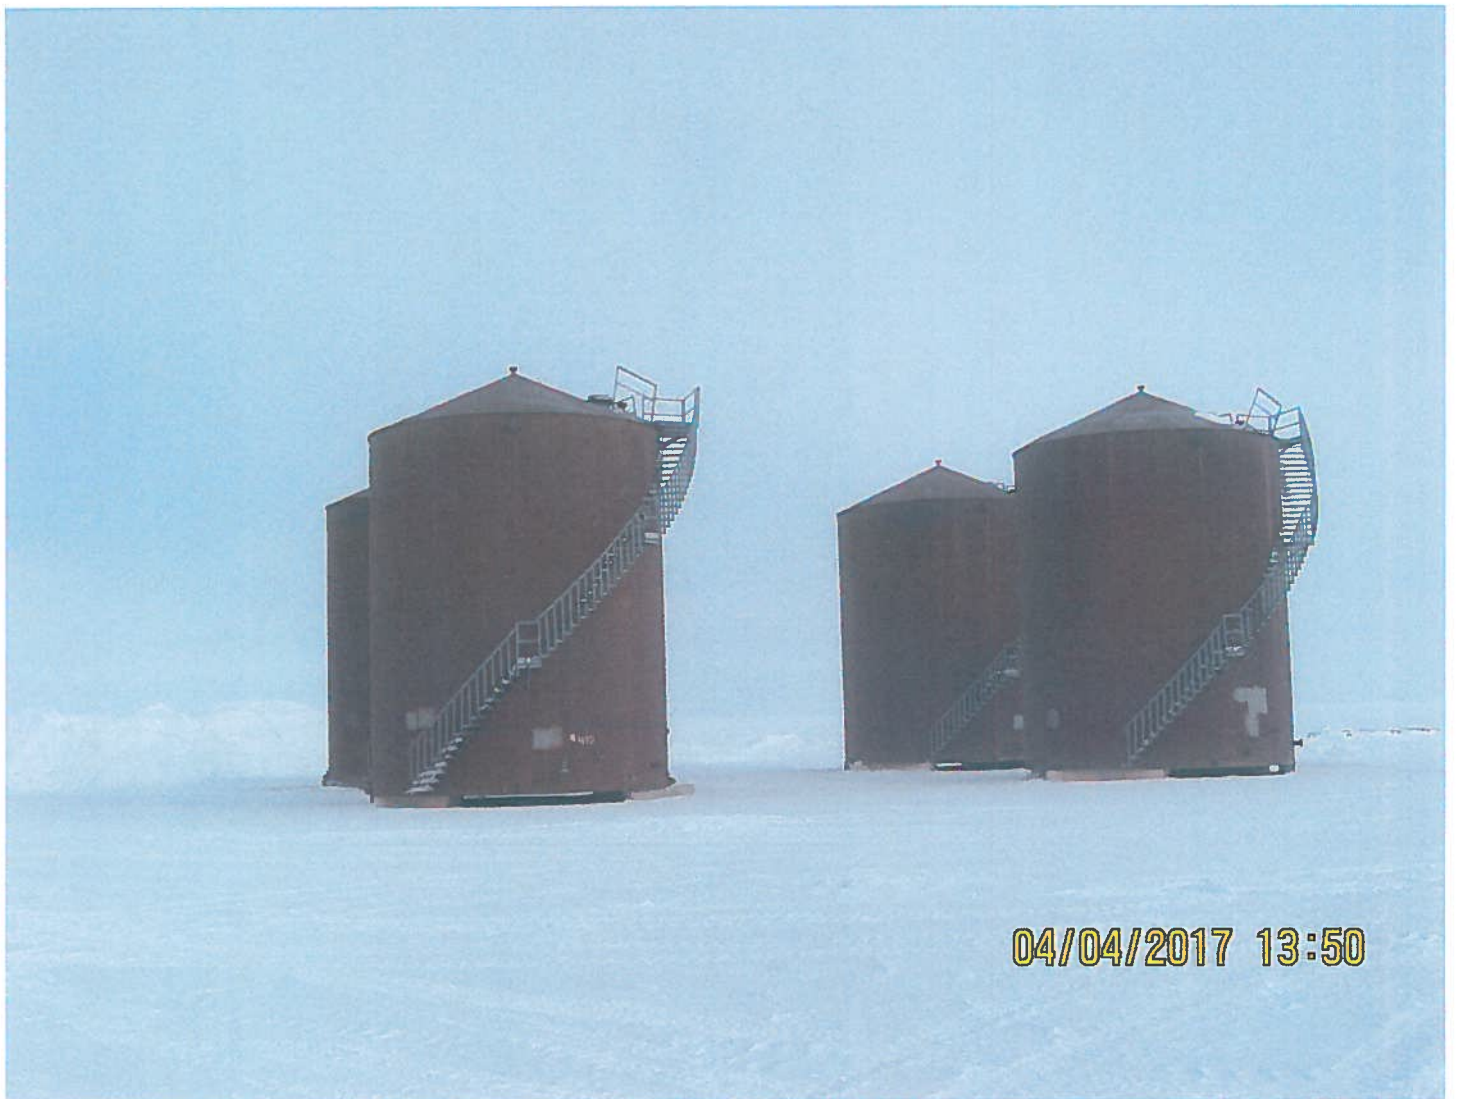
Photo 1: Sable Office Complex Laydown Area - Four - 500,000 Litre fuel tanks will be placed in an engineered berm at the Sable Office Complex Laydown Area.

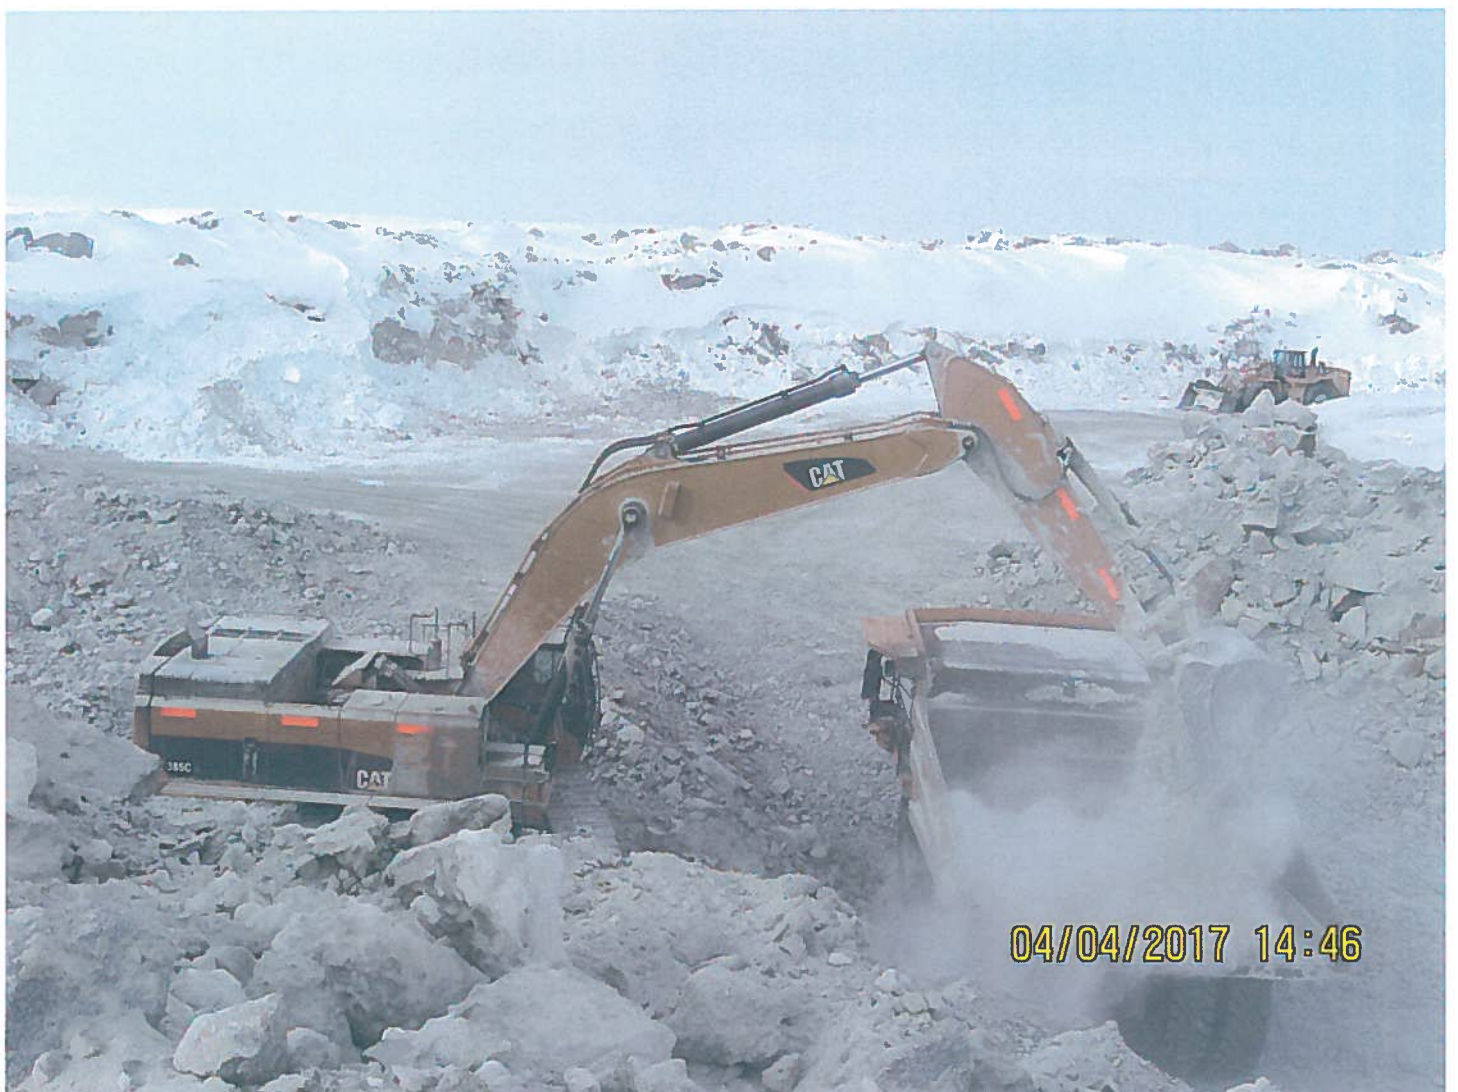
Photo 2: Sable Quarry Pit - Clean granite is being excavated from the Sable Quarry Pit and being stock piled near the crusher pad for future construction projects

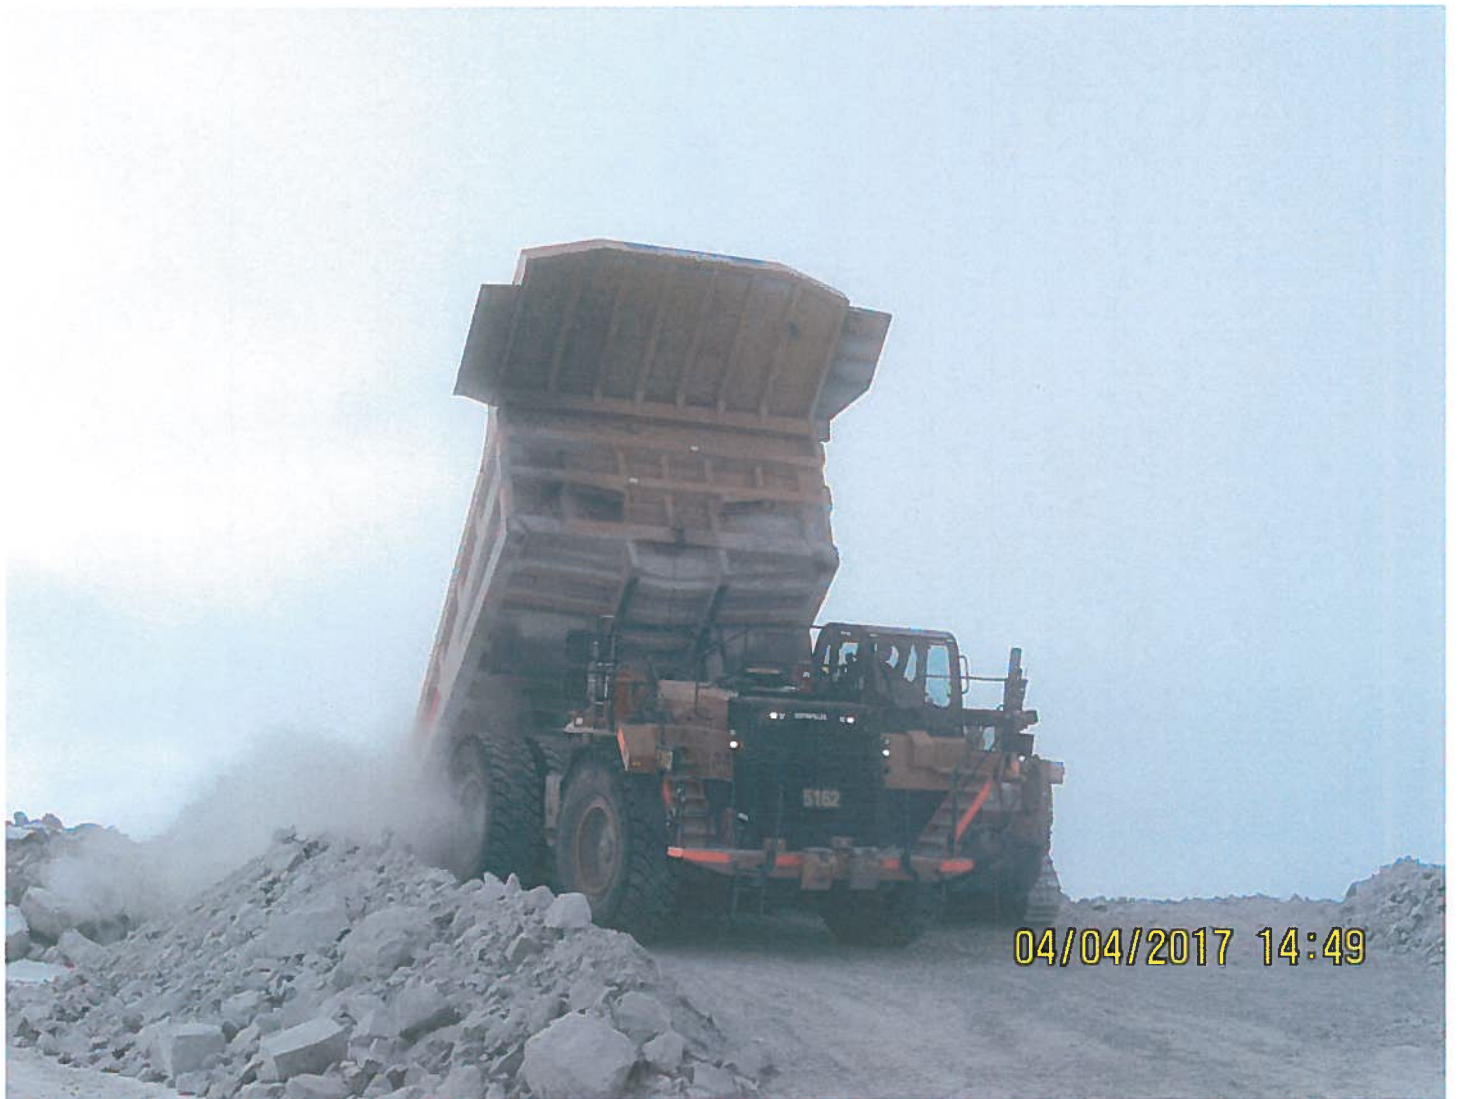
The pads and site roads for all of the Sable facilities are being maintained to the satisfaction of the Inspector. Clean granite is being excavated from the Sable Quarry Pit and being stock piled near the crusher pad for future construction projects (Photo 2, 3).

Photo 3: Sable Crusher Pad - Clean granite from the Sable Quarry is loaded into haul trucks and stock piled near the crusher pad.

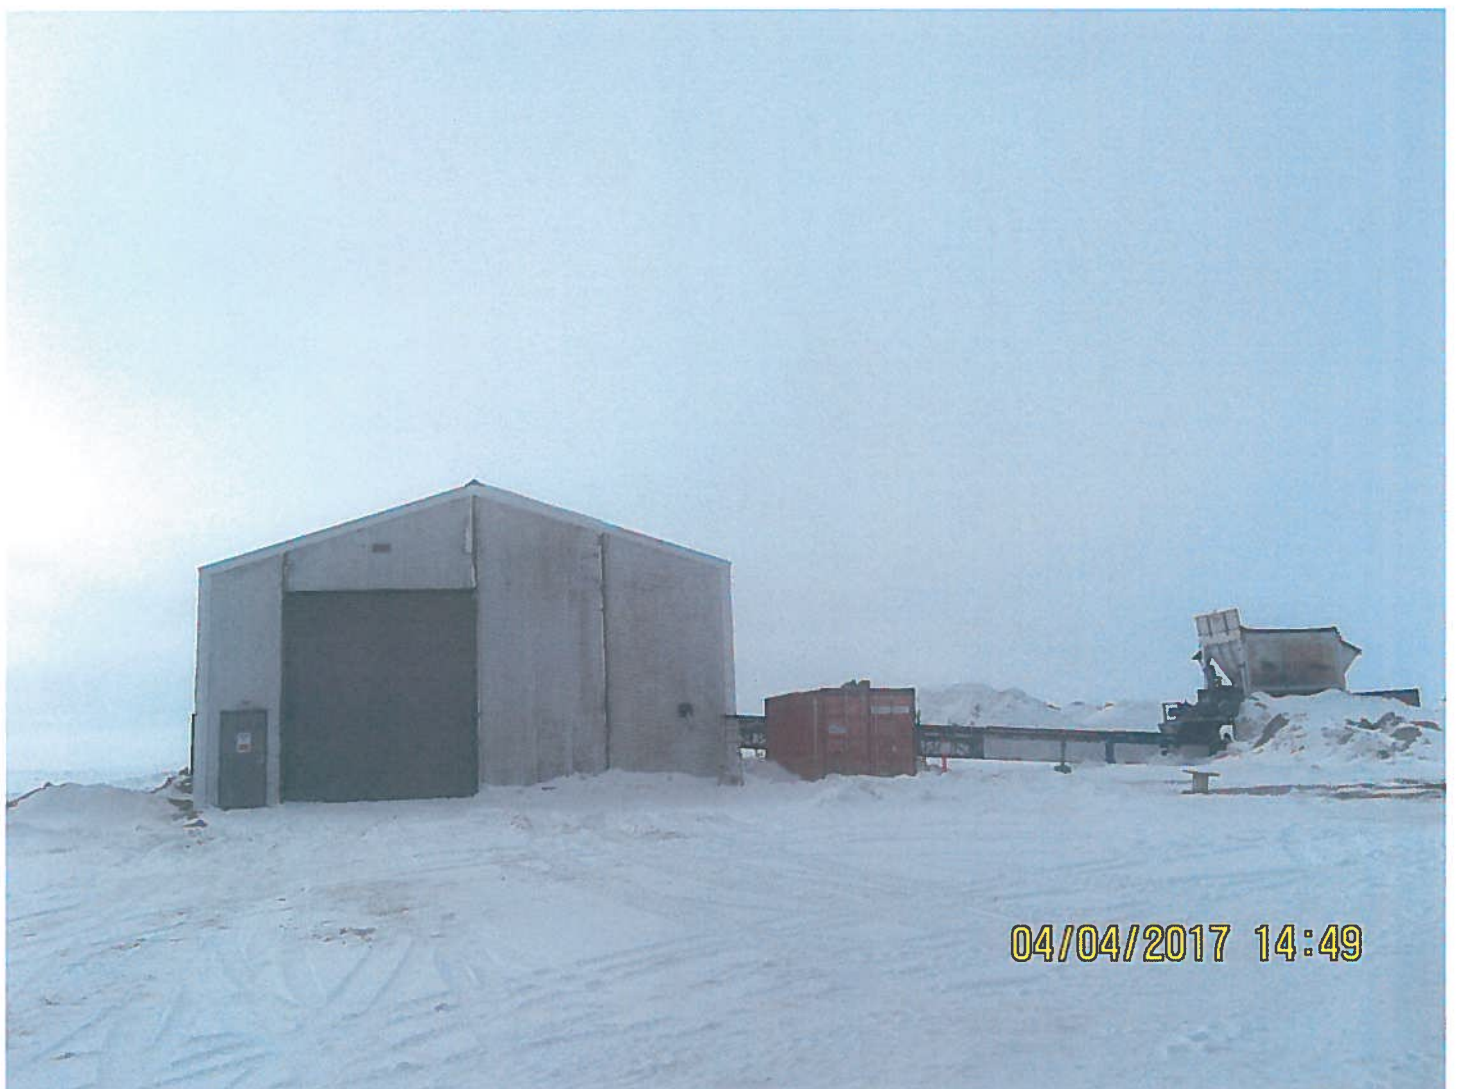
The Sable Crusher and Frozen Core Plant are currently shut down. The Inspector was informed that the Frozen Core Plant will be decommissioned in the near future (Photo 4). All components for this facility will be removed and stored at the Nuna Zone 12 laydown area at main camp. The sable crusher will be shut down until the first week of June 2017. Crushing of clean granite will resume for the continued construction of the Two Rock Sedimentation/Filter Dyke in Two Rock Settling Pond. Additional crush will be required for the construction of the base/platforms and berm for the 2 million litre tank farm.

Photo 3: Frozen Core Plant - The Frozen Core Plant will be decommissioned in the near future. All components for this facility will be removed and stored at the Nuna Zone 12 laydown area at main camp.

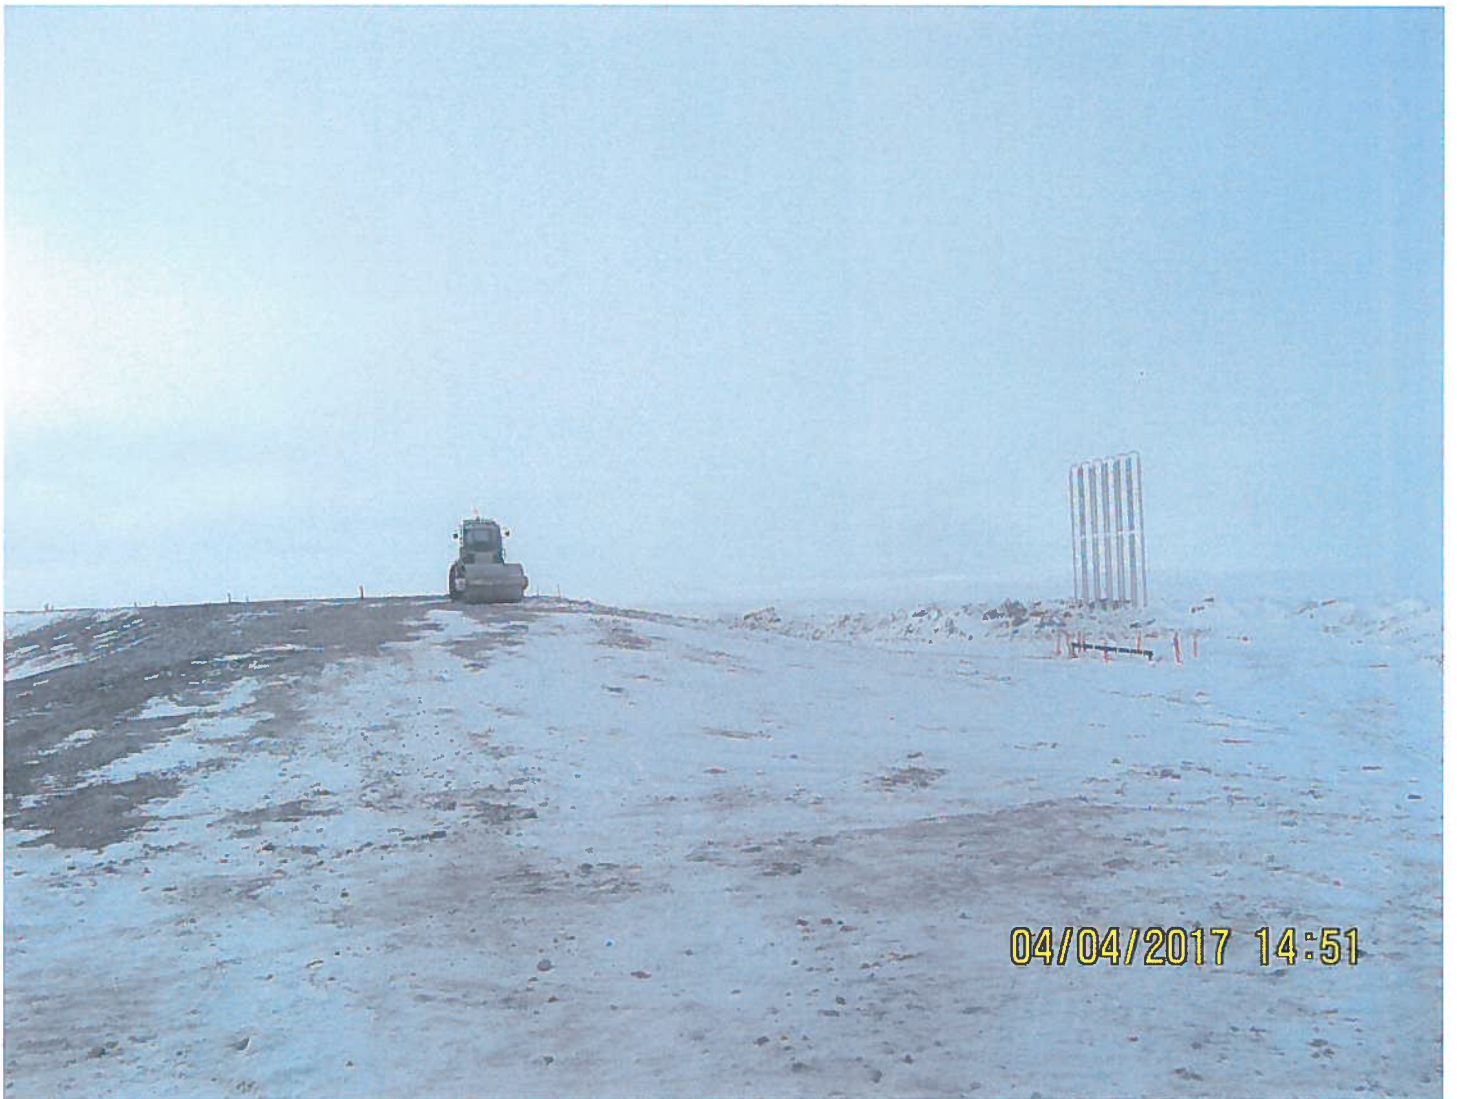
Photo 5: Two Rock Frozen Core Dam - The Two Rock Frozen Core Dam has now been completed as per submitted design plans

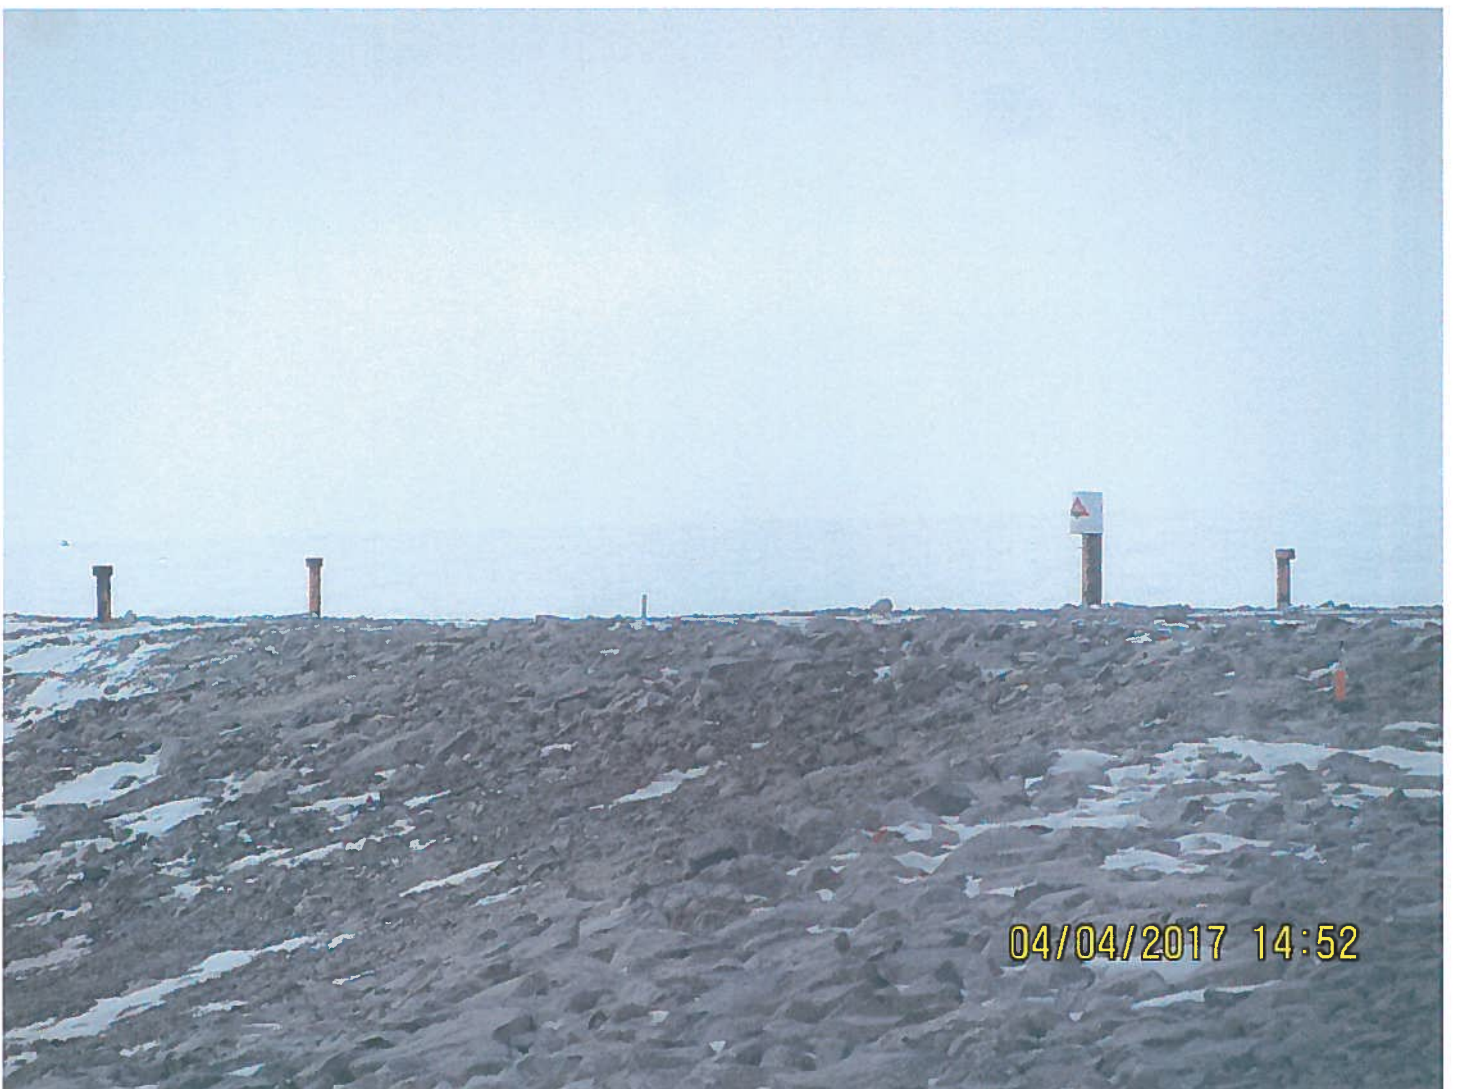
The Two Rock Frozen Core Dam has now been completed as per submitted design plans (Photo 5). A total of 9 vertical ground temperature monitors were installed within the Two Rock Frozen Core Dam to a depth of approximately 8-10 meters (Photo 6).

Photo 6: Two Rock Frozen Core Dam - A total of 9 vertical ground temperature monitors were installed within the Two Rock Frozen Core Dam to a depth of approximately 8-10 meters

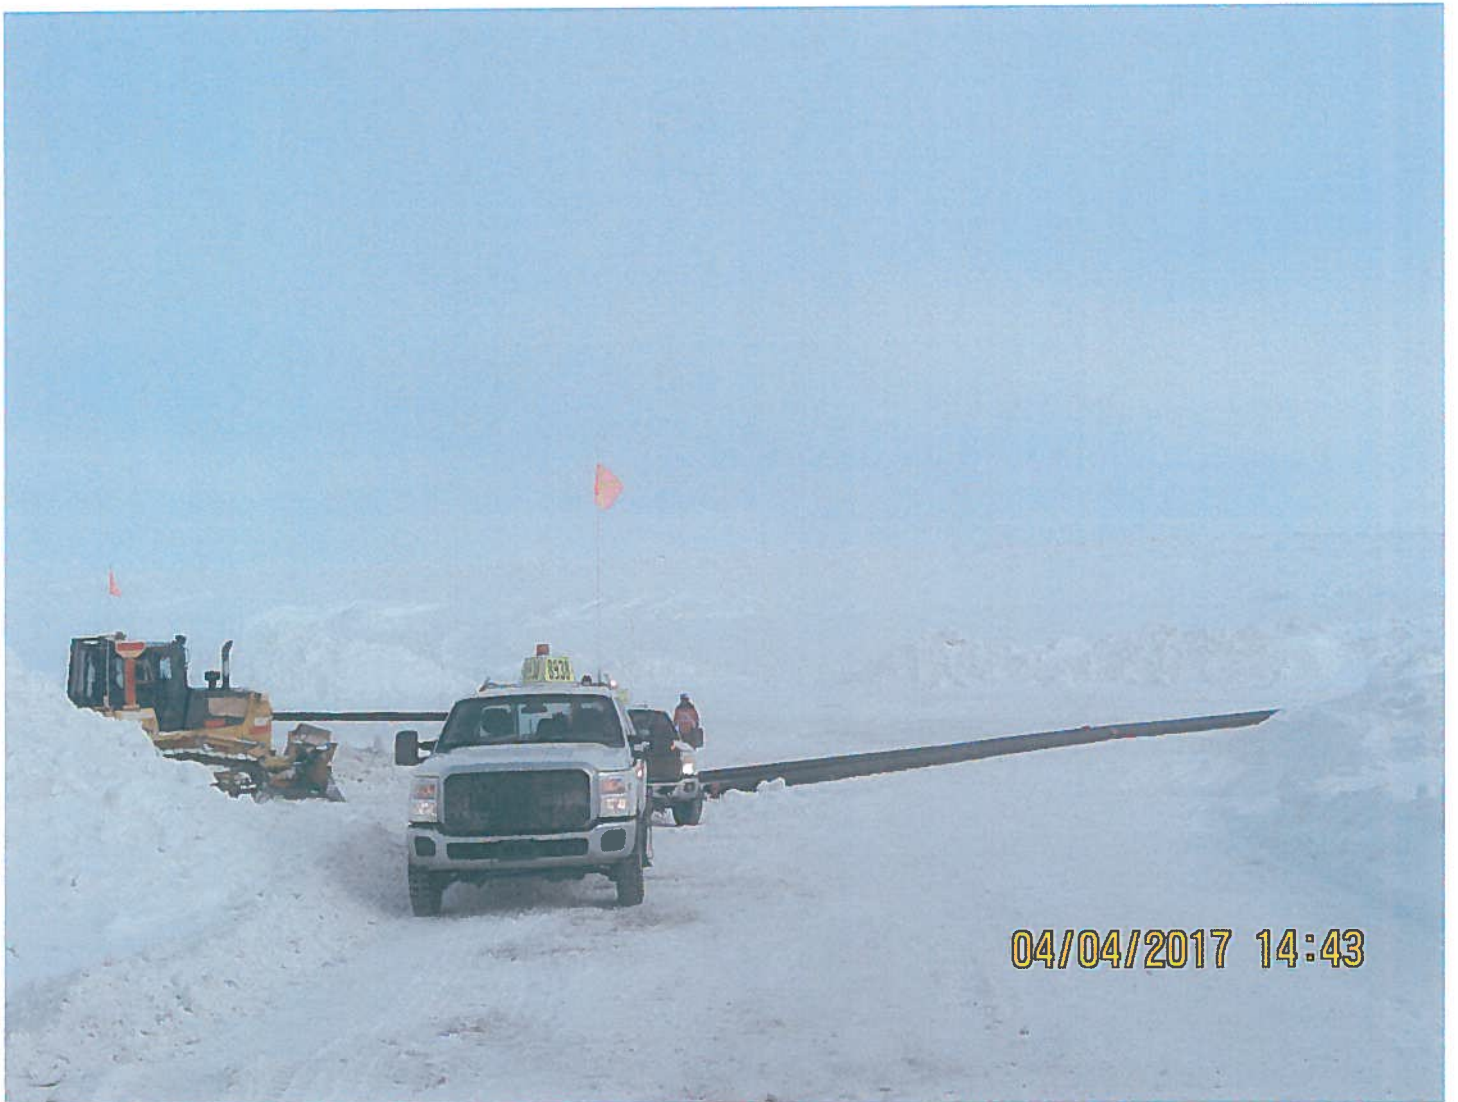
A 10" HDPE temporary dewatering line was being assembled on Sable Lake during this inspection (Photo 7). The dewatering line will be placed in frozen conditions running from Sable lake to Ulu Lake. Dewatering of Sable Lake is scheduled to begin during freshet in 2017. Dewatering will occur in two stages. A portion of the water will be pumped to the receiving environment(Ulu Lake) providing the water meets Effluent Quality Criteria(EQC) and in stage two water will be pumped to the Two Rock Settling Pond(TRSP). The proposed Sable Lake Dewatering Plan is currently out for review via the WLWB's Online Review System.

Photo 7: Sable Lake Dewatering Line - A 10" HDPE temporary dewatering line was being pieced together on Sable Lake during this inspection. The dewatering line will be placed in frozen conditions running from Sable lake to Ulu Lake
