**Land Use Permit  
W2016D0003  
Sable Development**

**Re: February 13<sup>th</sup> 2017 Land Use Permit Inspection W2016D0003**

## ENVIRONMENTAL INSPECTION REPORT

Permittee: Dominion Diamond Ekati Corporation	Inspection Date: February 13 <sup>th</sup> 2017
---	--

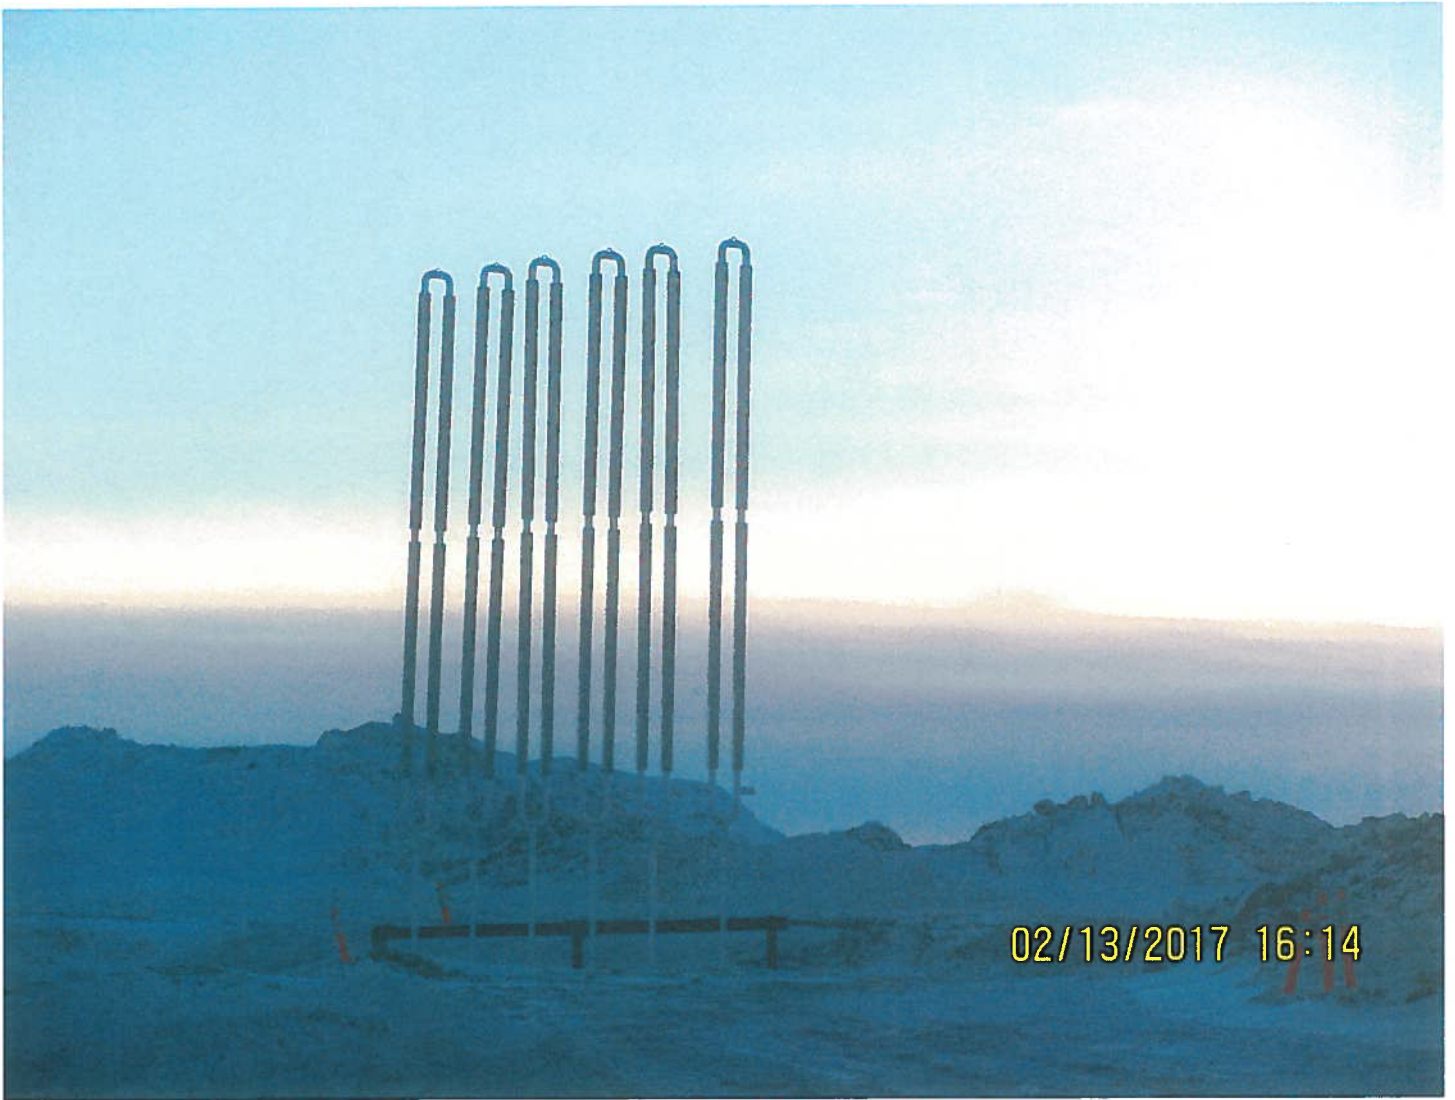
A total of 12 individual thermosyphons have now been installed at the Two Rock Frozen Core Dam (Photo 1 and 2). Slurry (3/4” granite/fines/water) will continue to be placed until the design height specifications of the frozen core dam have been met. The Inspector observed Nuna staff removing snow from the trench by hand and compressed air (Photo 3). A clean surface is required to ensure the layers of slurry bond together.

Photo 1: Sable Development/Frozen Core Dam- A total of 12 individual thermosyphons have now been installed at the two rock frozen core dam. Photo is of the six thermosyphons installed on the East side of the Frozen Core Dam

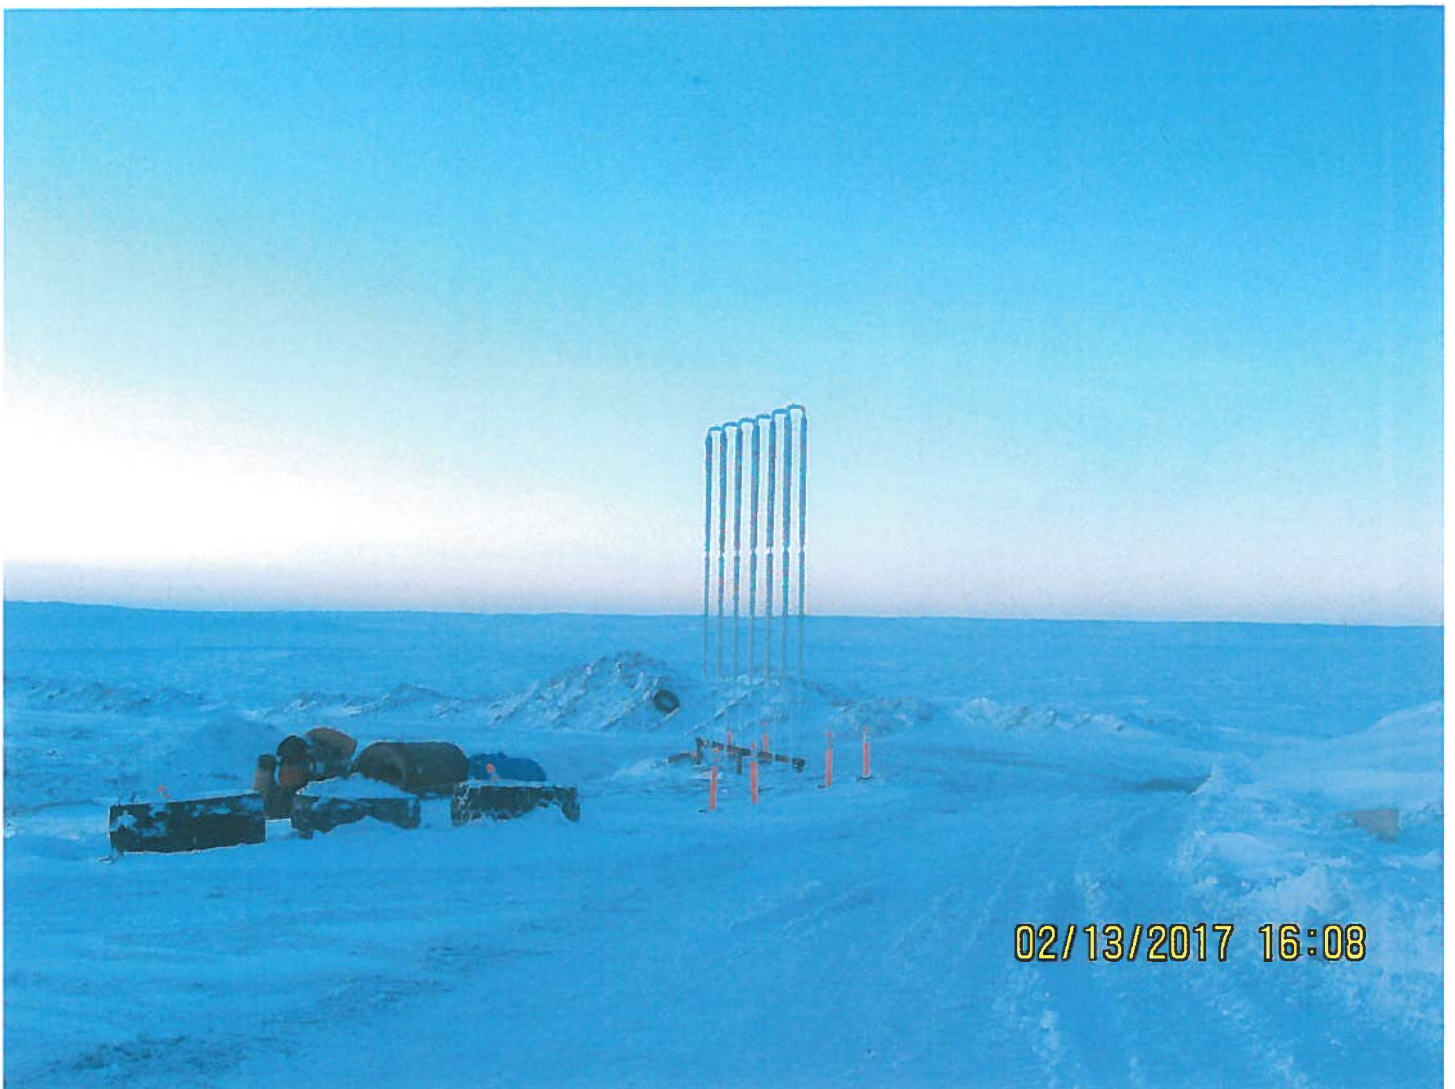
Photo 2: Sable Development/Frozen Core Dam- Photo of the six thermosyphons installed on the West side of the Frozen Core Dam

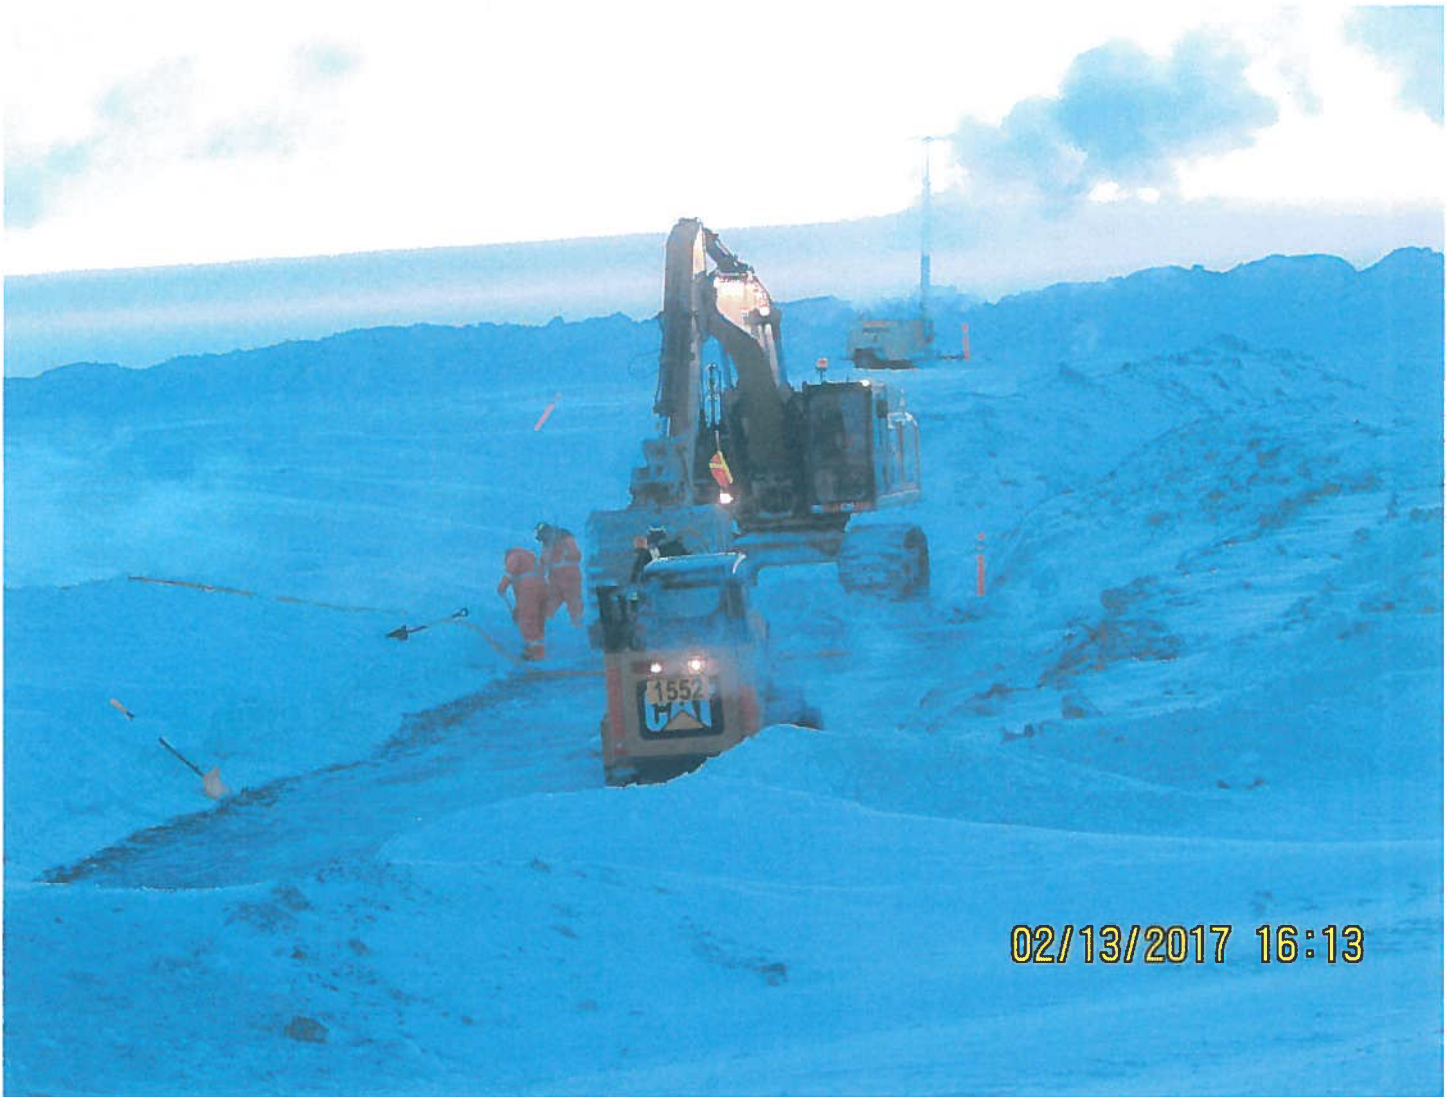
Photo 3: Sable Development/Frozen Core Dam- Nuna staff preparing the frozen core dam surface for the next layer of slurry. The surface needs to be free of snow to ensure there is a solid bond between the slurry layers.

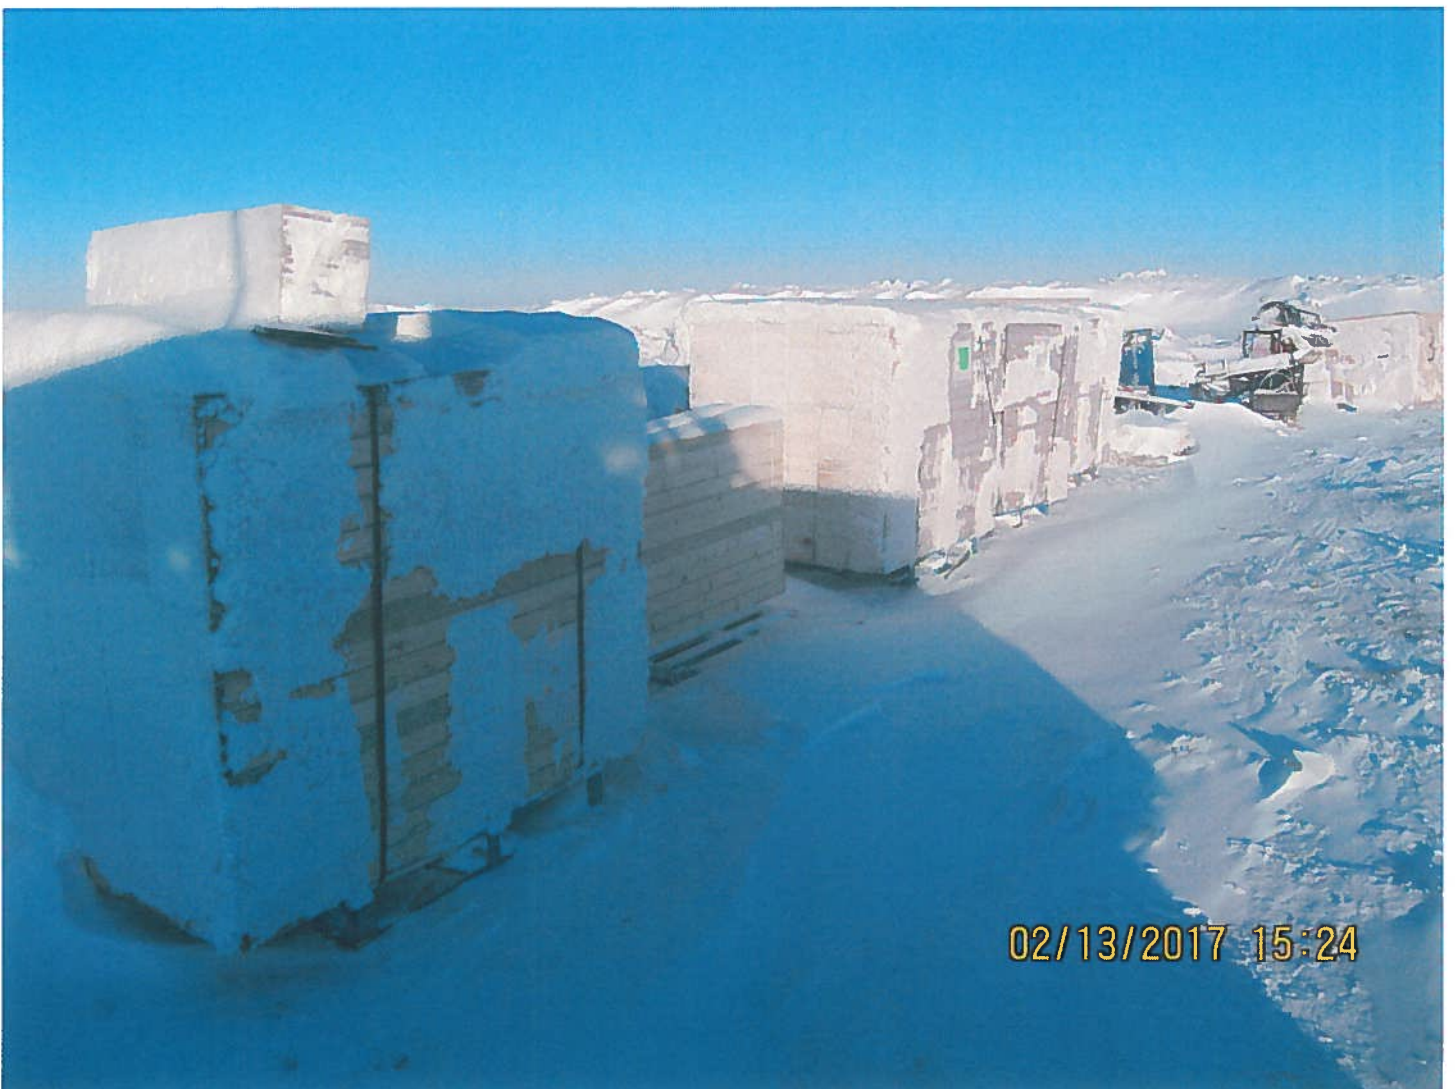
A total of six holes will be drilled on Sable Lake to determine characteristics of the rock. Two drill holes (SB17-F and SB17-A) had been completed at the time of this inspection. Foraco was preparing the drill for the next target (SB17-E). Ice surfaces had been cleared around the lake in preparation for drilling. Faraco has established a small lay down area within the Quarry Pit. The Inspector noted drilling components, core storage boxes, drilling lubricants and a double walled fuel tank stored at this laydown (Photo 4). The drill shack was inspected and the Inspector noted several fully stocked spill kits that were readily accessible (Photo 5). A spill kit and clean up supplies were also noted at the entrance of Sable Lake (Photo 6). Waste streams were being separated using clearly labeled waste drums. The site was well organized and no hydrocarbon drips or stains were noted. All stationary equipment had drip trays placed under the engines (Photo 7). Drill cuttings are captured in a recirculating drill sump are eventually pumped into the Sable quarry pit. Cuttings and pit water will be removed with a vac-truck and disposed of at the Long Lake Containment Facility in the spring. Refueling of equipment is carried out as required by a mobile 2500 L double walled fuel truck. The Inspector was informed that the drilling program will be complete in the last week of February. The Inspector has informed DDEC that once the program is completed, a final site inspection will be conducted on the Sable Lake geotechnical drill program.

Photo 4: Sable Development/Sable Quarry- Staging area for supplies required for a 6 hole geotechnical drill program on Sable Lake.

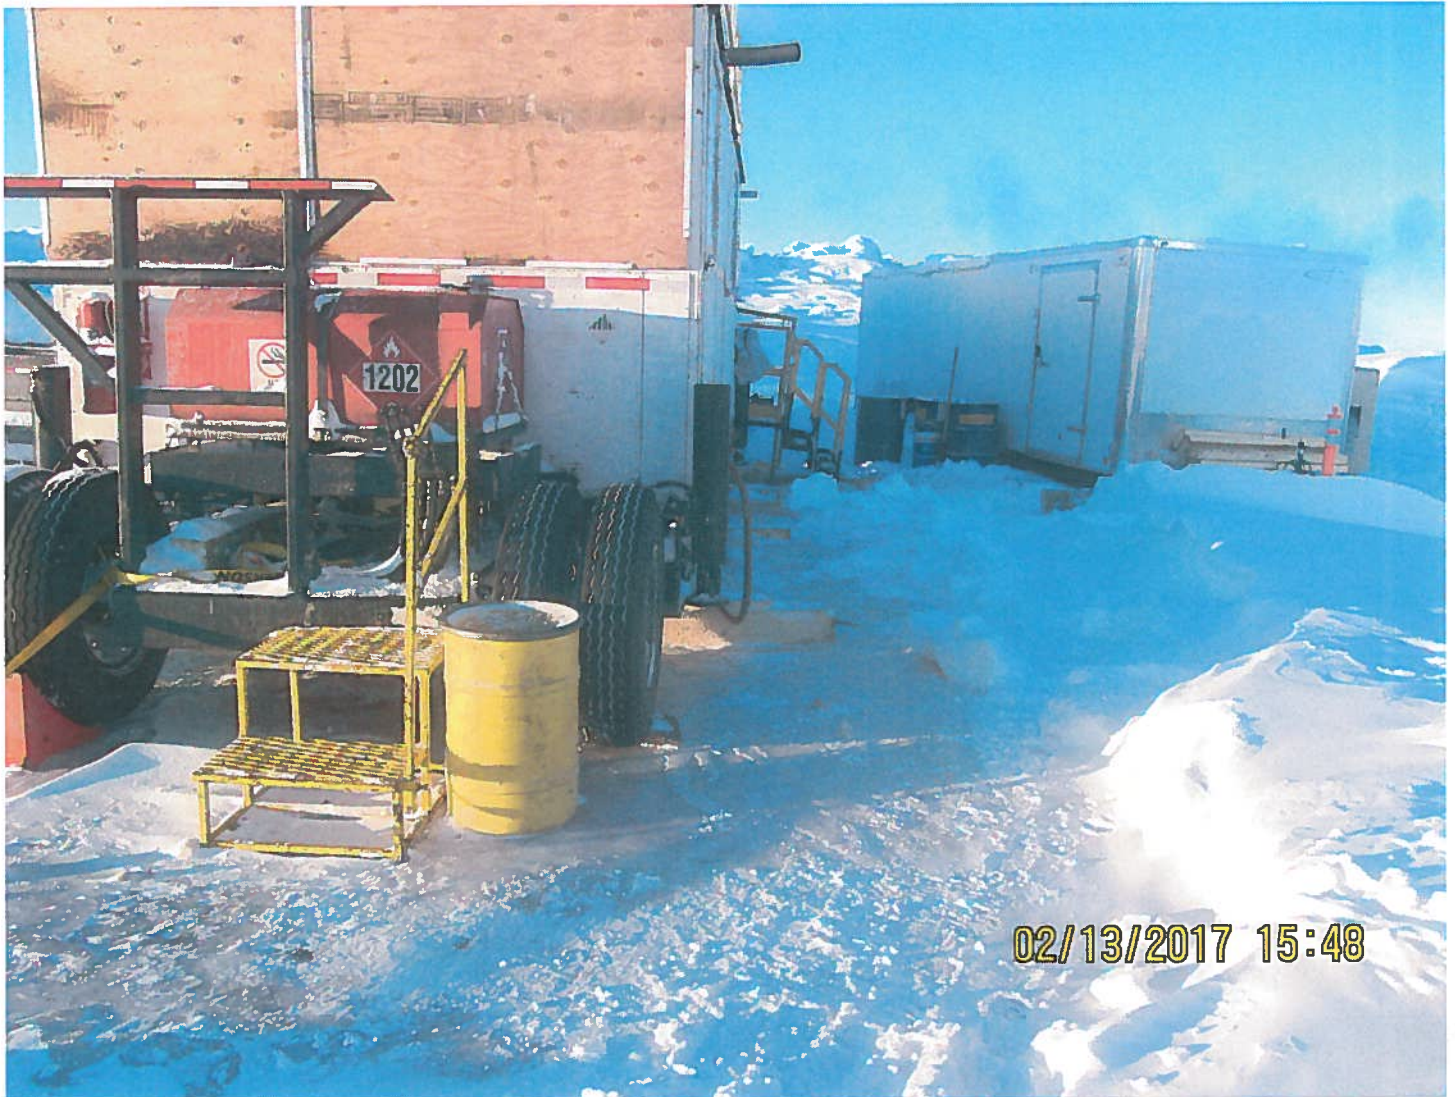
Photo 5: Sable Development/Sable Lake-The drill shack was inspected and the Inspector noted several fully stocked spill kits that were readily accessible

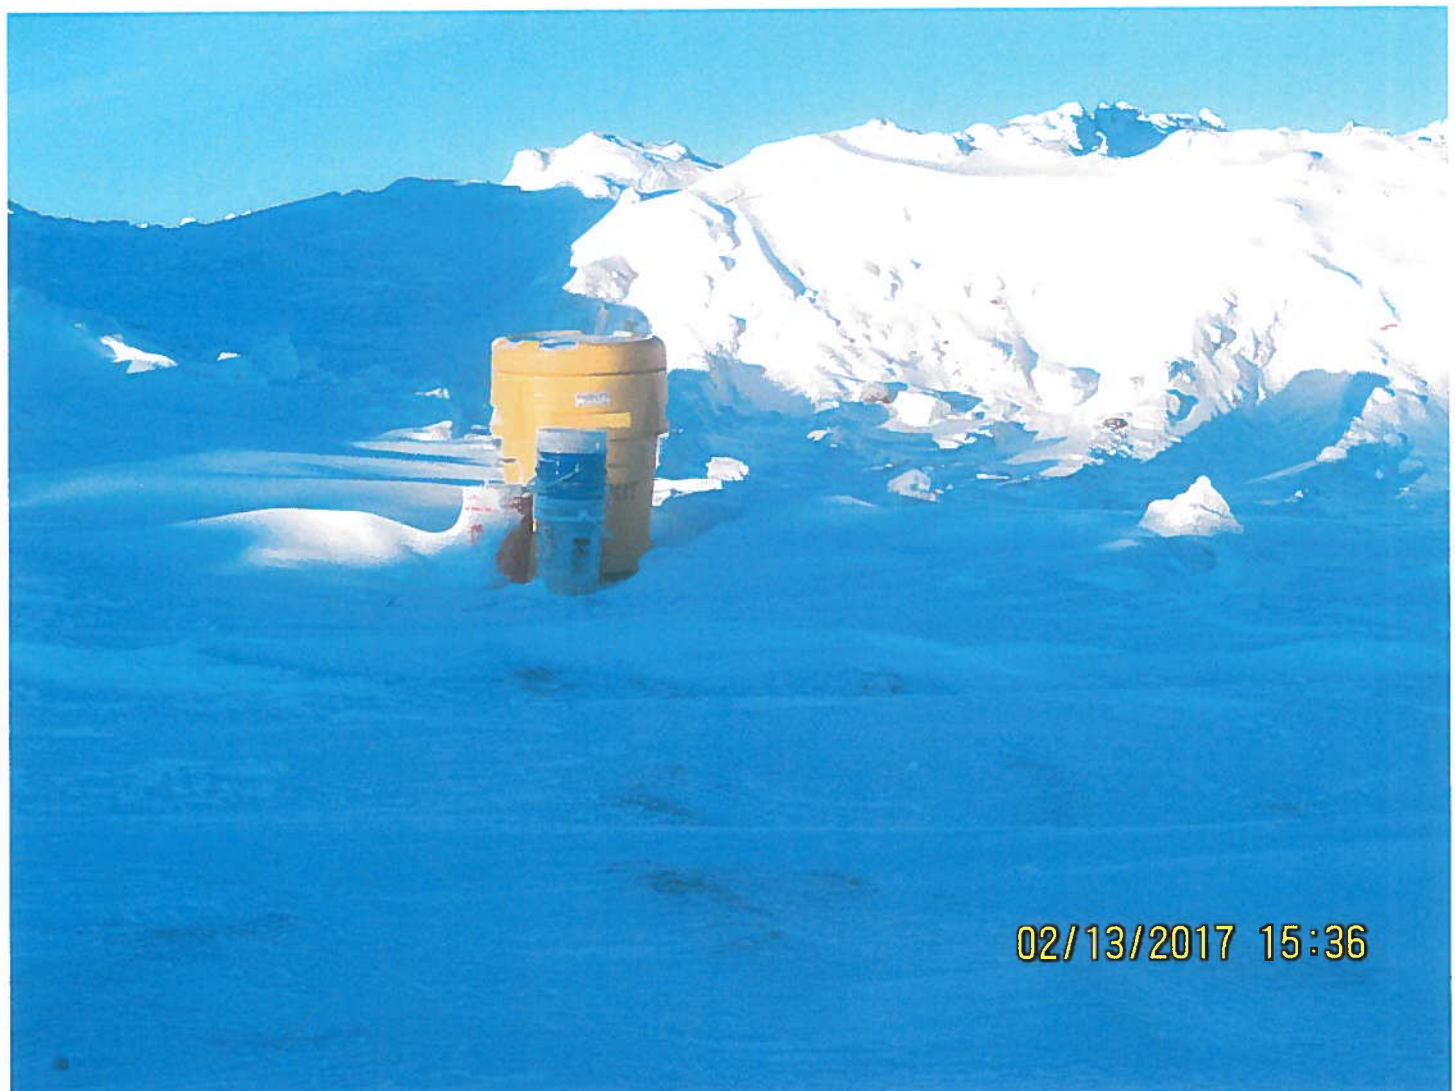
Photo 6: Sable Development/Sable Lake-A spill kit and clean up supplies were noted at the entrance of Sable Lake

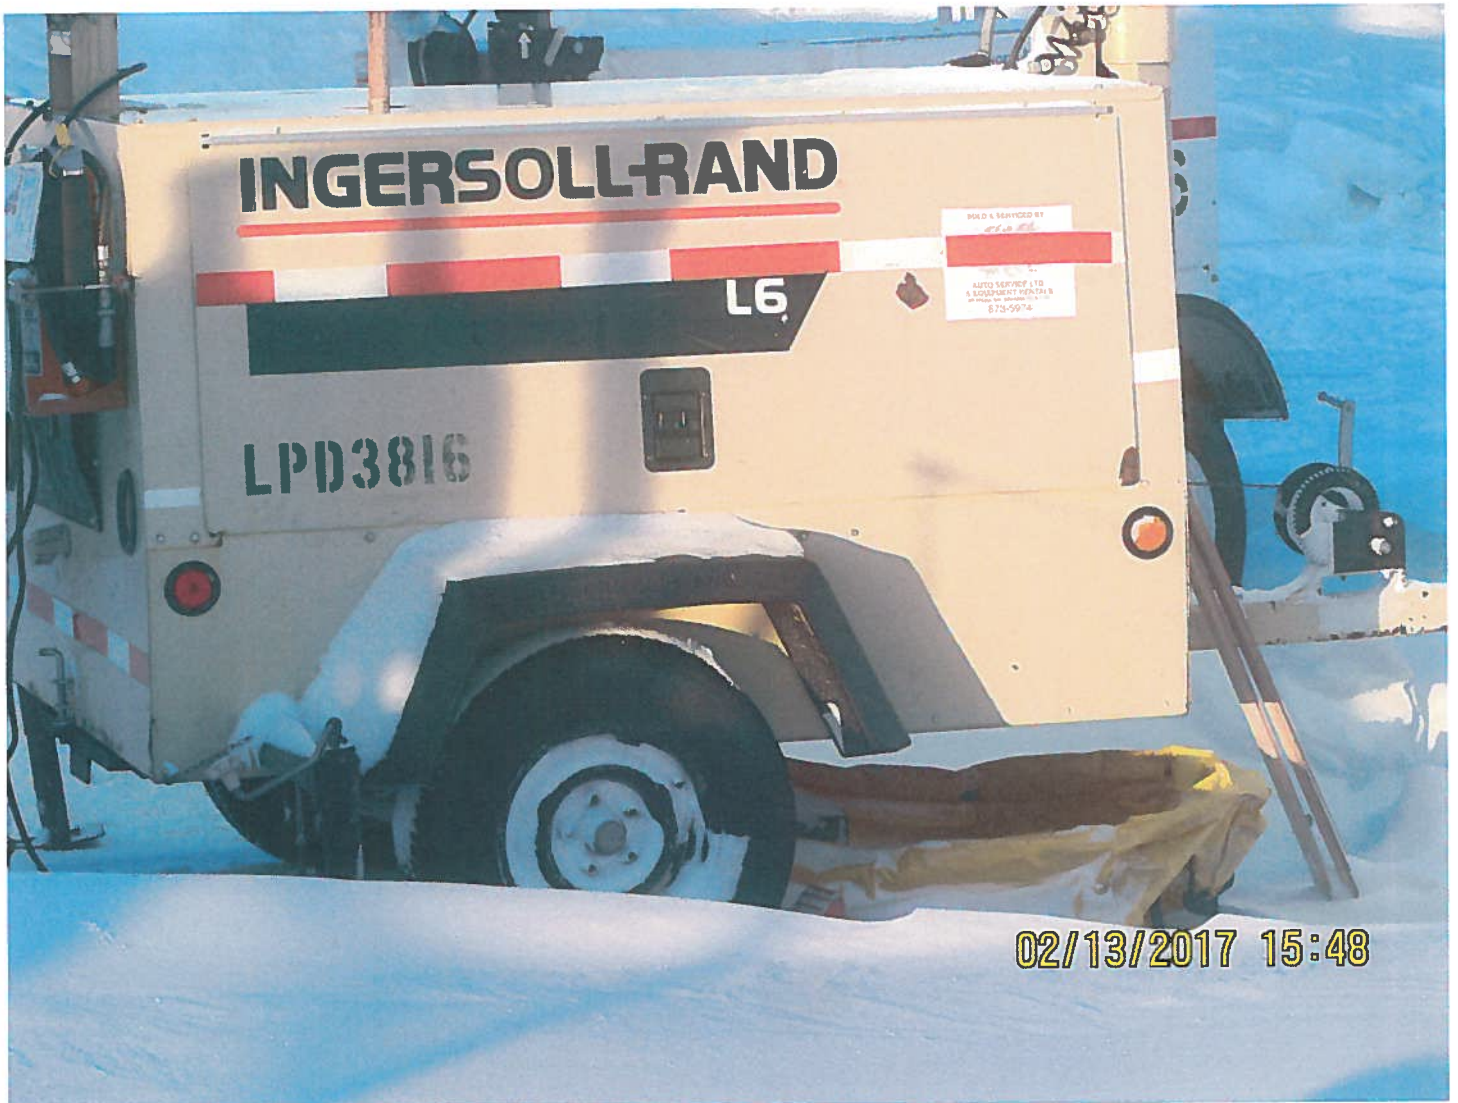
Photo 7: Sable Development/Sable Lake- All stationary equipment had drip trays placed under the engines

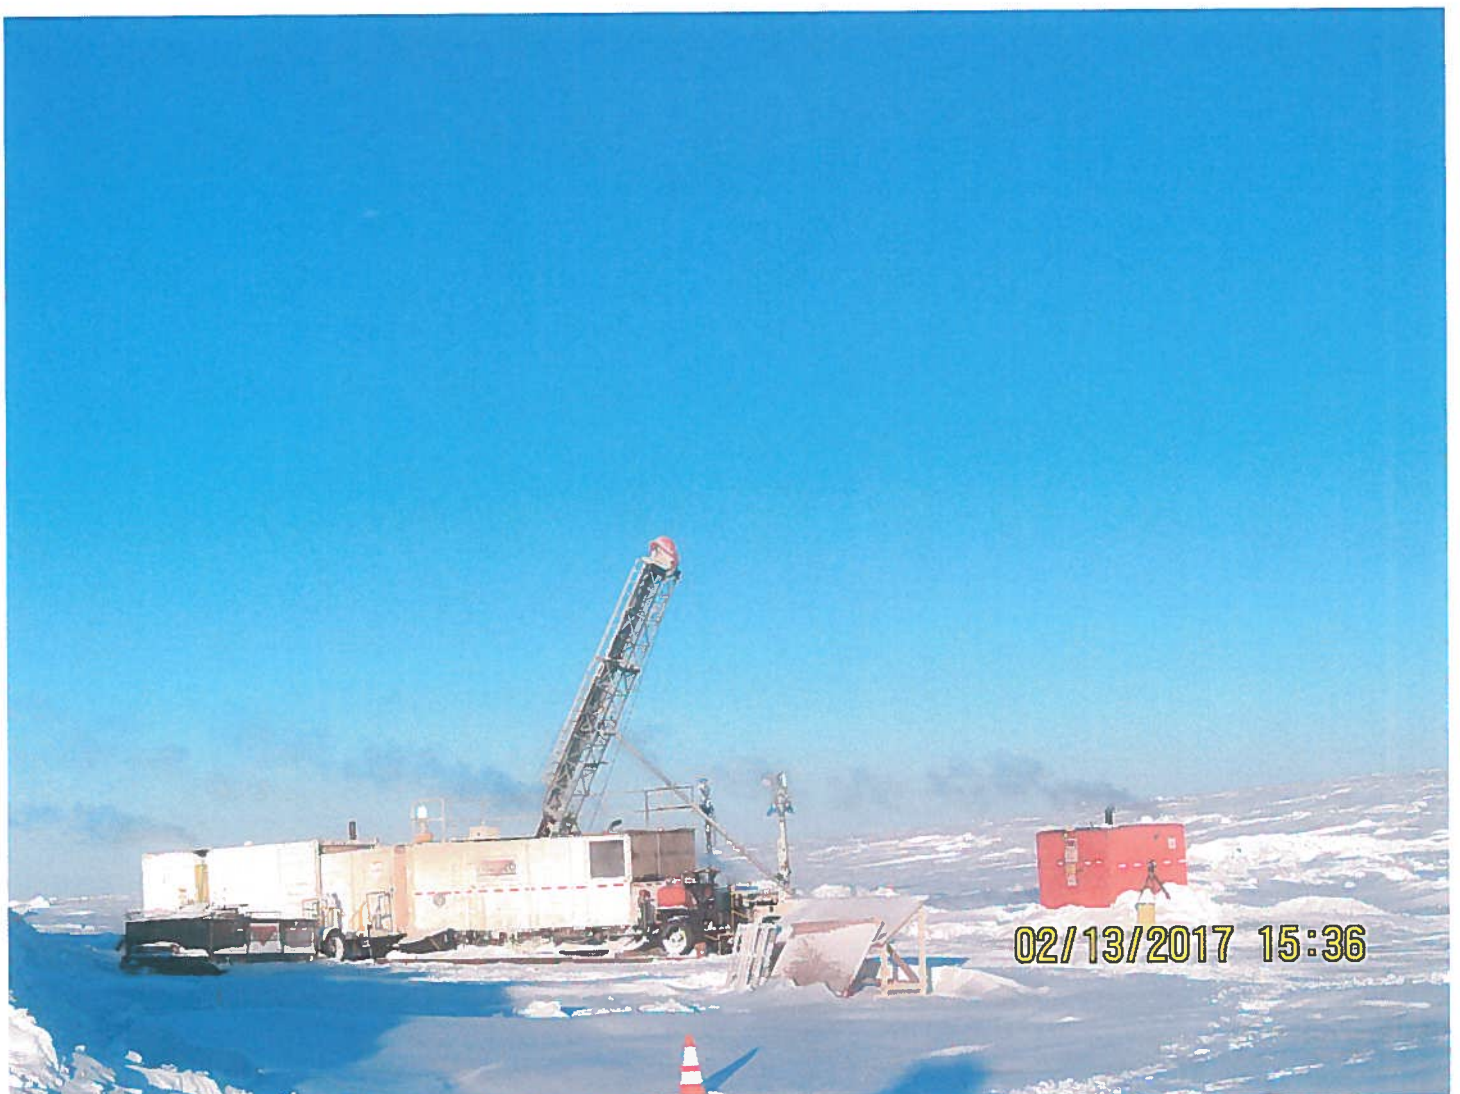
Photo 8: Sable Development/Sable Lake- Foraco Drill Shack and generator on Sable Lake. Geotechnical drilling will be completed in the last week of February.
