**Land Use Permit  
W2016D0003  
Sable Development**

**Re: September 5<sup>th</sup> 2017 Land Use Permit Inspection W2016D0003**

### ENVIRONMENTAL INSPECTION REPORT

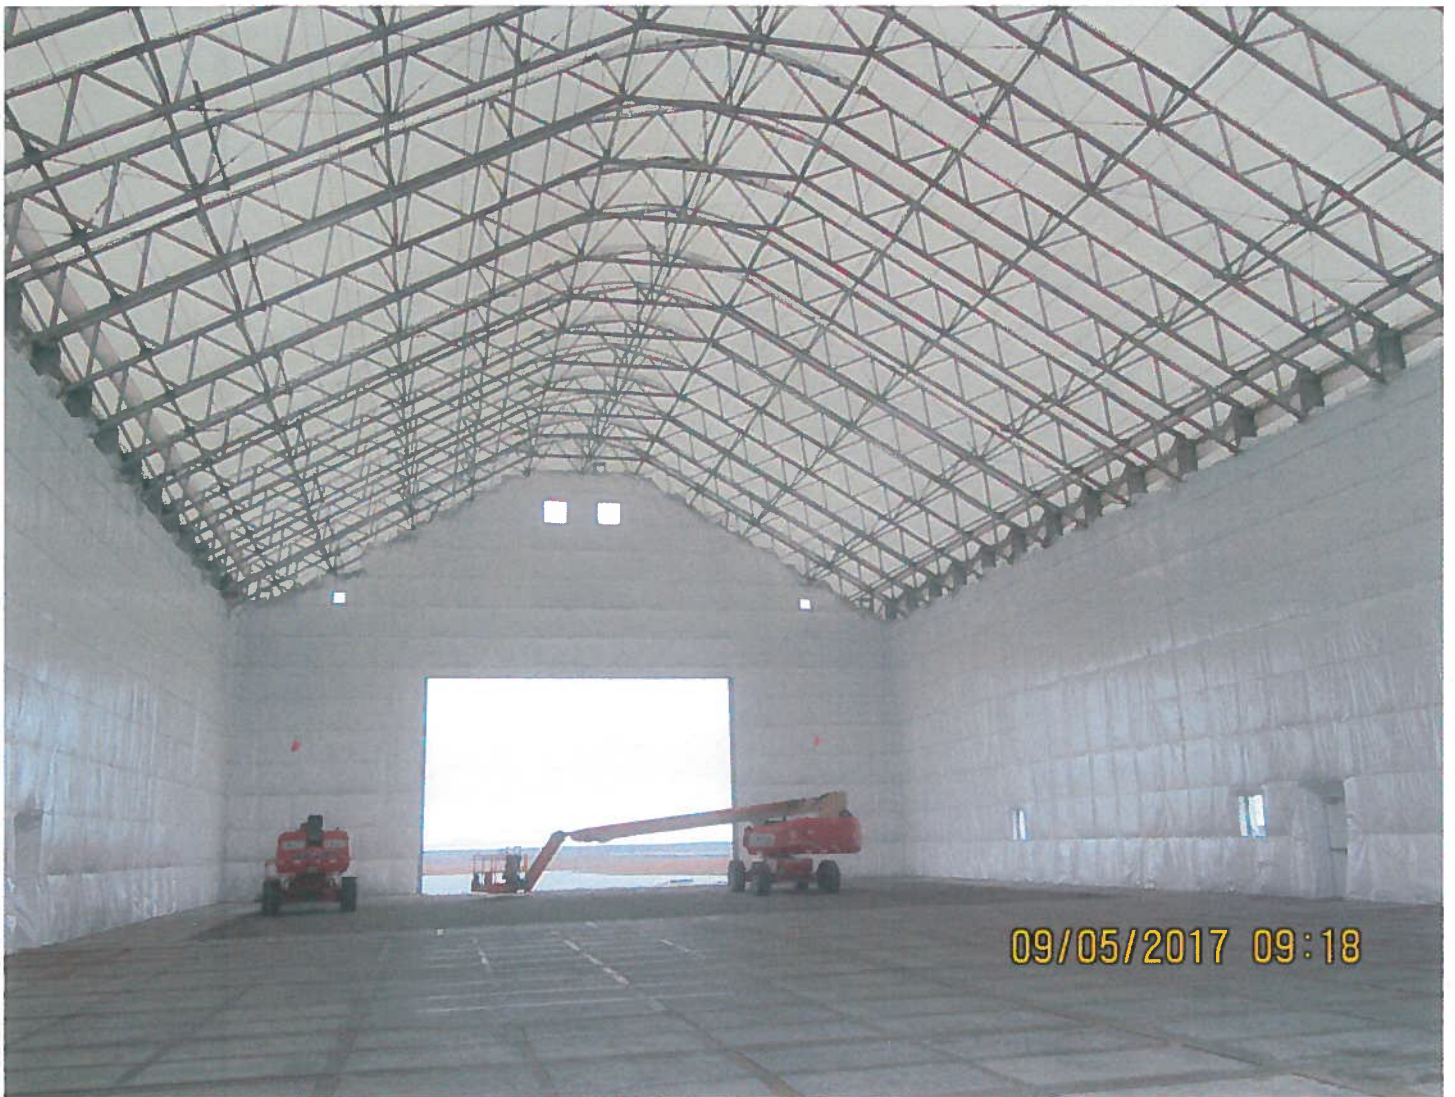
The Frame of the maintenance shelter has now been completed. All 4 walls and the roof of this building have now been covered (Photo 1). The footprint of this shelter is 30 x 70 meters.

Photo 1: Sable Office Complex - The Frame of the maintenance shelter has now been completed. All 4 walls and the roof of this building have now been covered

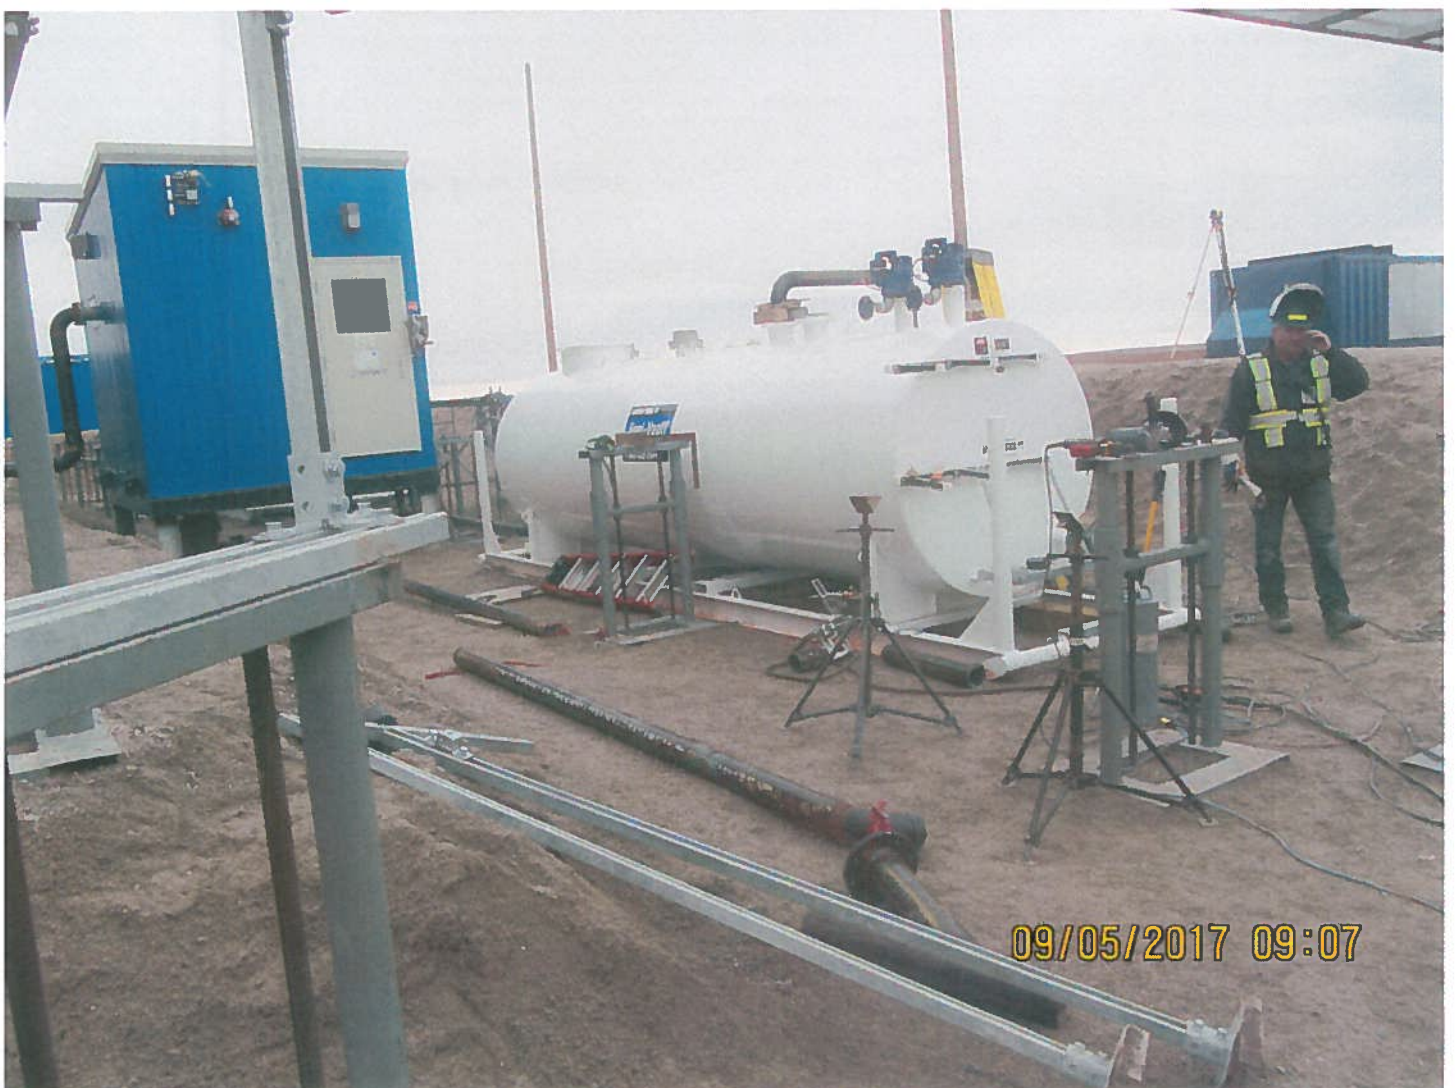
Work with fuel piping and electrical continues within the 4 - 500,000 Litre fuel tank berm (Photo 2). Components such as refueling nozzle cradles/containers (Photo 3) and berm pump out sumps (Photo 4) were being installed during this inspection. All wastes are being sorted in segregation bins (Photo 5) and garbage is being stored in a secure bin that is regularly disposed (Photo 6).

Photo 2: Sable Office Complex - Work with fuel piping and electrical continues within the 4 - 500,000 Litre fuel tank berm

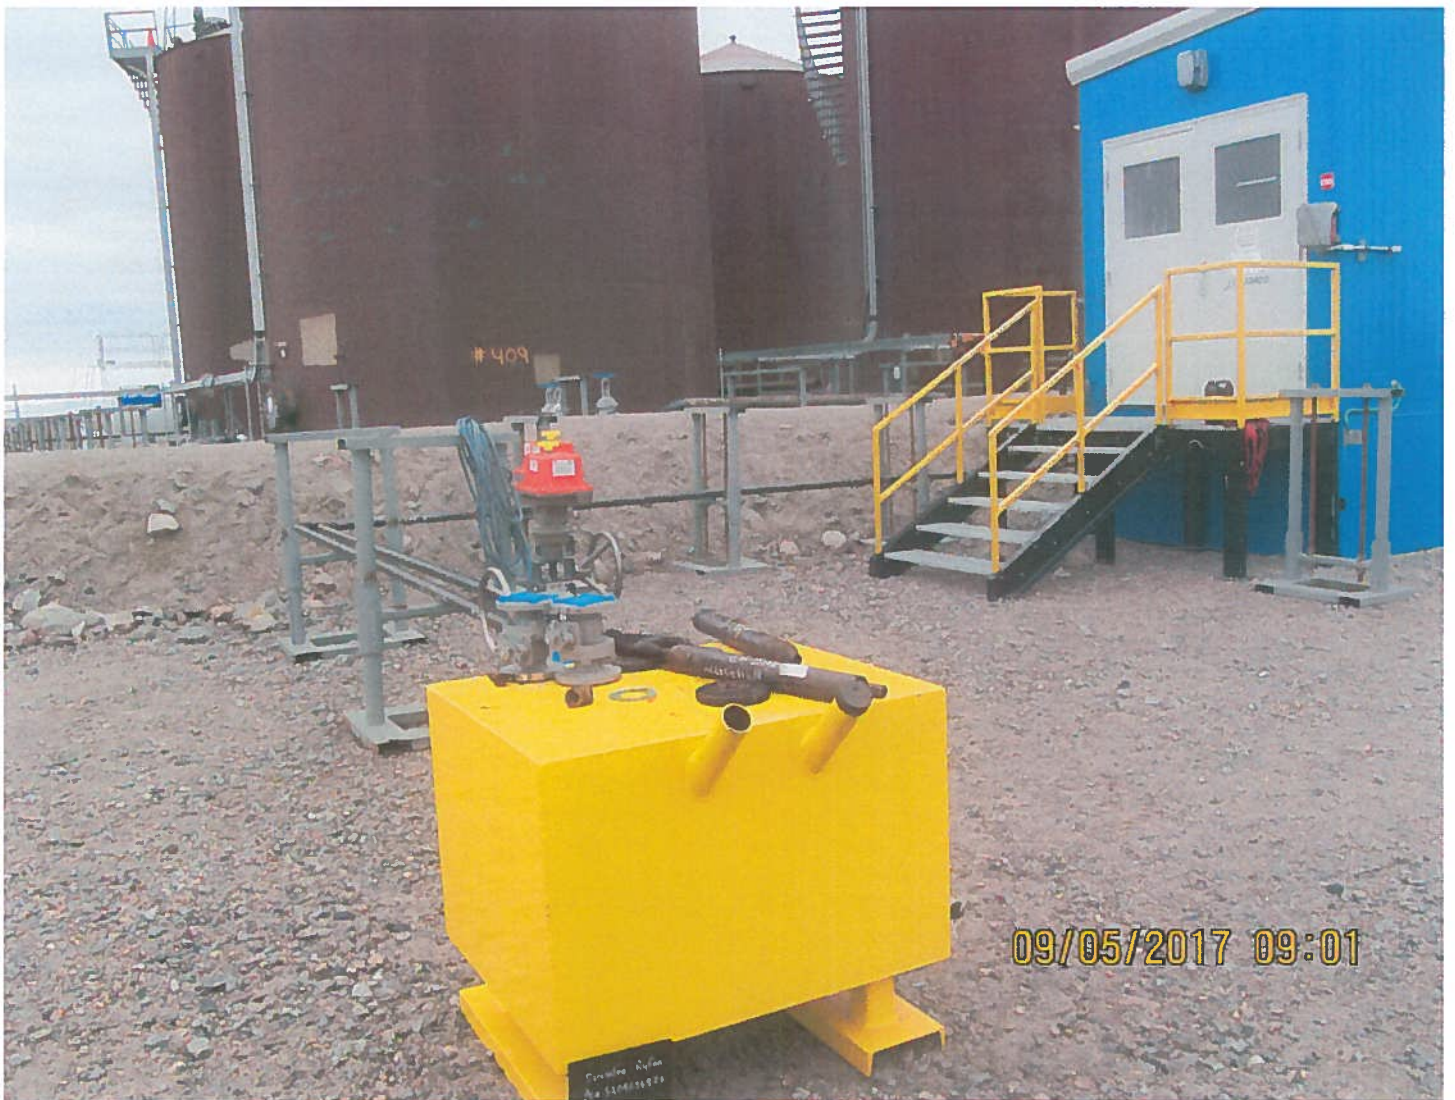
Photo 3: Sable Office Complex - A refueling nozzle cradle will be installed as part of the refuelling stations in the near future. The Inspector noted piping and fittings were in position for this unit.

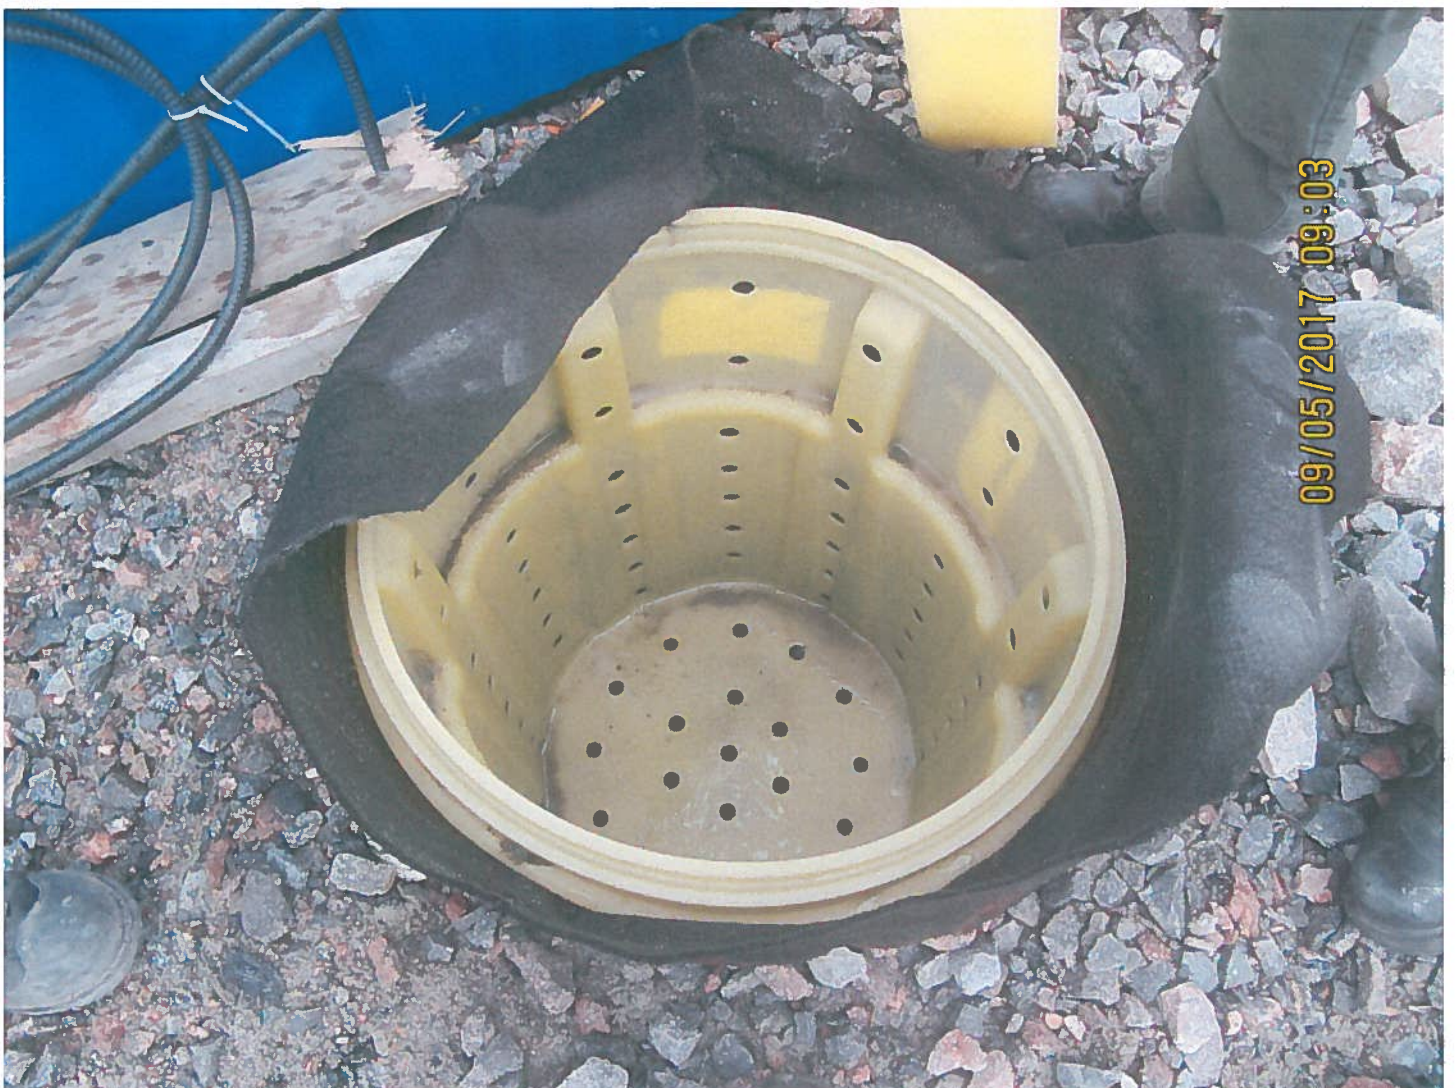
Photo 4: Sable Office Complex - A Berm pump out sump was installed to assist in the removal water from this facility.

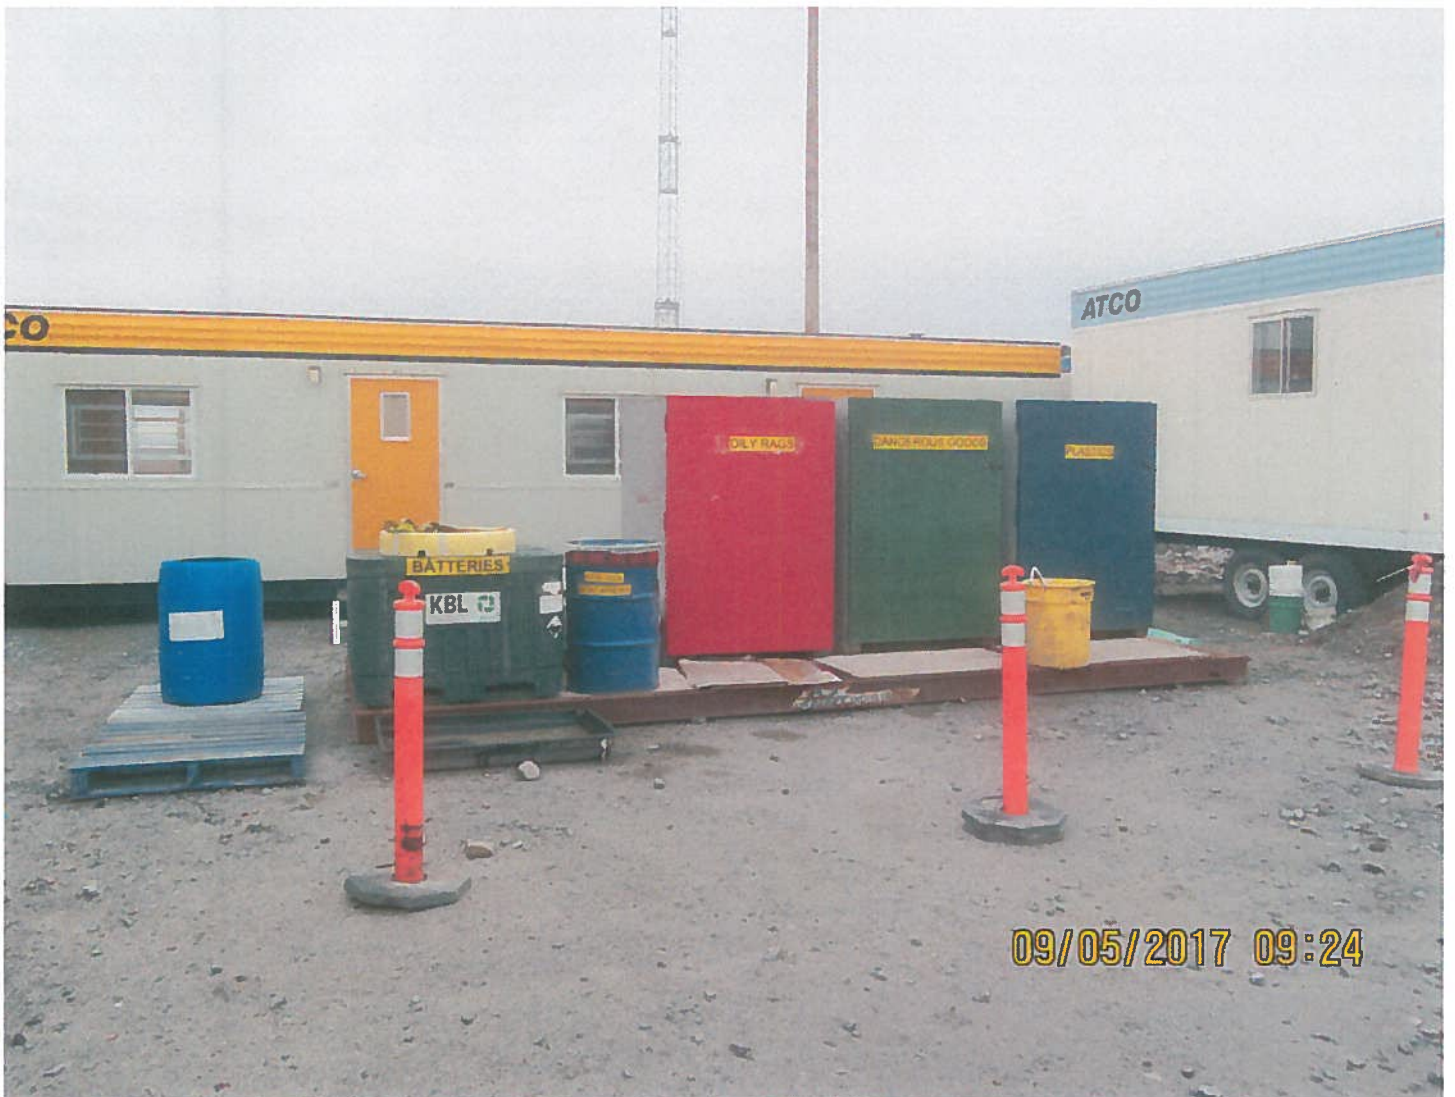
Photo 5: Sable Office Complex - An arrangement of sorting bins was noted in the front of the Sable Office Building. Wastes are removed from here and disposed of to approved facilities.

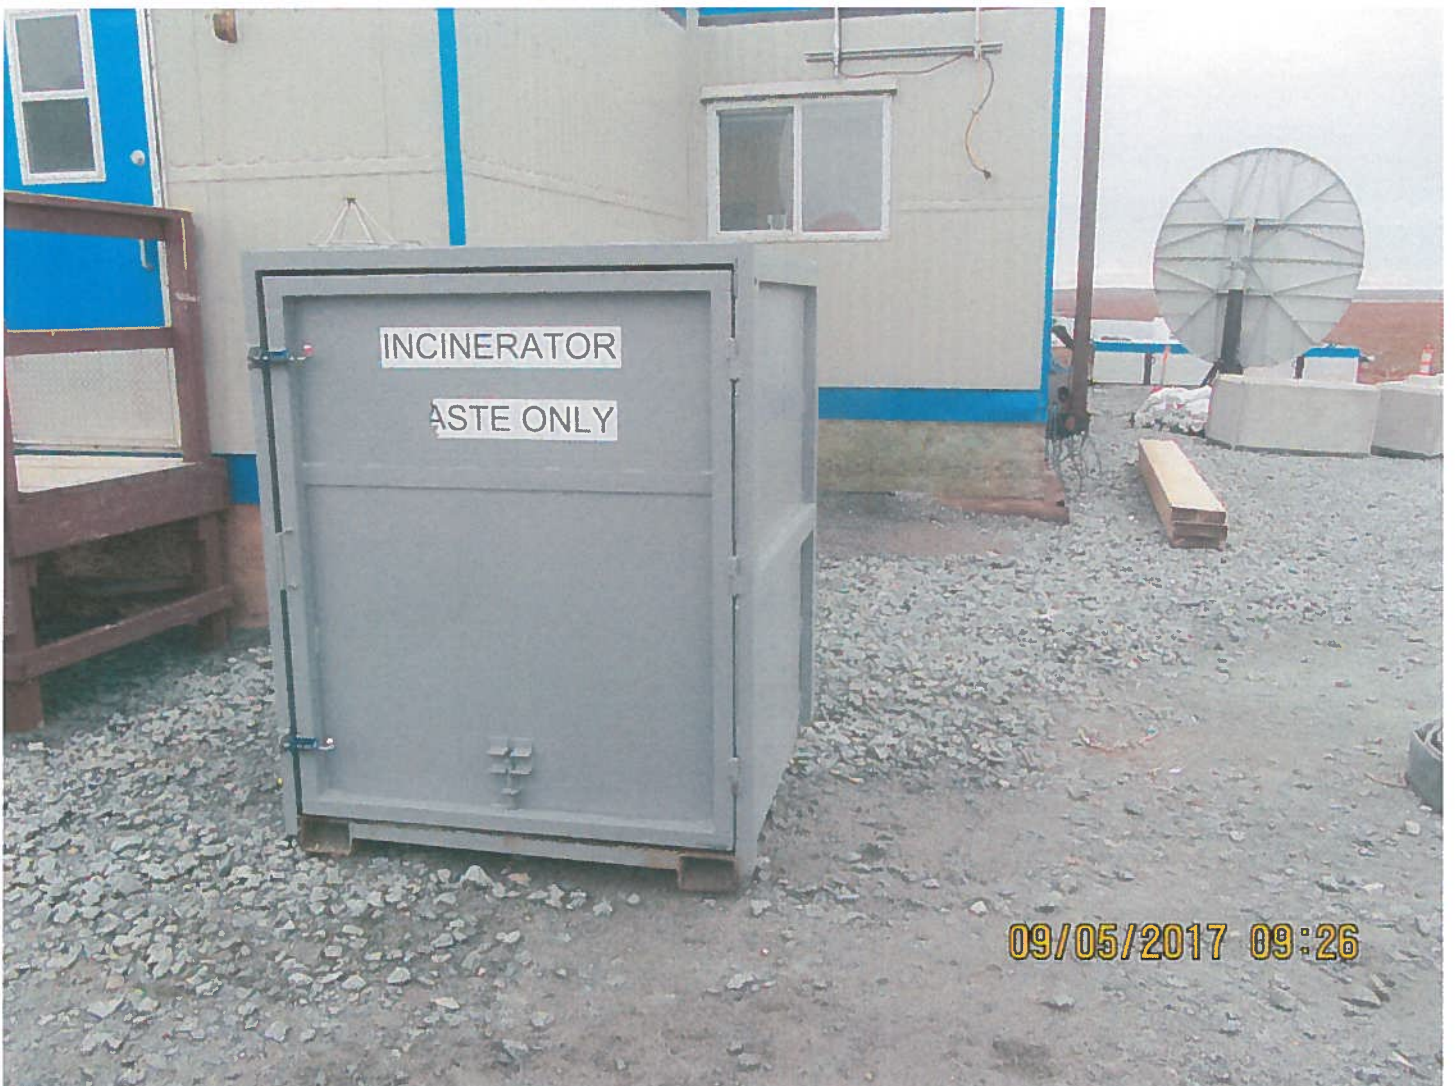
Photo 6: Sable Office Complex - All garbage that requires incineration is stored in a secure bin. Garbage is removed to the Incinerator building on a regular basis.

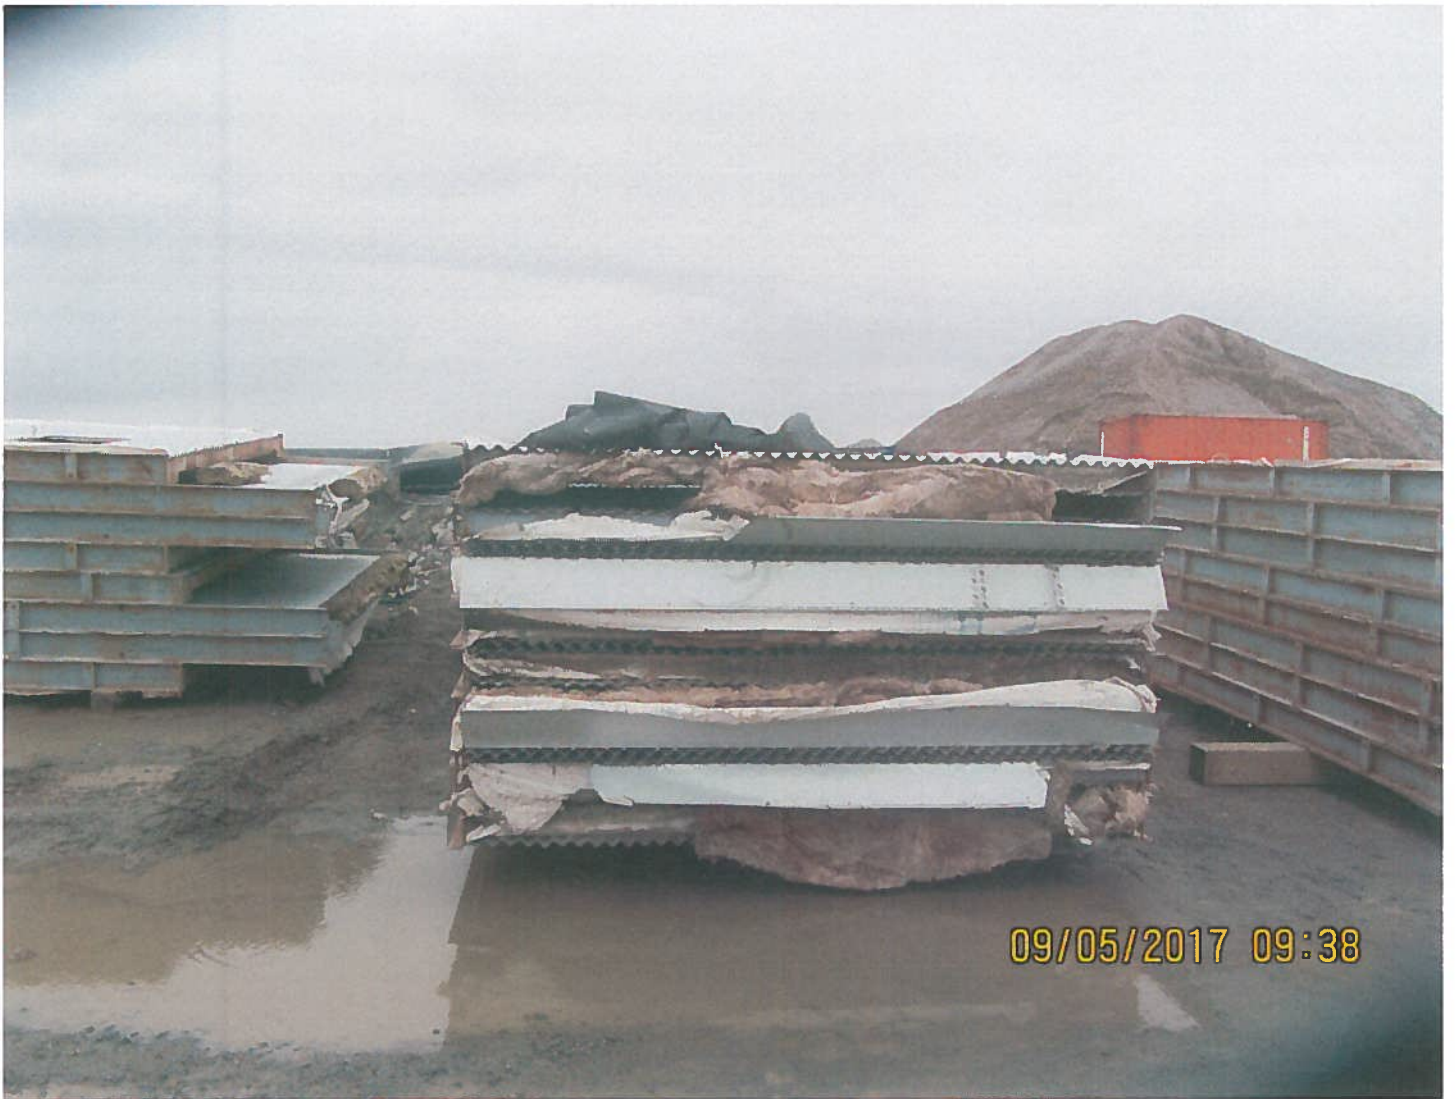
The Frozen Core building has now been taken down (Photo 7). The Inspector requested a thorough cleanup be conducted at the location of the laydown area of the Frozen Core Plant. DDEC completed the clean up shortly after this inspection. (Photo 8).

Photo 7: Sable Frozen Core Plant - The Sable Frozen Core Plant building was decommissioned and stacked for removal.

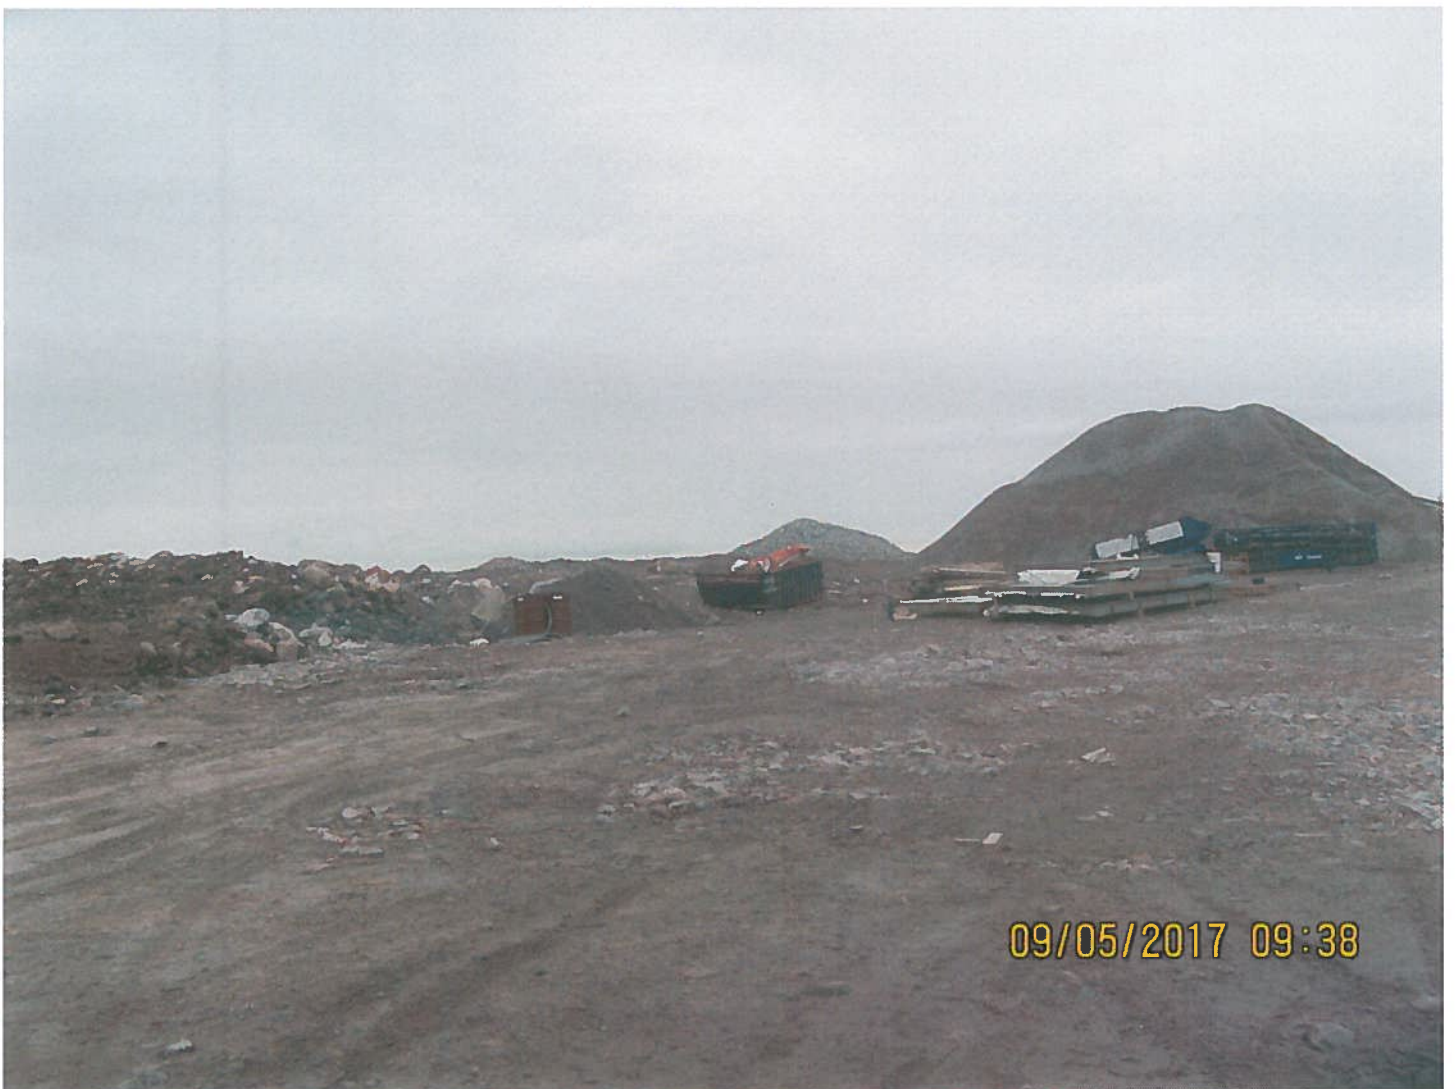
Photo 8: Sable Frozen Core Building Laydown Area - The Laydown for this facility was cleaned up shortly after this inspection.
