Subject: W2016D0003: Spill 2019353 Report

Pursuant to Part C Condition 18(c) of Land Use Permit W2016D0003, Dominion Diamond Mines ULC (Dominion) is providing a detailed report on Spill 2019353 which occurred on August 29, 2019 within Sable Pit.

Summary

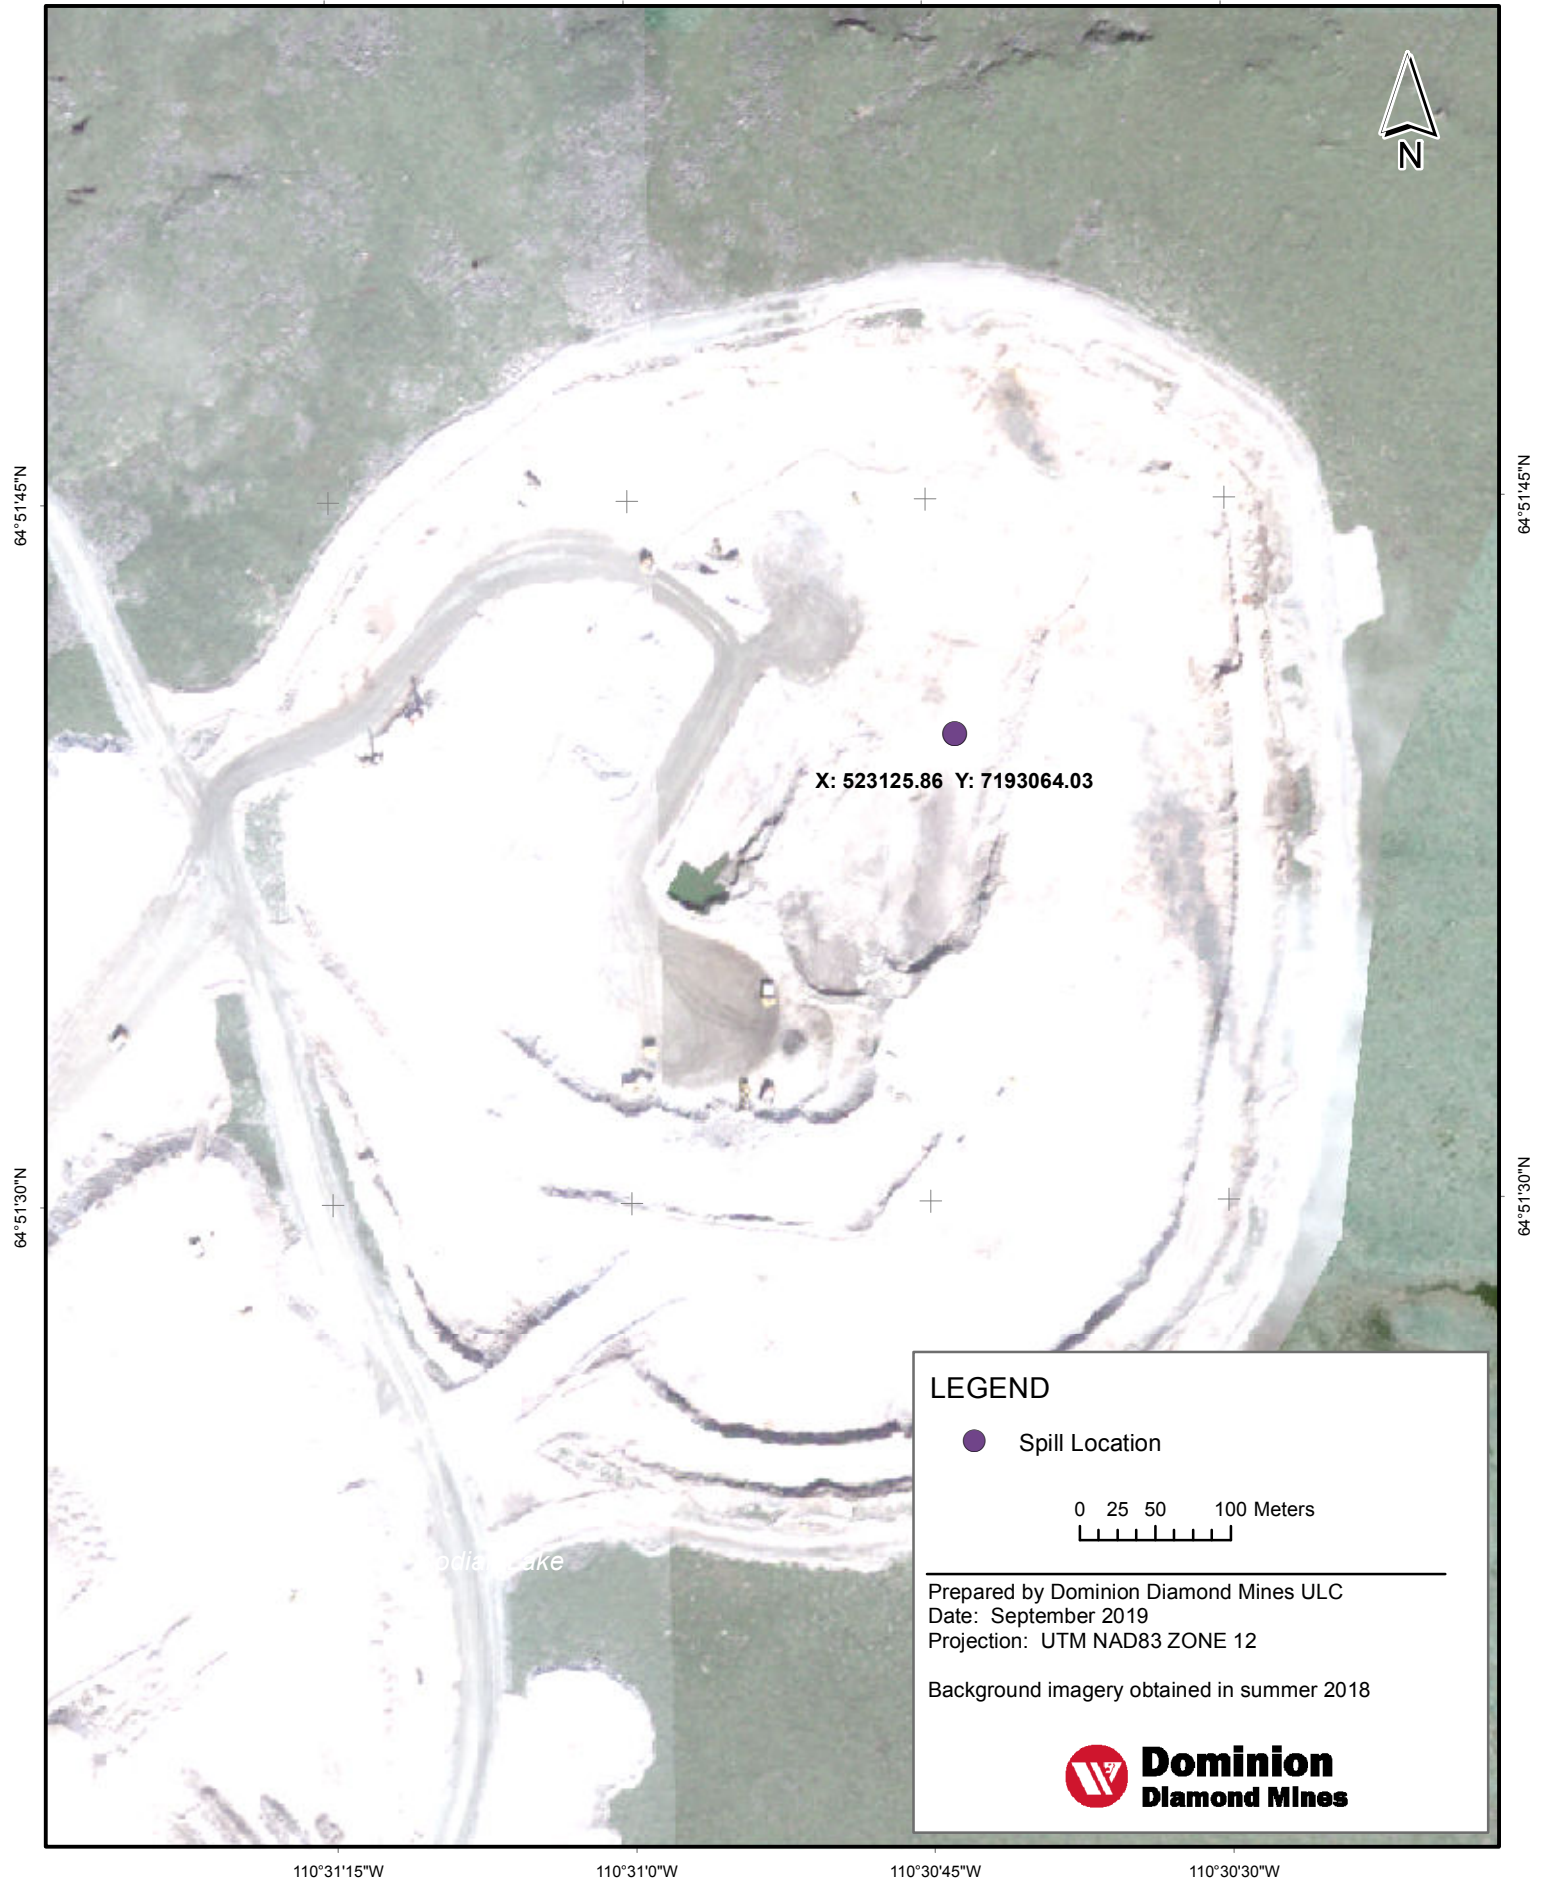
**Figure 1: Location of Spill 2019353
Sable Pit, Ekati Diamond Mine**

At 1:30 am on August 29, 2019 a 1,000 L hydraulic oil spill occurred within the Sable Pit in blast pattern SB434-06 (See Figure 1 for location). A CAT6060 Shovel (Unit 2569) swing hose rubbed through causing hydraulic oil to spray out under high pressure.

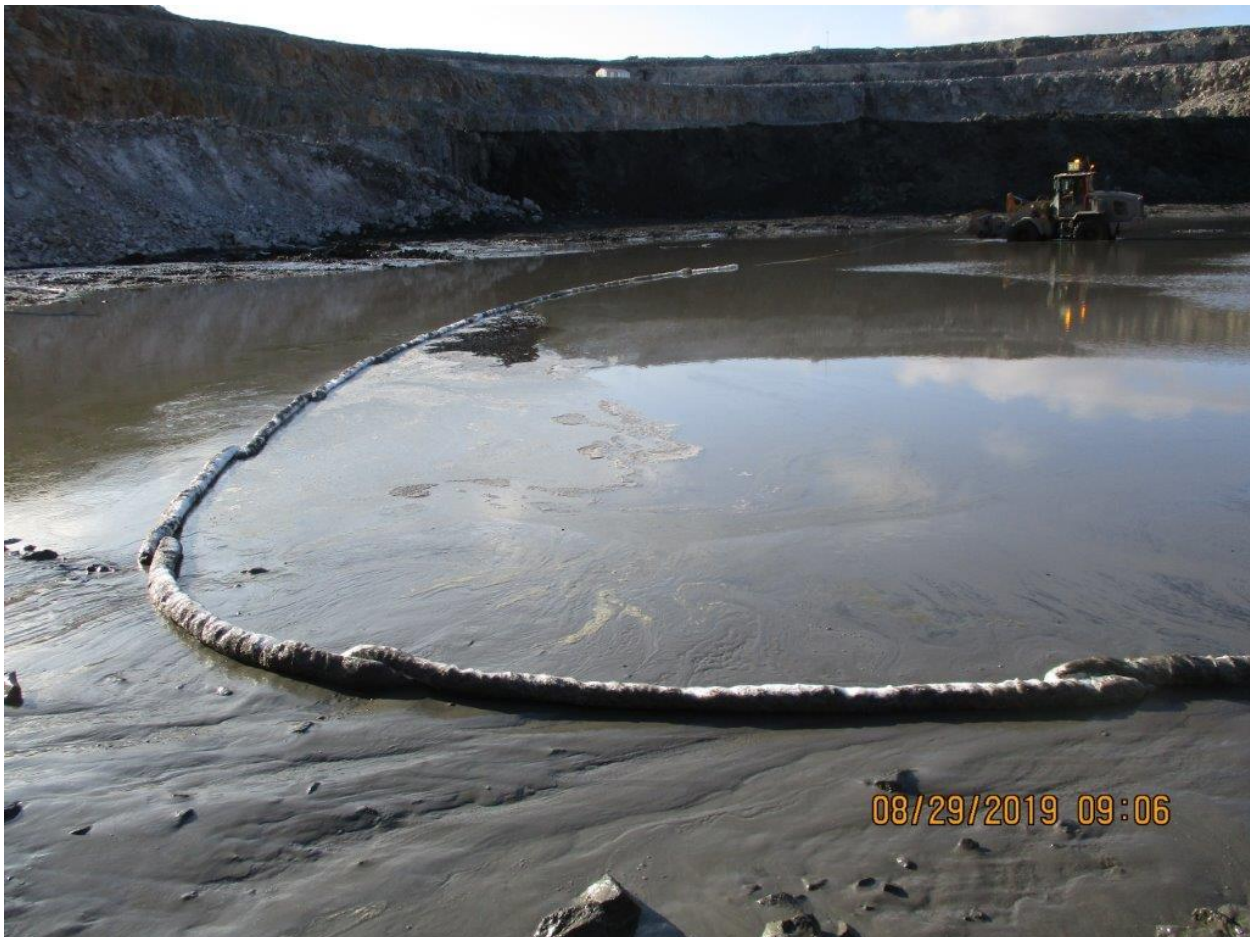
Figure 2. Spill booms used to coral hydraulic oil within Sable Pit

- The wet conditions and placement of the 6060 Shovel made it difficult to immediately address the spill. Once the 6060 Shovel was moved on the morning of August 29th, spill booms were attached to together and dragged across the bench to coral the hydraulic oil (see Figure 2). The vacuum truck was used to remove the contaminated liquids (see Figure 3). The vacuum truck transported the contaminated liquids back to Main Camp and emptied them into totes for off-site disposal. Some contaminated solids were recovered as well, and they were disposed of in Zone S.

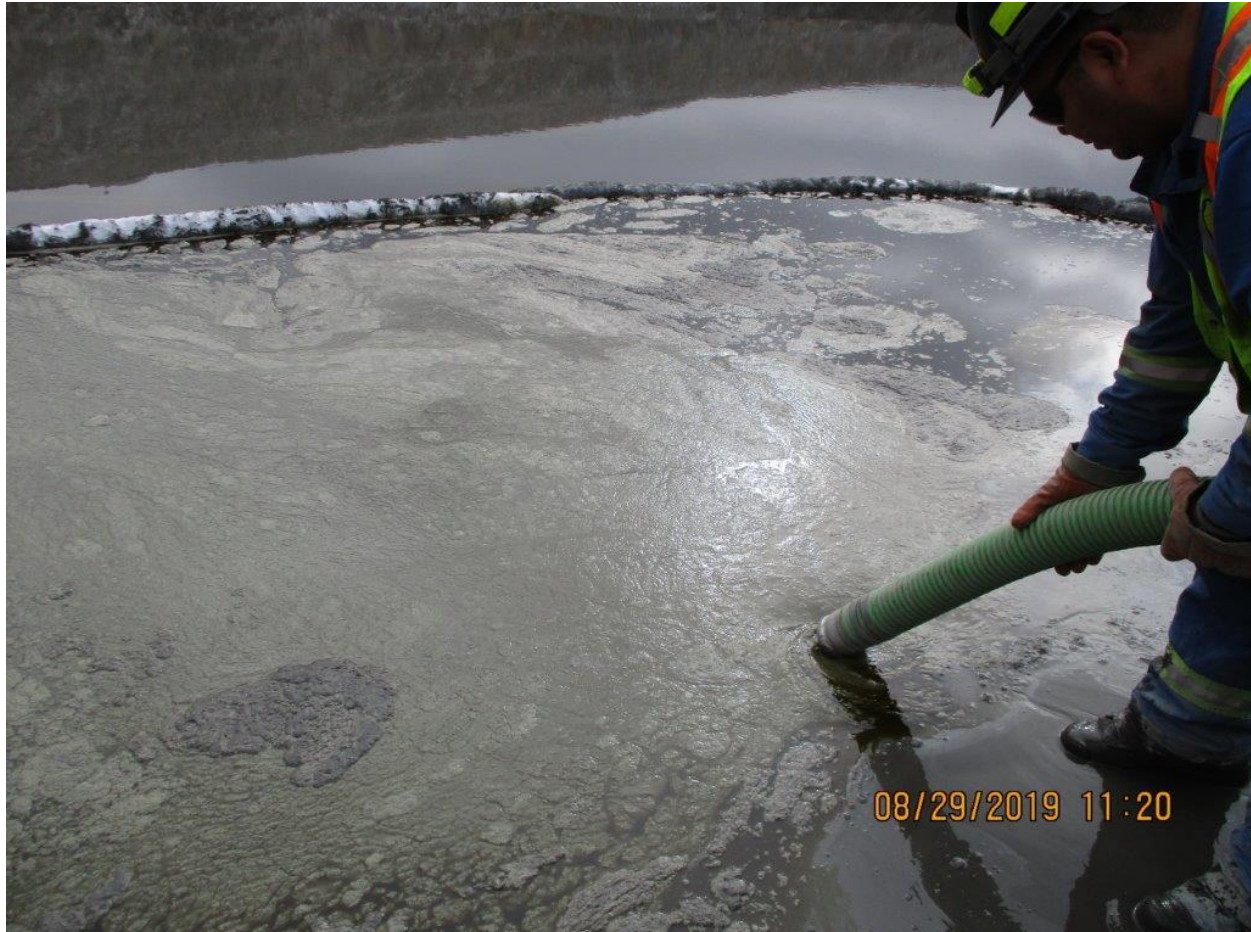
Figure 3. Vacuum truck used to recover hydraulic oil
