Subject: W2016D0003: Spill 2019394 Report

Pursuant to Part C Condition 18(c) of Land Use Permit W2016D0003, Dominion Diamond Mines ULC (Dominion) is providing a detailed report on Spill 2019394 which occurred on September 24, 2019 at the Sable fuel bay.

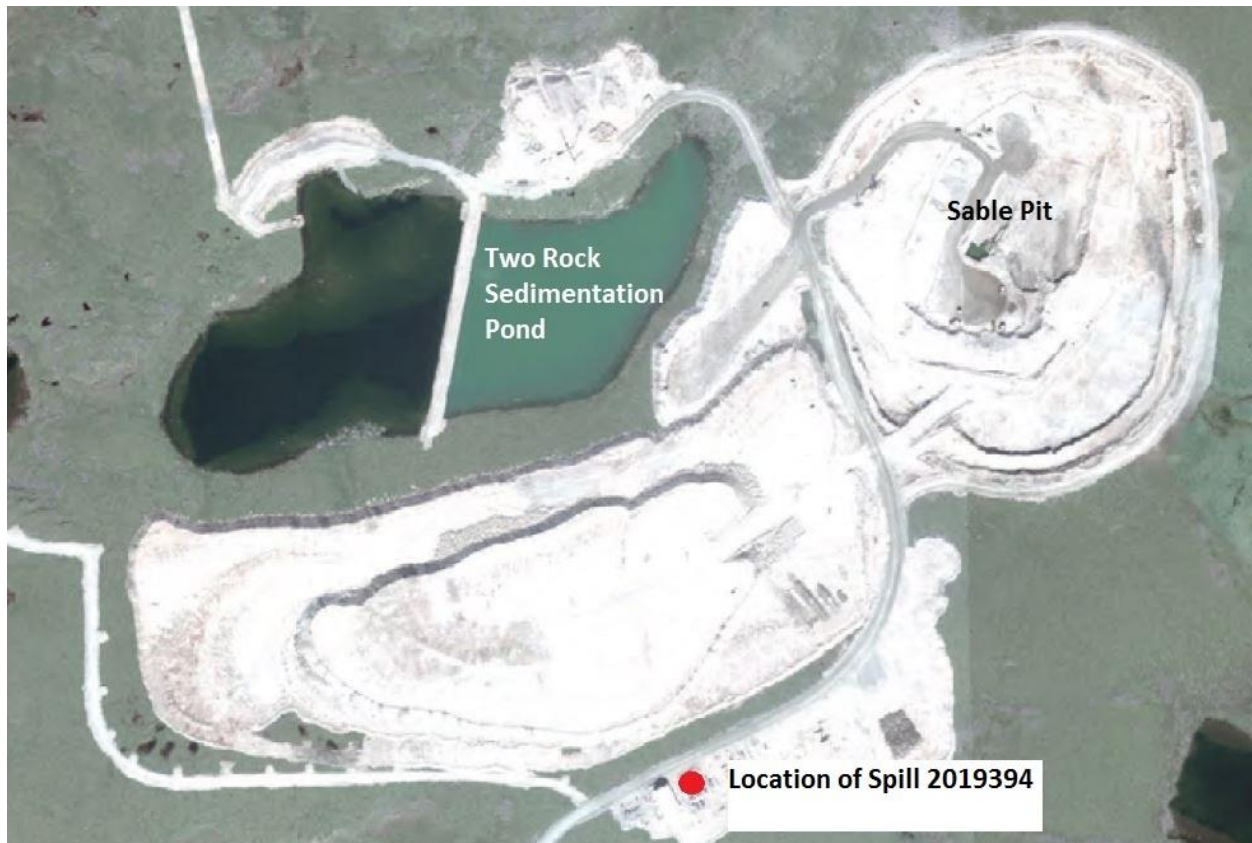
Figure 1. Location of Spill 2019394

At 13:30 on September 24, 2019 a Lube Truck (unit TKS6717) reported to the Sable fuel bay for refueling. The operator overfilled the fuel tank onto the lined gravel pad beneath. Approximately 500 L of diesel was spilled before the operator could stop the flow of fuel.
