Subject: W2016D0003: Spill 2019416 Report

Pursuant to Part C Condition 18(c) of Land Use Permit W2016D0003, Dominion Diamond Mines ULC (Dominion) is providing a detailed report on Spill 2019416 which occurred on October 7, 2019 within Sable Pit.

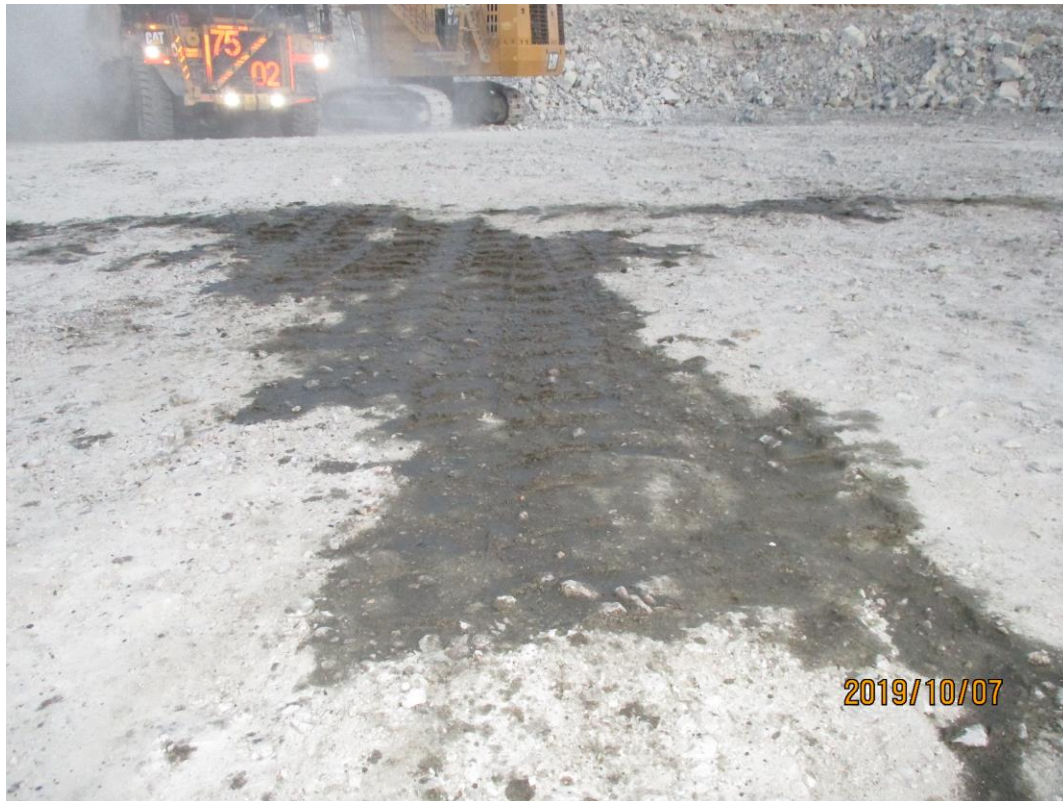
Figure 1. Spill 2019416

At 9:45 pm on October 7, 2019 a hydraulic line on CAT6060 Shovel (Unit 2569) ruptured causing a 1,500 L hydraulic oil spill on the 480 level bench of Sable Pit. The coordinates of the spill were:

Wear and tear of the hydraulic hose caused the line to rupture.

The operator shut down the equipment and contacted their Team Leader. The unit could not operate, and the Surface Mining team arranged for the unit to be moved out of the pit for repair and to gain access to the spilled material.

- Once Unit 2569 was moved out of the way, clean-up commenced on October 8, 2019 and was completed that same day. The contaminated gravel was scraped up using a dozer and transported back to main camp in a 777 Haul Truck. The contaminated material was placed in Zone S for final disposal.
