Subject: W2016D0003: Spill 2019456 Report

Pursuant to Part C Condition 18(c) of Land Use Permit W2016D0003, Dominion Diamond Mines ULC (Dominion) is providing a detailed report on Spill 2019456 which occurred on November 6, 2019 within the Sable Maintenance Shelter.

Summary

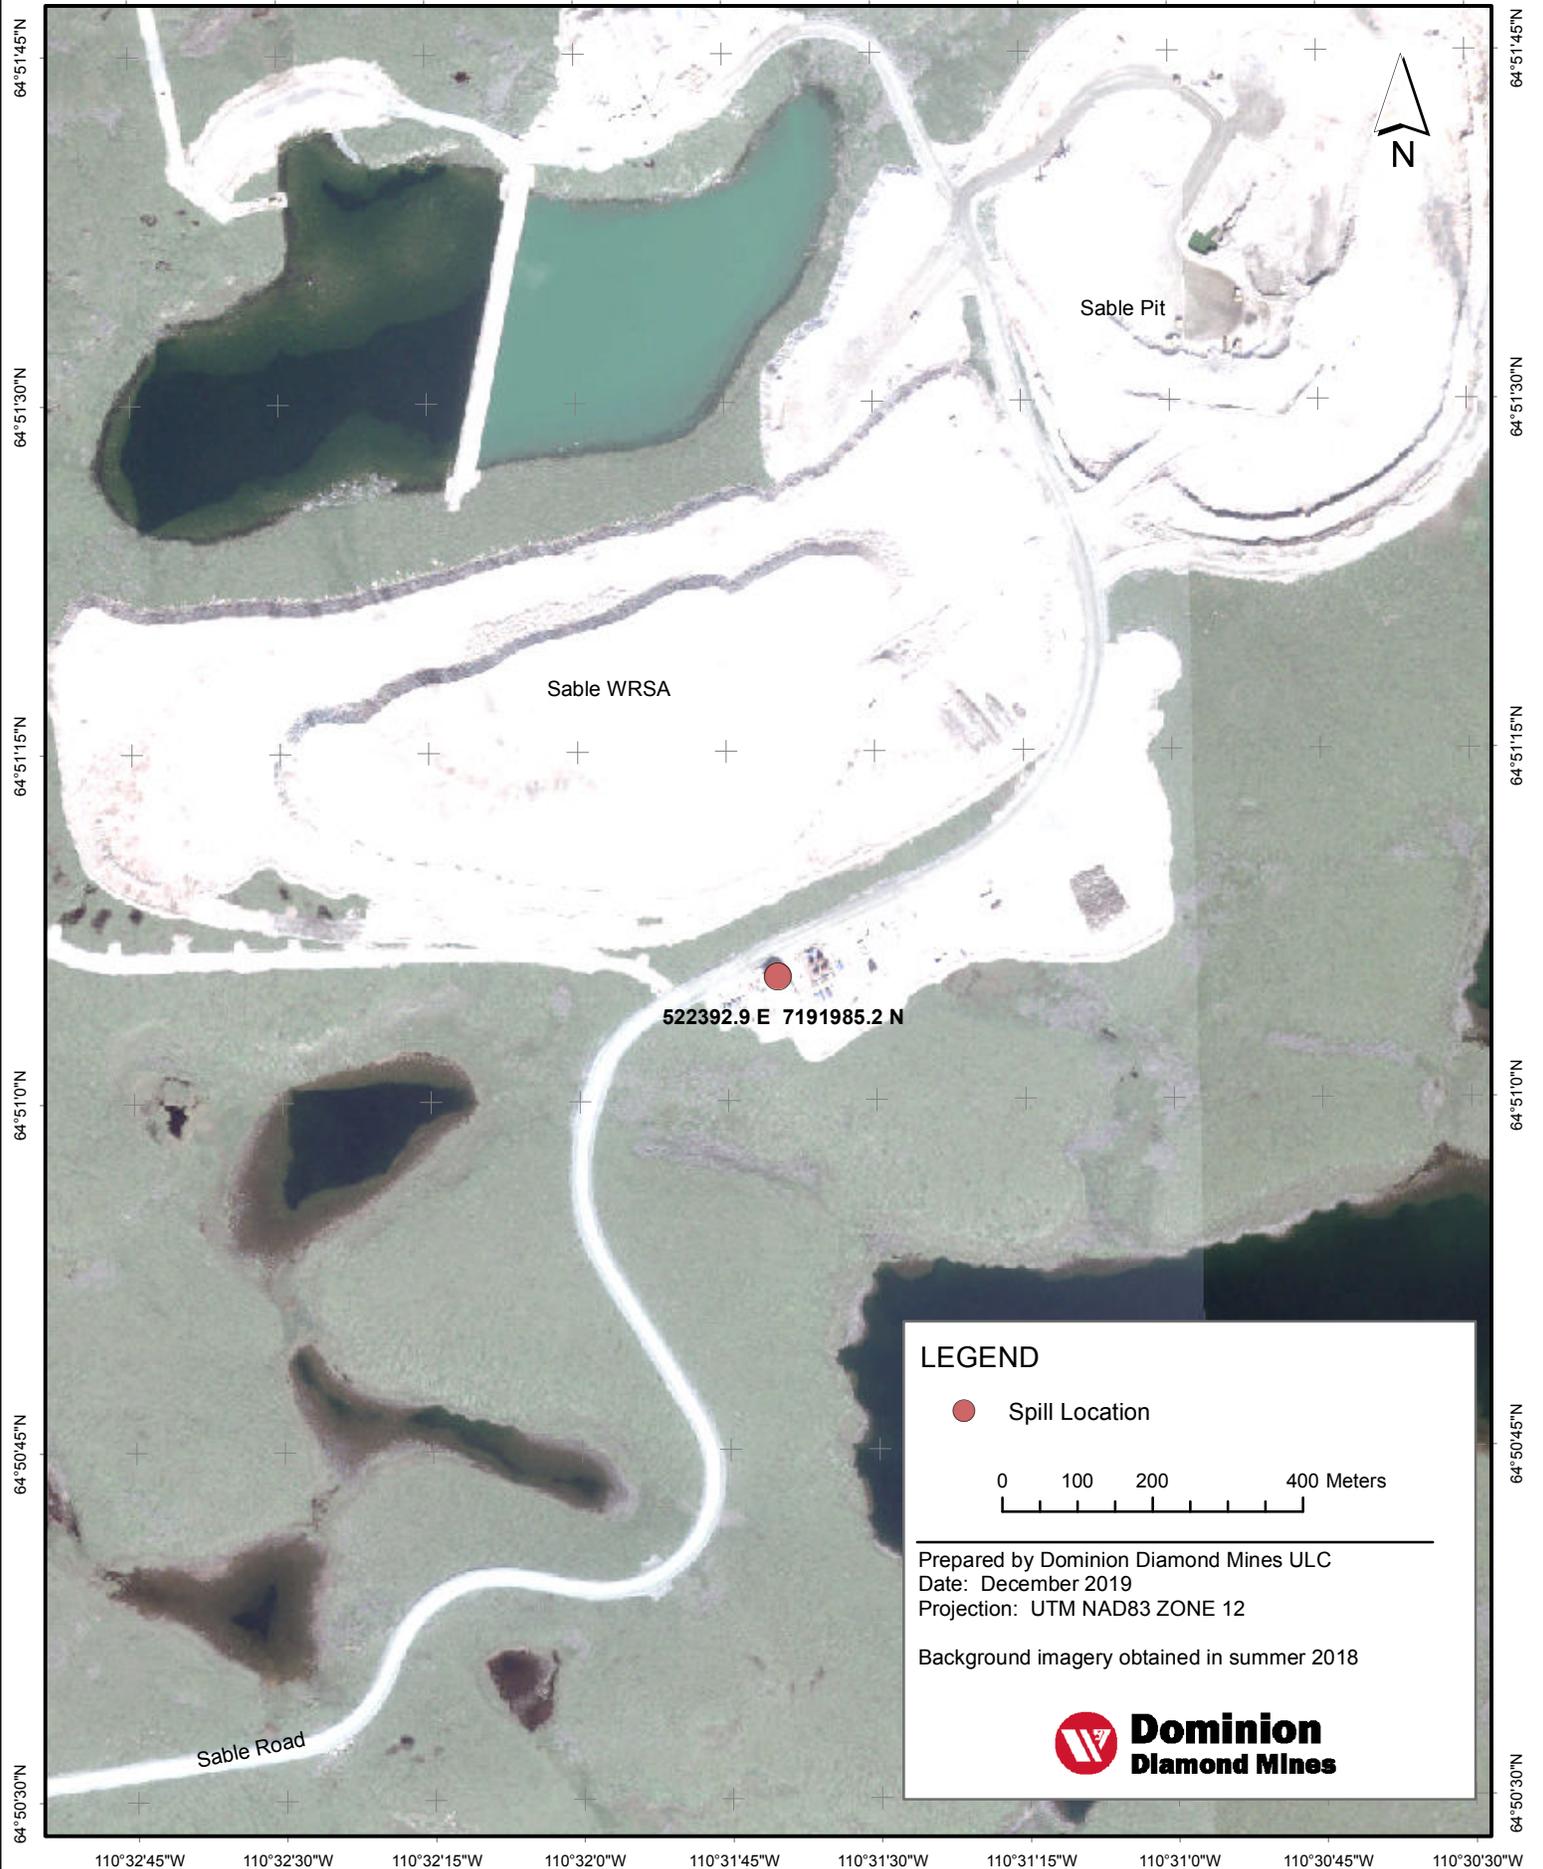
Figure 1: Location of Spill 2019456
Sable Maintenance Shelter, Ekati Diamond Mine

Between 16:30 and 19:00 on November 6, 2019 the O-ring failed on a filter of a pressurized "Lube Island" in the Sable Maintenance Shelter. The failure caused approximately 450 L of 5W-40 engine oil from the steel tank to be pumped out through the damaged oil filter onto the ground in the shop. The shop floor is constructed of rig-matting (aka. access matting). See Figure 1 for the location of the spill.

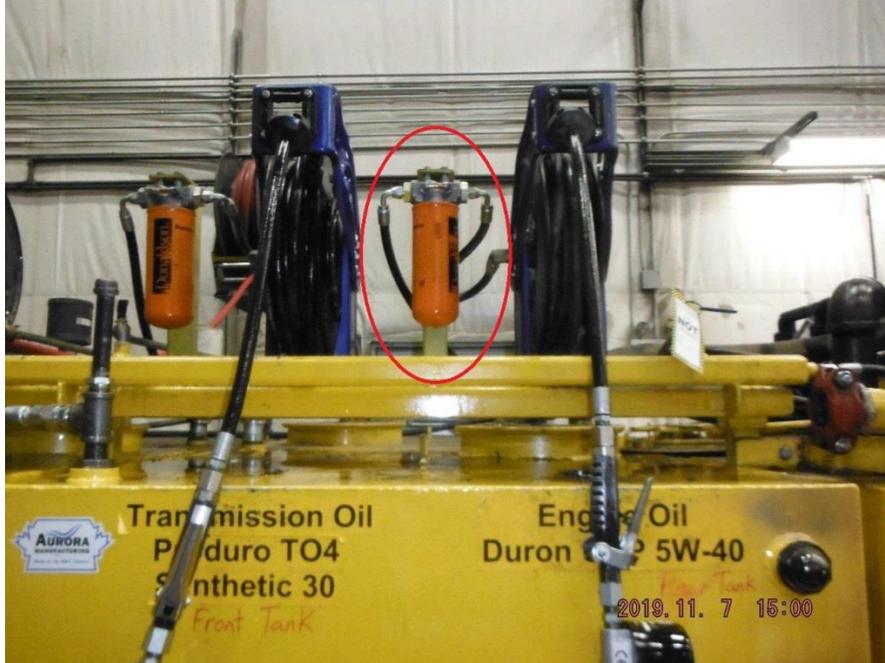
Figure 2. Failed oil filter on Lube Island

- The exposed seal on this model of oil filter makes failures of this nature possible (See Figure 2)
- The Lube Island was left pressurized while the shop was unattended between shifts, so the spill was not discovered until personnel arrived at the shop for night-shift
- The shop floor is not made of solid concrete, thus creating the potential for small, isolated leaks between the mats onto the ground (see Figure 3)

- Dominion has ordered new low-flow canister filters for the Lube Island. Unlike the filter which failed on November 6th, the canister filters have no exposed seals and will eliminate the risk of spill reoccurrence. These filters will be installed immediately upon delivery to Ekati mine.

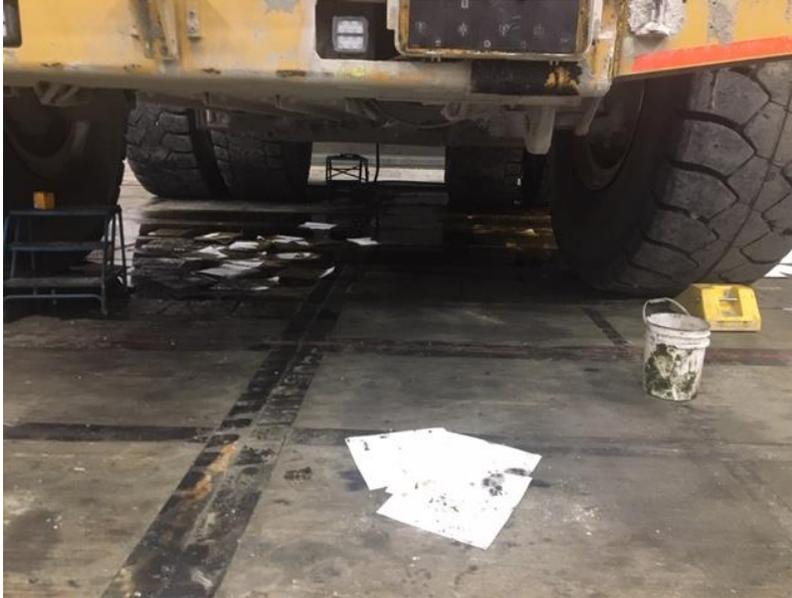
Figure 4. Spill 2019456 during clean up

- The majority of the spill was captured with absorbent pads immediately after the spill was discovered. Some of the spill was absorbed by the rig-matting which makes up the floor surface in the area of the spill. This flooring is made up of hardwood tightly cased between steel I-beams which are interlocked. The mats are utilized in the Sable Maintenance Shelter to support the weight of heavy equipment and to provide a protective surface to absorb spills which may occur during service. After a thorough inspection on November 26th it seems possible that oil could have leaked between the small junctions in the mats. The steel I-beams and hardwood lay flat on the packed, level ground surface beneath, therefore any oil that leaked through would be isolated between the small cracks in the flooring. The rig-matting cannot be lifted because several mats are welded together and extend beyond the perimeter of the shop to provide a stable, safe working surface for the heavy equipment in the shop (See Figure 6 for design).
