Subject: W2016D0003: Spill 2022039 Report

Pursuant to Part C Condition 18(c) of Land Use Permit W2016D0003, Arctic Canadian Diamond Company Ltd. (Arctic) is providing a detailed report on Spill 2022039 which occurred on February 15, 2022, at Sable Development.

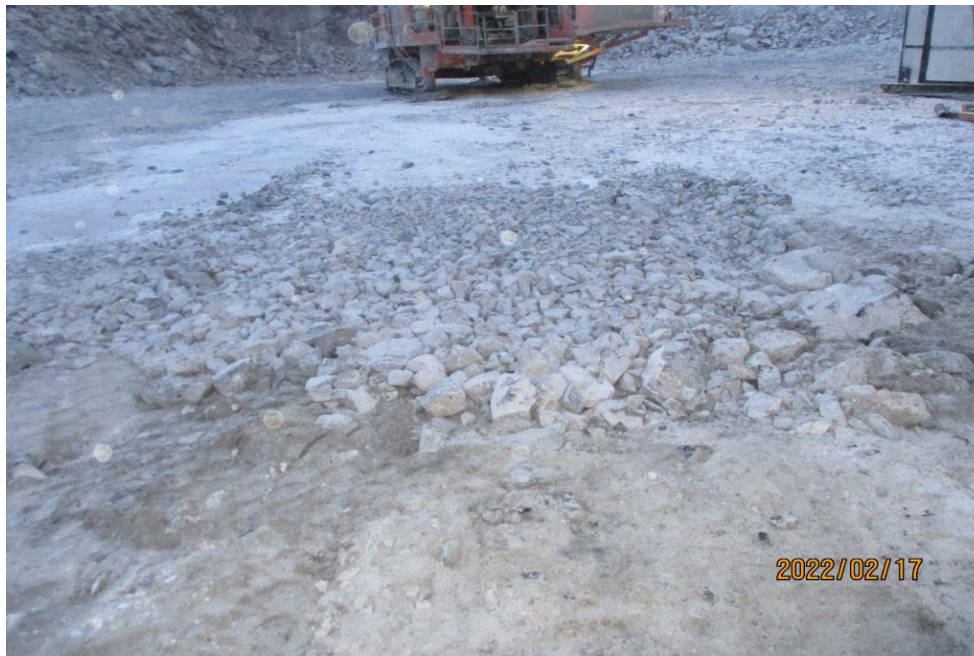
Photo 1. Photo of cleaned up diesel fuel where Shovel 2570 was located during the spill. Note, no visible hydrocarbon staining.

On February 17, 2022, leadership directed heavy equipment to clean up impacted material (underneath and adjacent to where Shovel 2570 was located during the spill). Diesel fuel impacted snow and rock were scraped up; 25 cubic meters of contaminated material was hauled to Panda/Koala Zone S (i.e., suitable disposal area for hydrocarbon impacted material).
