Subject: W2016D0003: Spill 2022061 Report

Pursuant to Part C Condition 18(c) of Land Use Permit W2016D0003, Arctic Canadian Diamond Company Ltd. (Arctic) is providing a detailed report on Spill 2022061 which occurred March 01, 2022, at the Sable Development.

Summary

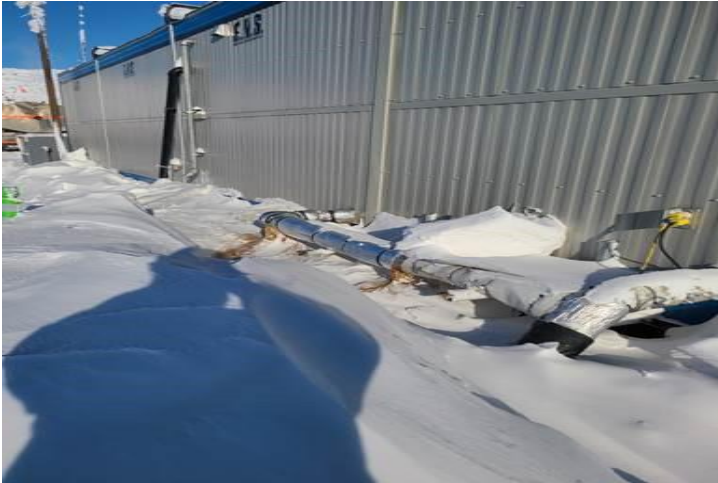
The electric heat trace was not working; the breaker also tripped inside the office panel, which resulted in the pipe freezing and cracking (see photo 1.). When the pipe cracked it resulted in sewage spilling onto disturbed ground.

Photo 1: View of cracked pipe which resulted in the initial spill. Photo taken facing north on March 01, 2022.

A crew was deployed to build hoarding and set up a hot box. While the pipe was being repaired a bucket was placed under the pipe to catch sewage (see photo 2.). A vacuum truck was used to clean up sewage. The cracked pipe was repaired on March 01, 2022 at 4:30 PM.

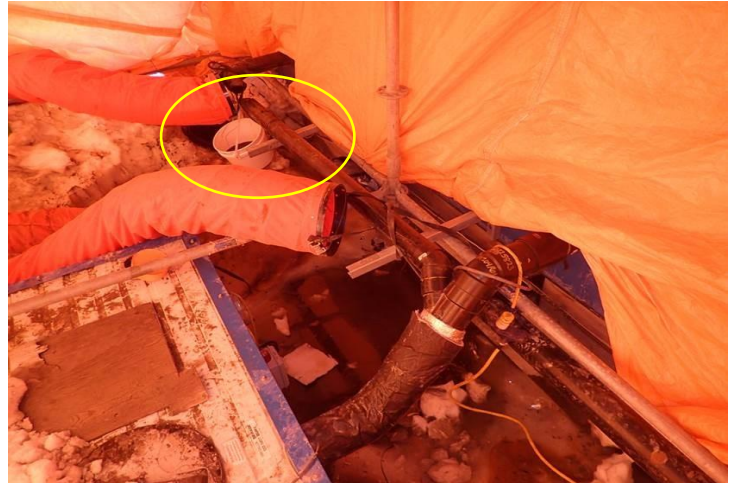
Photo 2: View of bucket placed under the pipe (to capture sewage) while it was repaired. Photo taken on March 01, 2022.

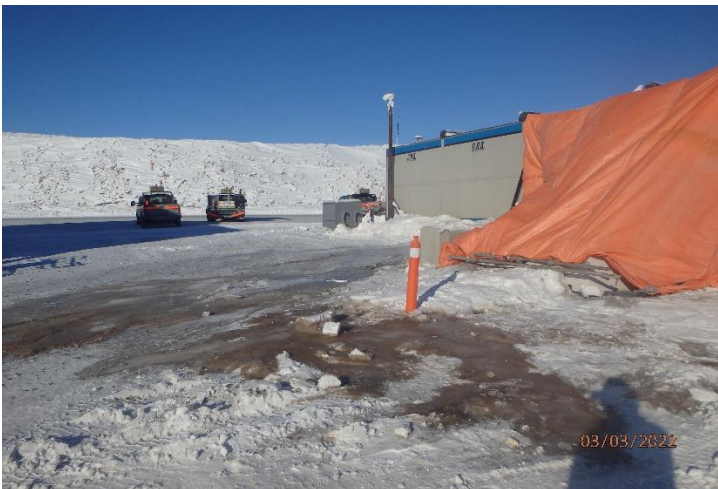
After the initial clean up and pipe repair another crack in the pipe occurred on March 02, 2022. This resulted in a secondary spill in the exact same location (see photo 3.). On March 04, 2022, heavy equipment scraped the impacted snow and ice from the secondary spill; it was piled in preparation for loading and hauling (see photo 4.). On March 13, 2022, impacted snow and ice were loaded into a 730 articulated haul truck and dumped in Zone S – Panda/Koala (i.e., suitable disposal site).

Photo 3: View of frozen sewage from the secondary spill. Photo facing north.

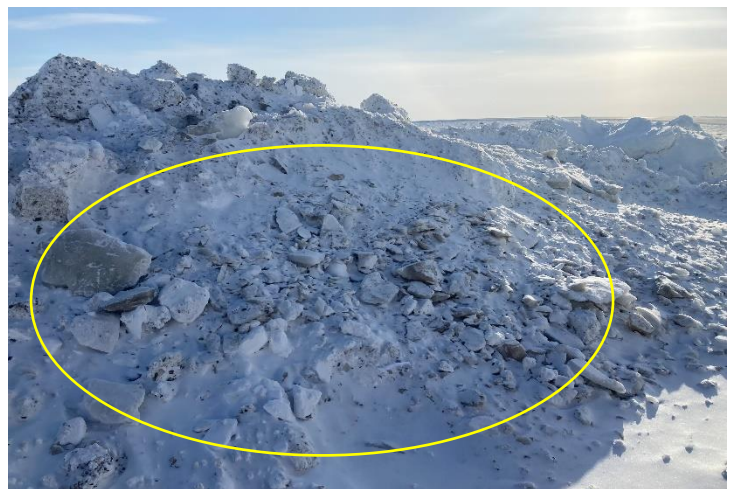
Photo 4: View of impacted snow and ice (frozen sewage) pile in preparation for loading and hauling to Zone S – Panda/Koala. Photo taken on March 12, 2022.
