Subject: W2016D0003: Spill 2022135 Report

Pursuant to Part C Condition 18(c) of Land Use Permit W2016D0003, Arctic Canadian Diamond Company Ltd. (Arctic) is providing a detailed report on Spill 2022135 which occurred on April 17, 2022, at Sable Development (Sable Pit Truck Park Area).

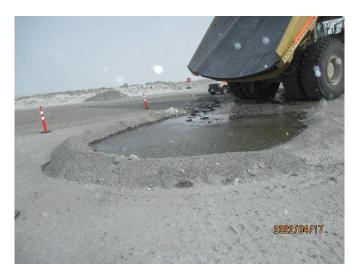
At 1:30 PM, on April 17, 2022, 7499 heavy haul truck spilled 1500 L of diesel fuel onto disturbed ground in Sable Development. The location of the spill was the Sable Pit Truck Park Area (i.e., area where heavy haul trucks park).

A rock contacted the heavy haul truck's fuel tank which resulted in a hole.

Photo 1: Sable Truck Park Area – View of small berm containing fuel. Note that the spill occurred on compacted/flat ground.

Workers immediately built a berm (Photo 1.) around the fuel spill and deployed a sucker pump to suck up the diesel fuel (Photo 2.).

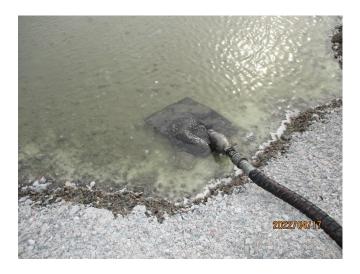
Photo 2: Sable Truck Park Area – View of sucker pump removing fuel from berm area shown in photo 1.

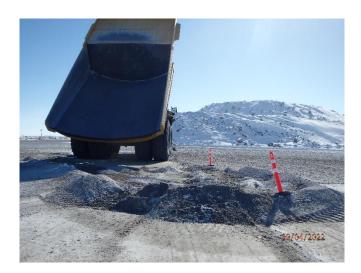
Photo 3: Sable Truck Park Area – View of crush placed down after the fuel was sucked up. The crush absorbed hydrocarbons.

Once the fuel was sucked up workers deployed fine crush to absorb remaining hydrocarbons (Photo 3). After the truck was removed from the spill area heavy equipment thoroughly scraped up impacted material and hauled it to a suitable disposal area (Panda/Koala Zone S).

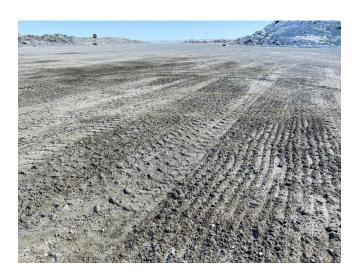
Photo 4: Sable Truck Park Area – View of spill area after clean-up.
