Subject: W2016F0006: Spill 2021104 Report

Pursuant to Part C Condition 17(c) of Land Use Permit W2016F0006, Arctic Canadian Diamond Company Ltd. (Arctic) is providing a detailed report on Spill 2021104 which occurred March 19, 2021 on the Sable Haul Road.

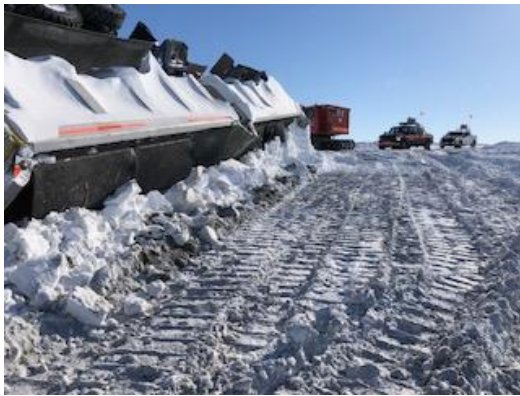
Duel-Powered Road Train (DPRT) trailers filled with kimberlite came loose from the truck cab and spilled onto the tundra off the Sable Haul Road. The two trailers were laying on their side with potential for a small amount of hydrocarbon spillage.

Figure 1. Spill 2021104 clean up in progress

Once the storm passed through the area, a recovery effort commenced to erect the road train trailers, recover the spilled kimberlite, and recover any visible hydrocarbon spills. Recovery of the overturned trailers with heavy equipment and cranes commenced on March 26 and was completed on March 27. Kimberlite was removed from the tundra and taken to the primary stockpile for eventual processing. Potentially contaminated snow was taken to the Contaminated Snow Containment Facility. The area was visited by the Lands Inspector on April 13, 2021 during a site inspection. The spill will remain open with the GNWT Spill Line until the area can be assessed under snow-free conditions.

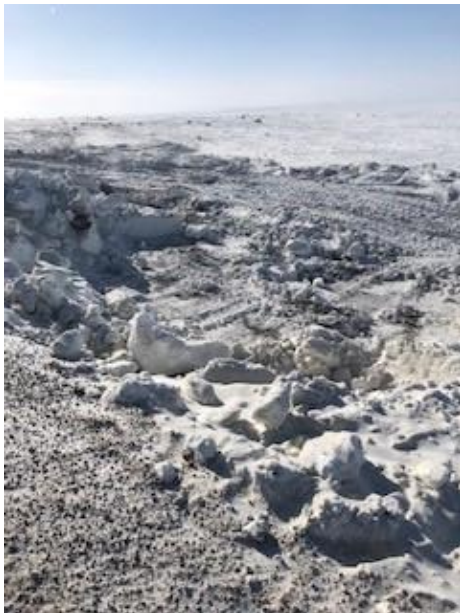
Figure 2. Spill 2021104 after clean-up
