**Attention: Kofi Boa-Antwi**

Dear Mr. Boa-Antwi,

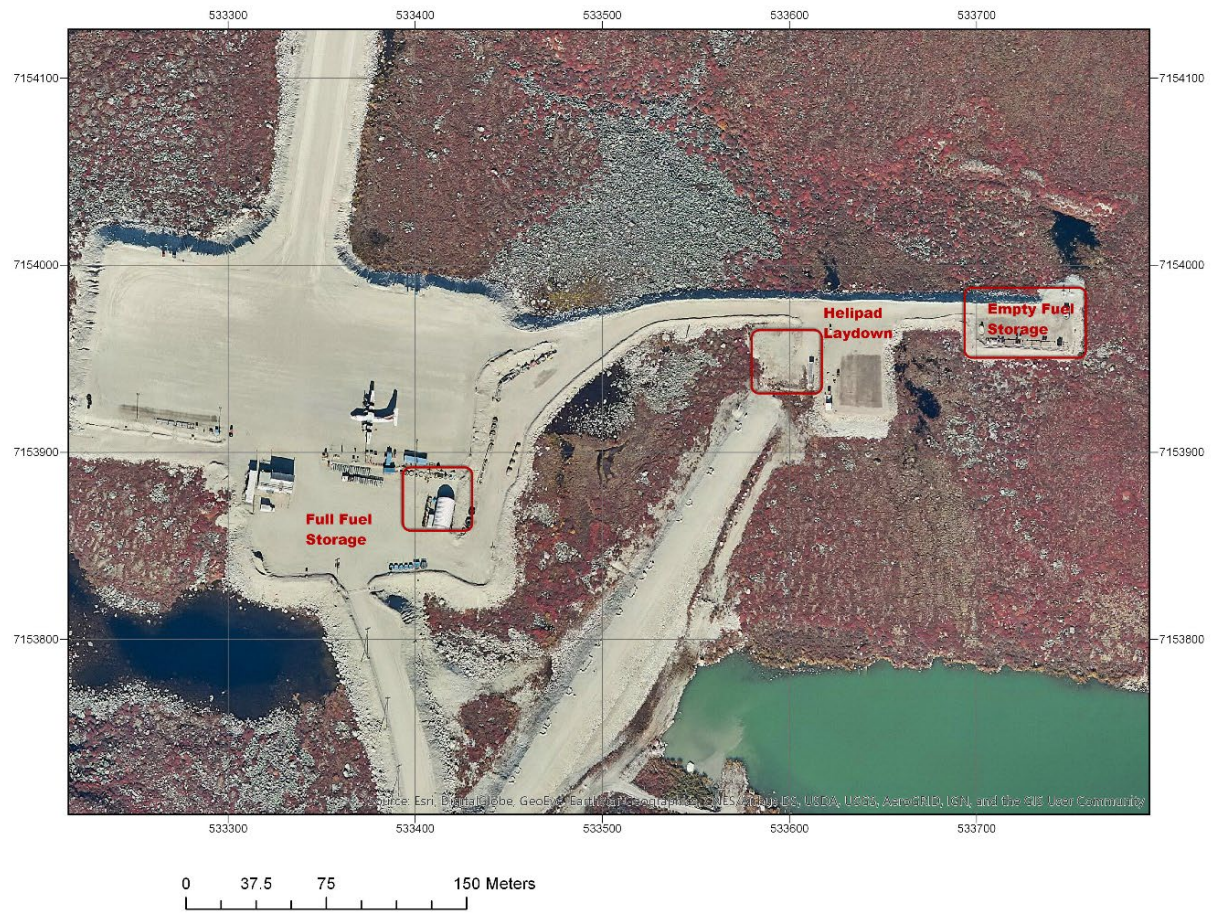
\*The fuel from the RTX exploration program was originally placed in the "Full Fuel Storage" area (Photo 1). Upon inspection a request was made to have the distance to the nearest Ordinary High Water Mark (OHWM) measured to determine the proximity to water. DDMI later noted the distance was within 100 m of the OHWM. As per section 26(1)(m), item 56, which states:

"The Permittee shall not place any Fuel Storage Containers or Tanks within 100 metres of the Ordinary High Water Mark of any any Watercourse, unless otherwise authorized in writing by an Inspector."

Photo 1 – Fuel storage areas

DDMI also confirmed that the RTX fuel cache area by the terminal is not lined, and have therefore stated the drums would be relocated to the existing lined fuel storage area near the helipad (Photo 1).
