Land Use Permit W2017D0004

Re: February 28th and March 14th, 2023, Misery Land Use Permit Inspection

ENVIRONMENTAL INSPECTION REPORT

Location(s) Inspected:	Misery Camp - Ekati Claim Block
---------------------------	---------------------------------

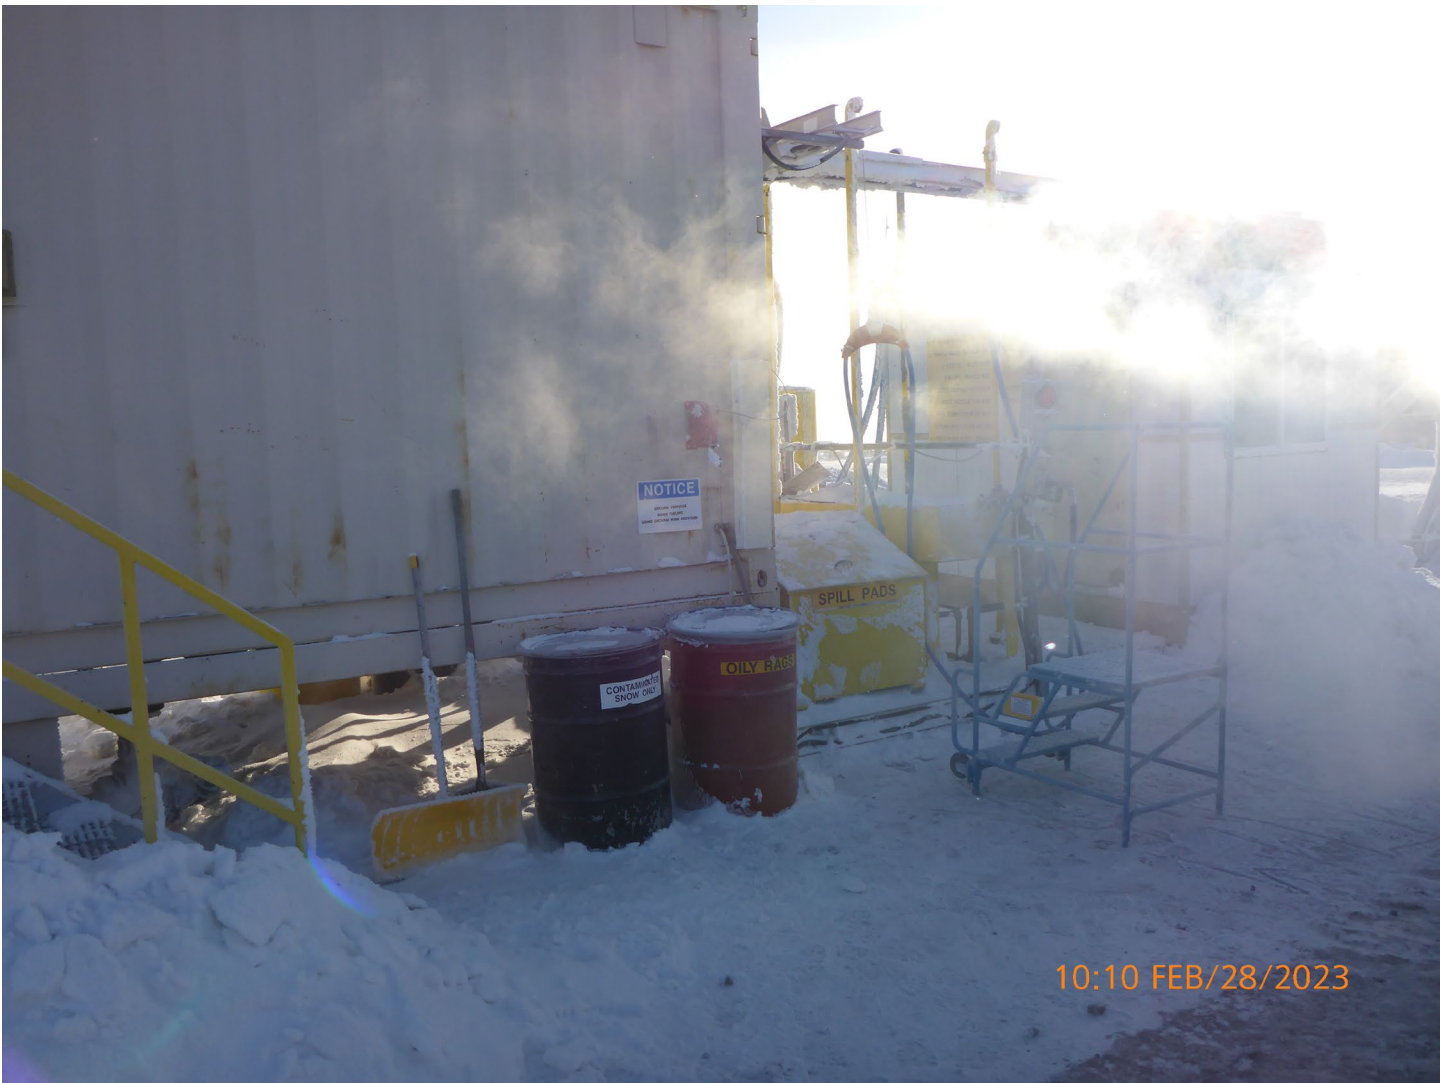
The refueling station at the Misery Camp was clean and maintained. Waste containers were labelled and there was no indication of misdirected waste. Spill pads were well stocked to respond to minor spills, and a fully stocked spill kit was easily accessible for potential spill response (Photos 1 through 3).

Photo 1 – Misery Refueling Station – Refueling station was clean and well organized. Waste containers were labelled and there was no indication of misdirected waste.

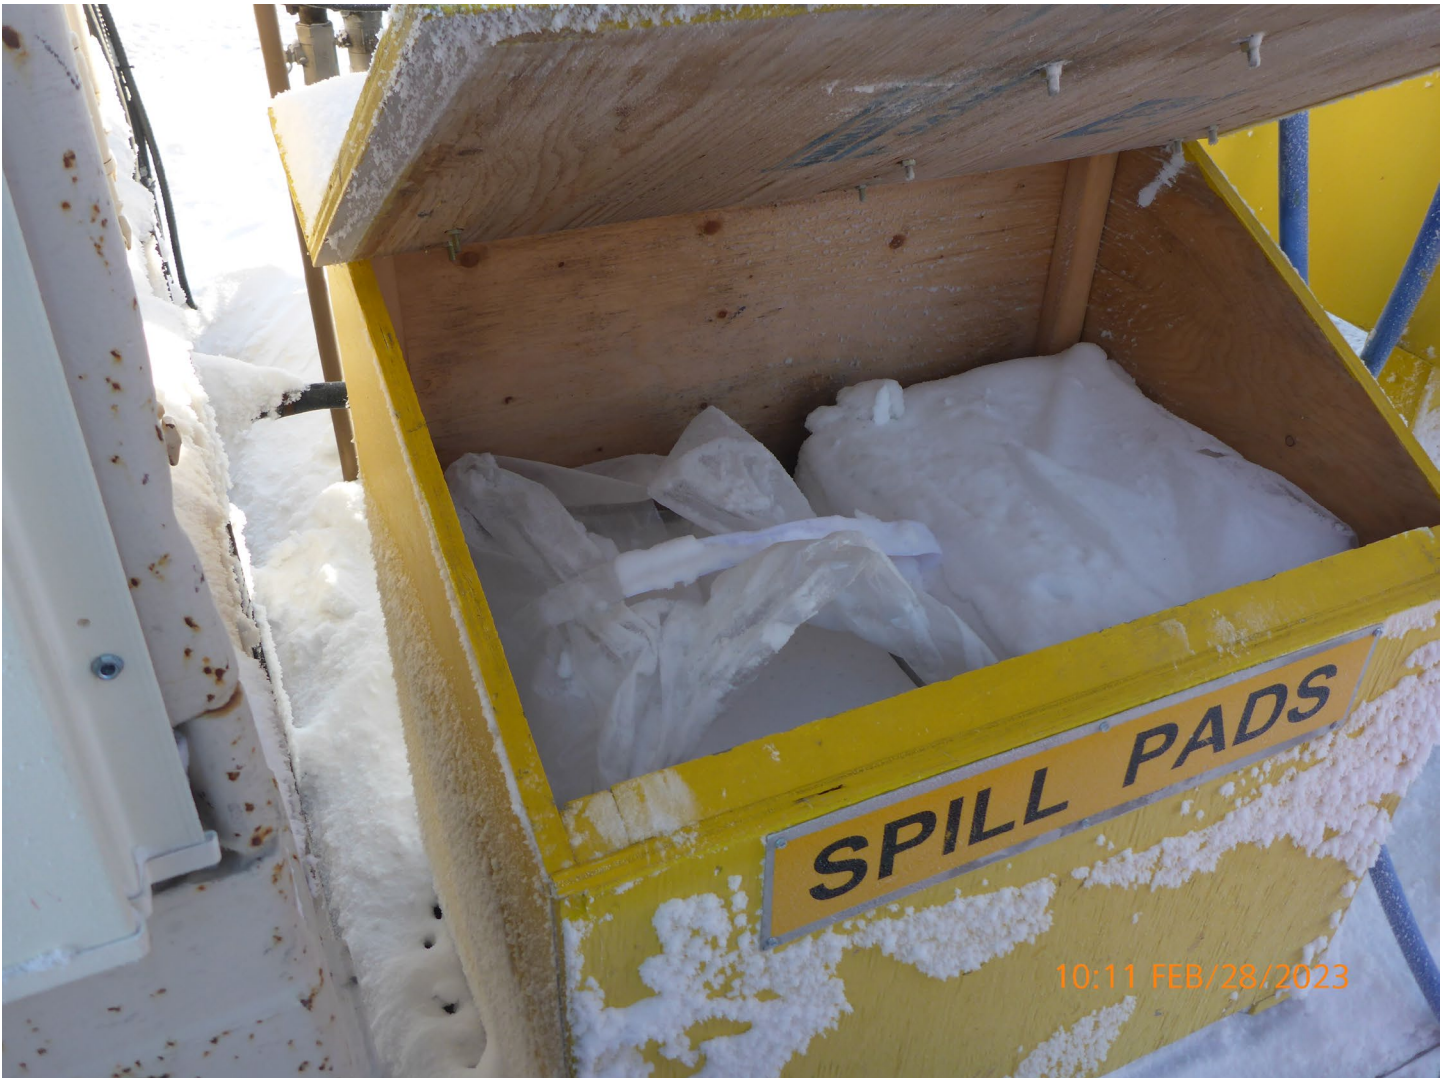
Photo 2 – Misery Refueling Station – Spill pads were well stocked to respond to minor spills.

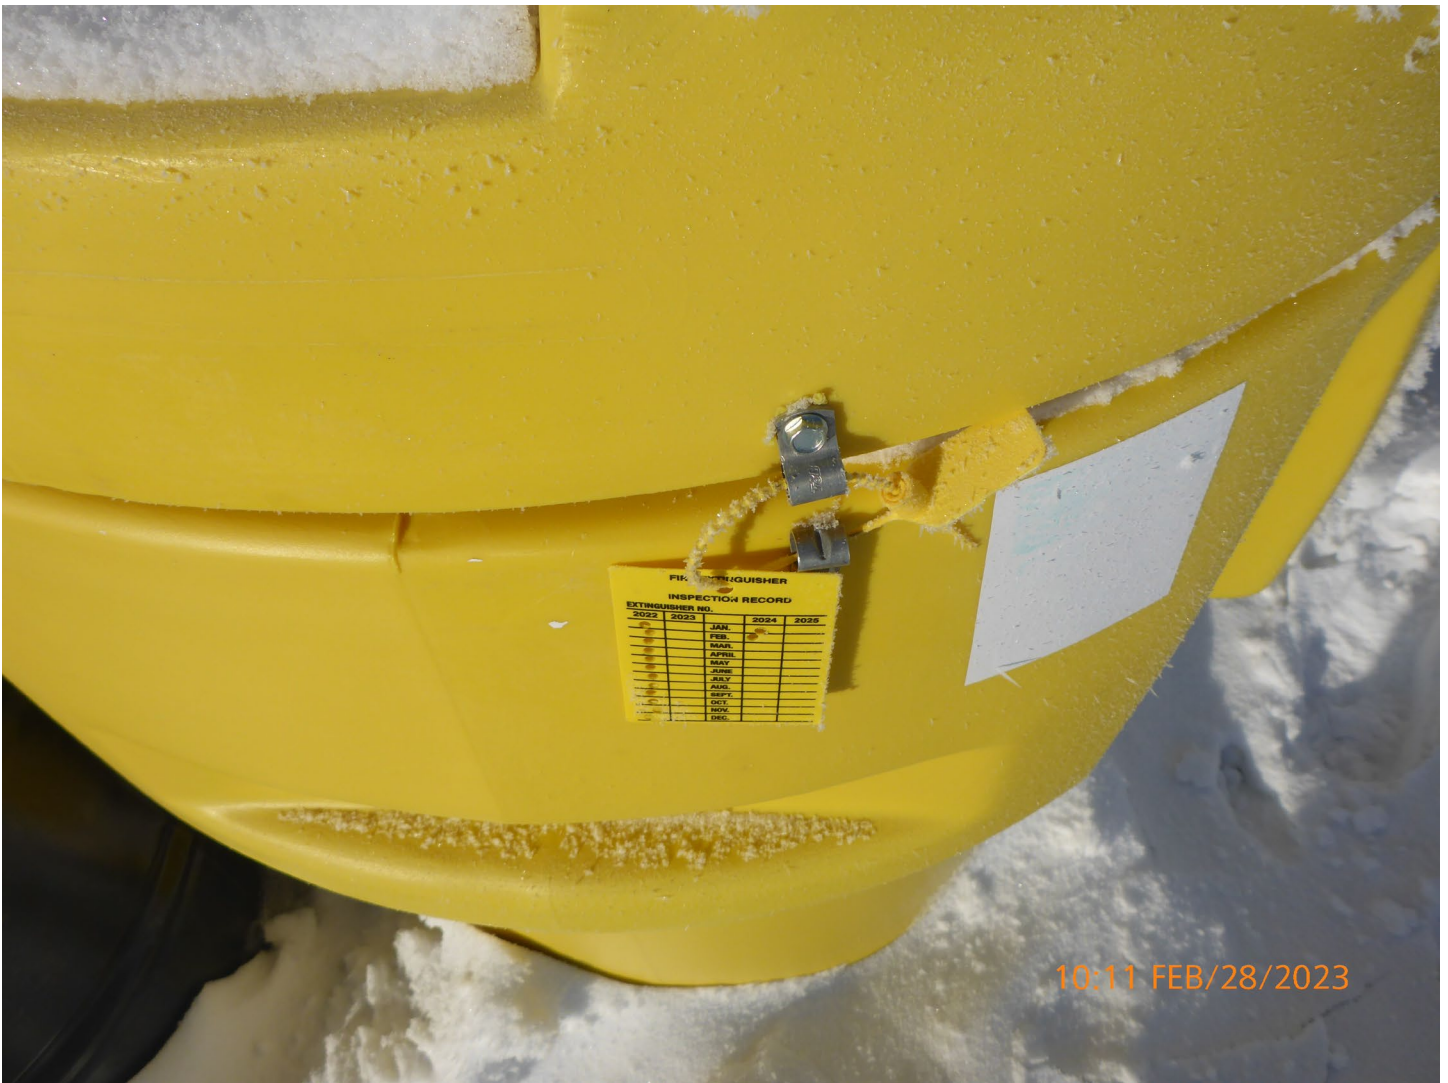
Photo 3 – Misery Refueling Station – Spill kit was fully stocked and easily accessible for potential spill response.

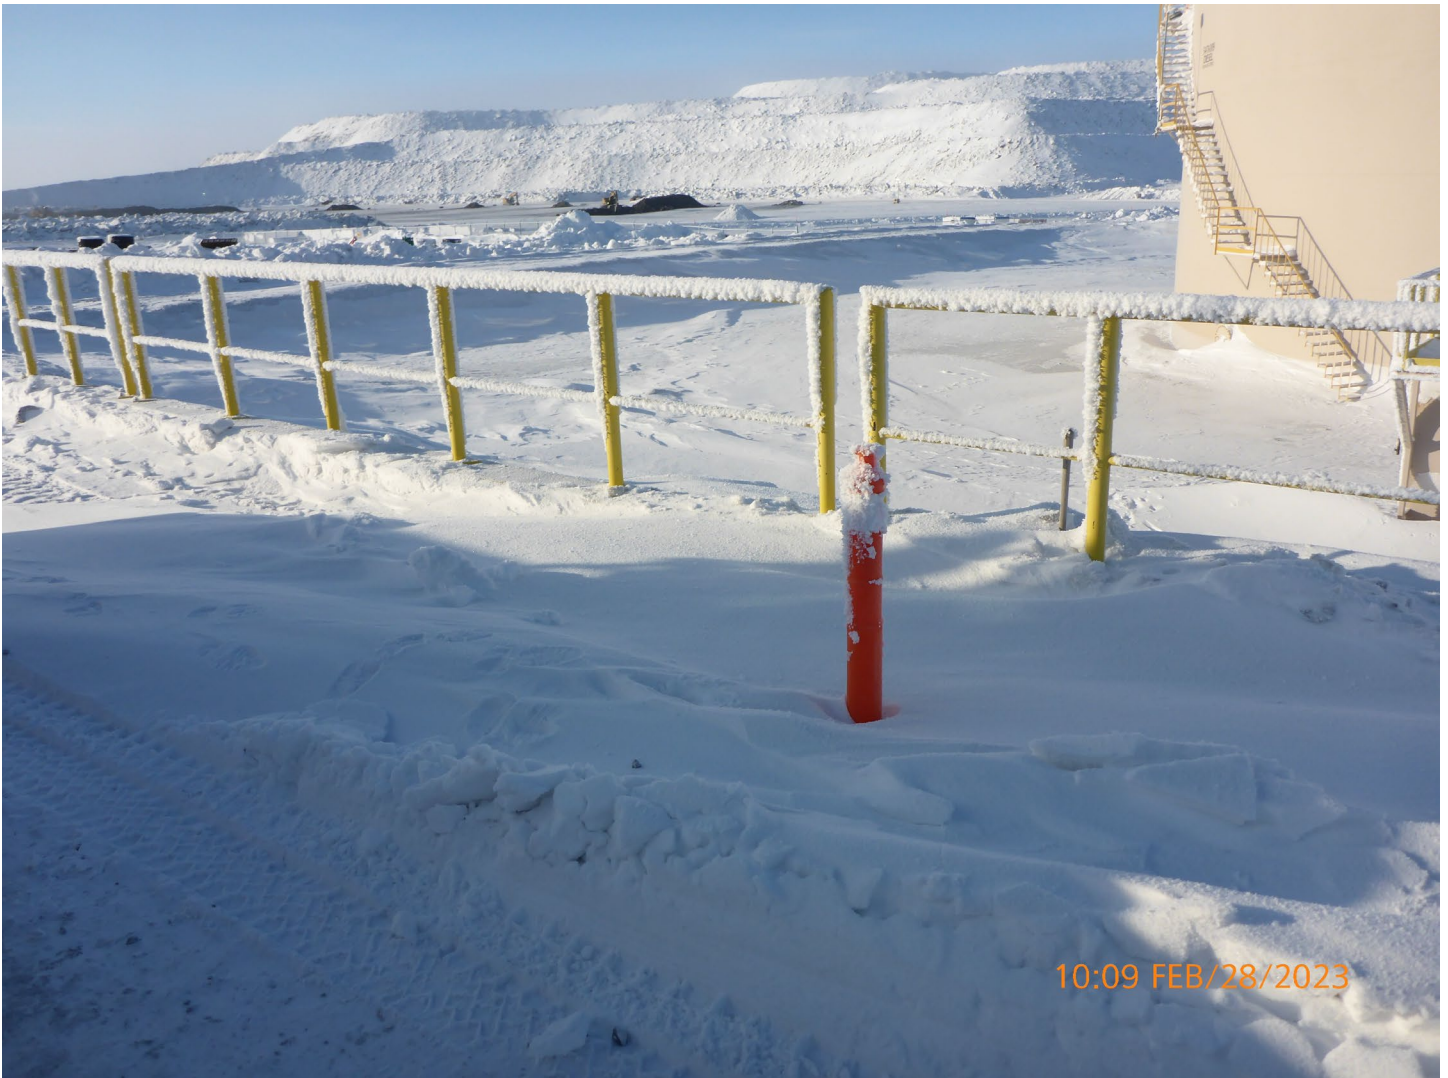
The spill containment sump was snowed in and not functional at the time of inspection (Photo 4). A follow-up inspection revealed that the snow covering the sump was cleared; however, the sump was still frozen in. Some holes were drilled into the ice to add some limited capacity; however, further action is required to ensure proper spill containment (Photo 5). Arctic staff indicated that the steam truck was down for repairs and awaiting parts. The sump will need to be thawed out and free of ice before freshet.

Photo 4 – Misery Refueling Station – The spill containment sump was snowed in and not functional.

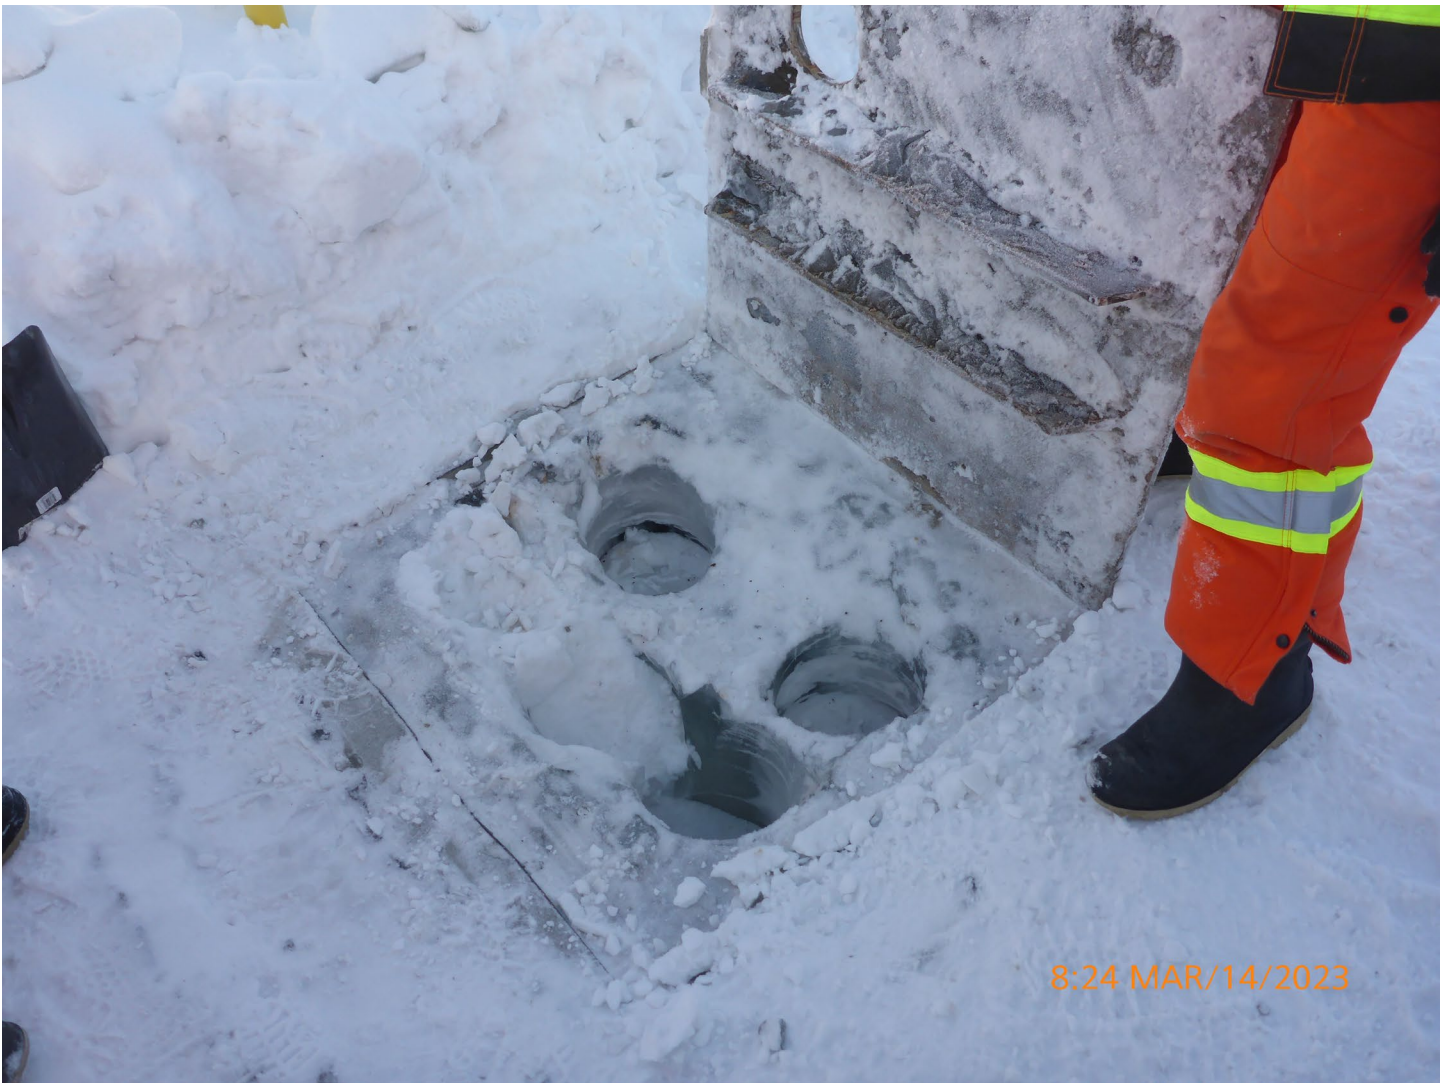
26.1(j)	Protection of Historical, Archeological and Burial Sites	A	
26.1(k)	Objects and Places of Recreational, Scenic or Ecological Value	NA	
26.1(l)	Security Deposit	A	
26.1(m)	Fuel Storage	A*	Fuel transfer containment was frozen and plugged with ice. This will need to be free of ice before freshet.
26.1(n)	Methods and Techniques for Debris and Brush Disposal	N/A	
26.1(o)	Restoration of the Lands	A	
26.1(p)	Display of Permits and Permit Numbers	A	
26.1(q)	Biological and Physical Protection of the Land	A

Photo 5 – Misery Refueling Station – Follow-up inspection revealed that the sump was still frozen in. Some capacity was available from some holes that were drilled in the ice, but further action is required to ensure proper spill containment. The sump will need to be thawed out and free of ice before freshet.

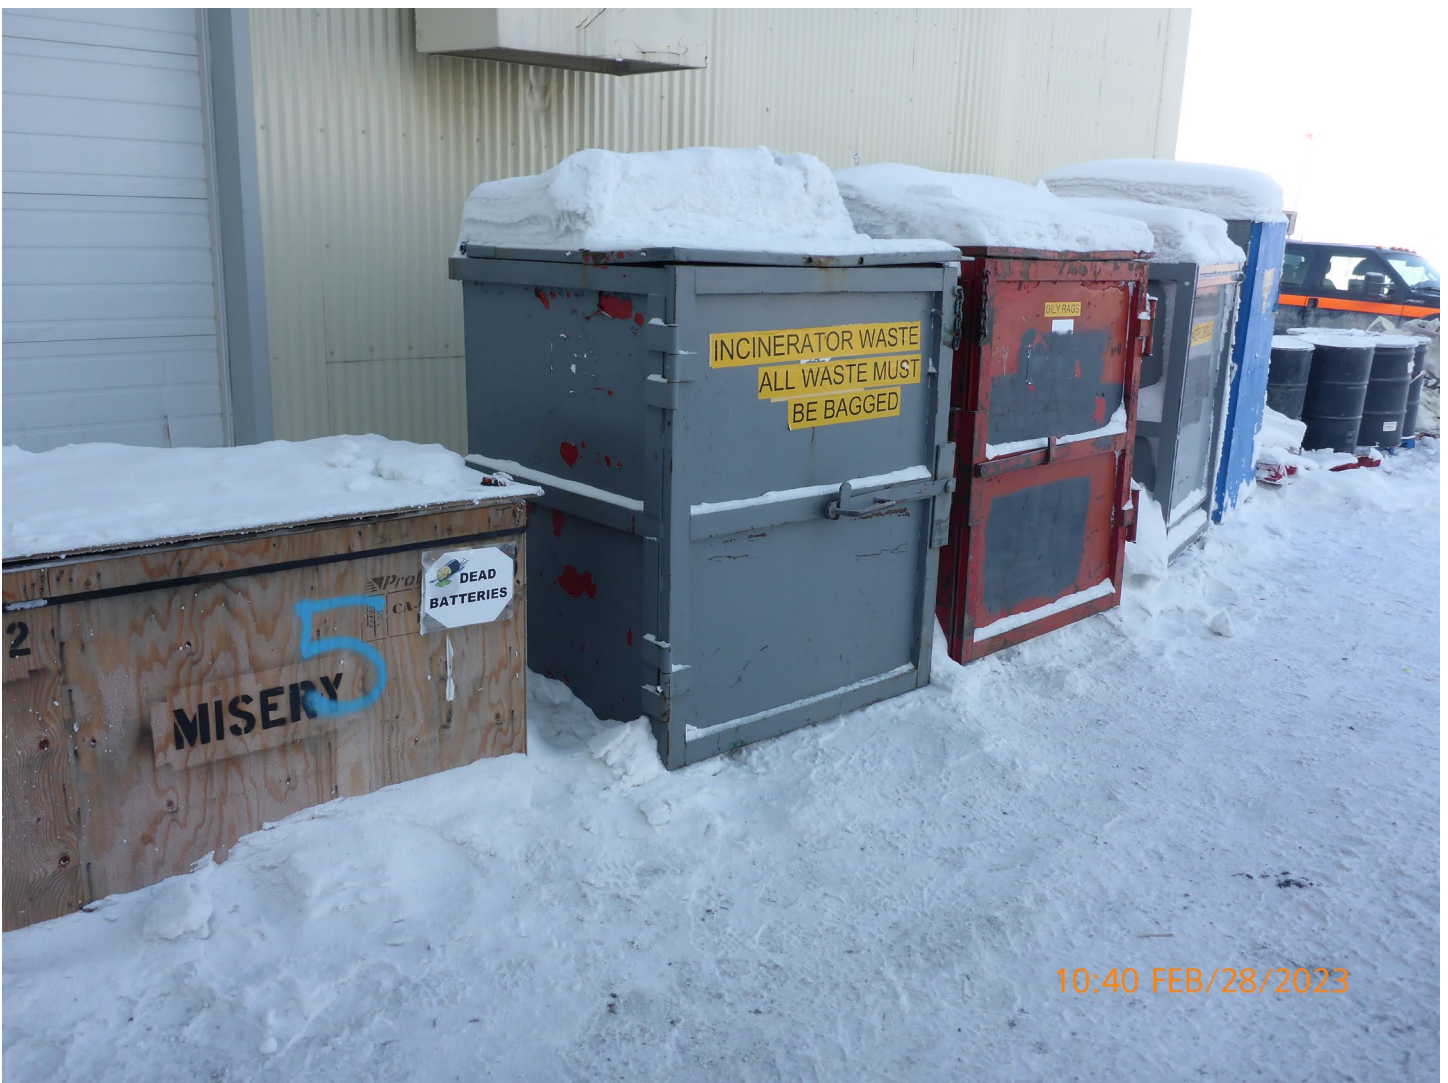
Waste containers on the Misery Camp Pad were present, properly labelled and easily accessible. Inspection of the waste containers showed that waste was being properly segregated and managed as per the approved Waste Management Plan (Photos 6 through 9).

Photo 6 – Waste Management – Waste containers were labelled and easily accessible.

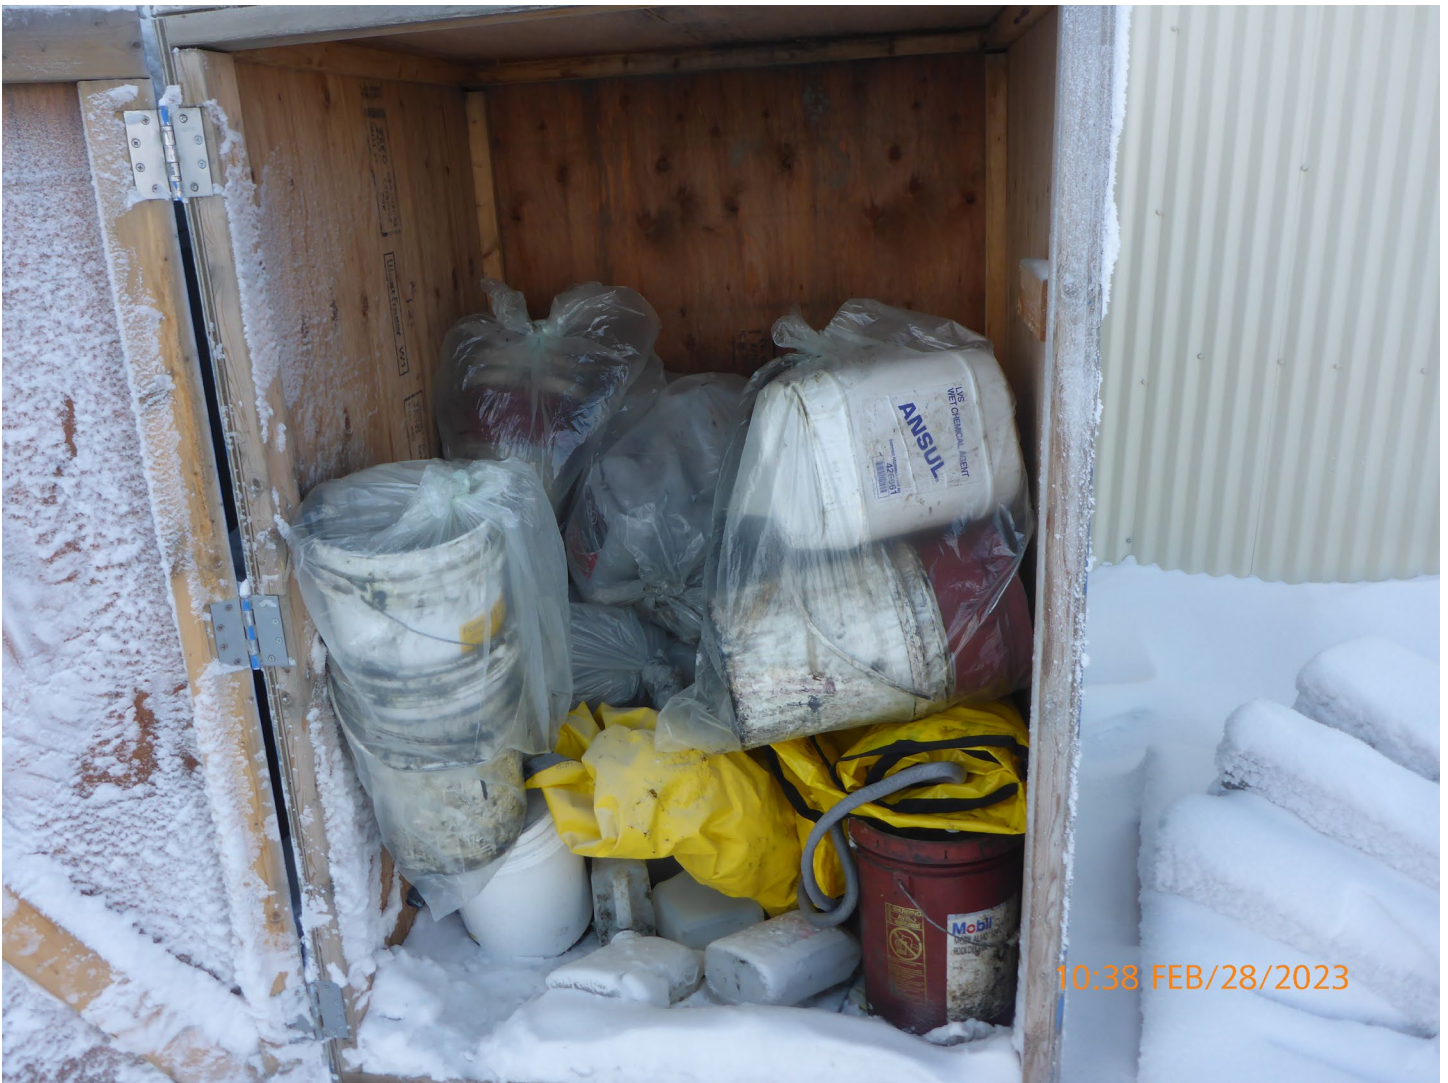
Photo 7 – Waste Management – Plastics disposal container had no indication of misdirected waste.

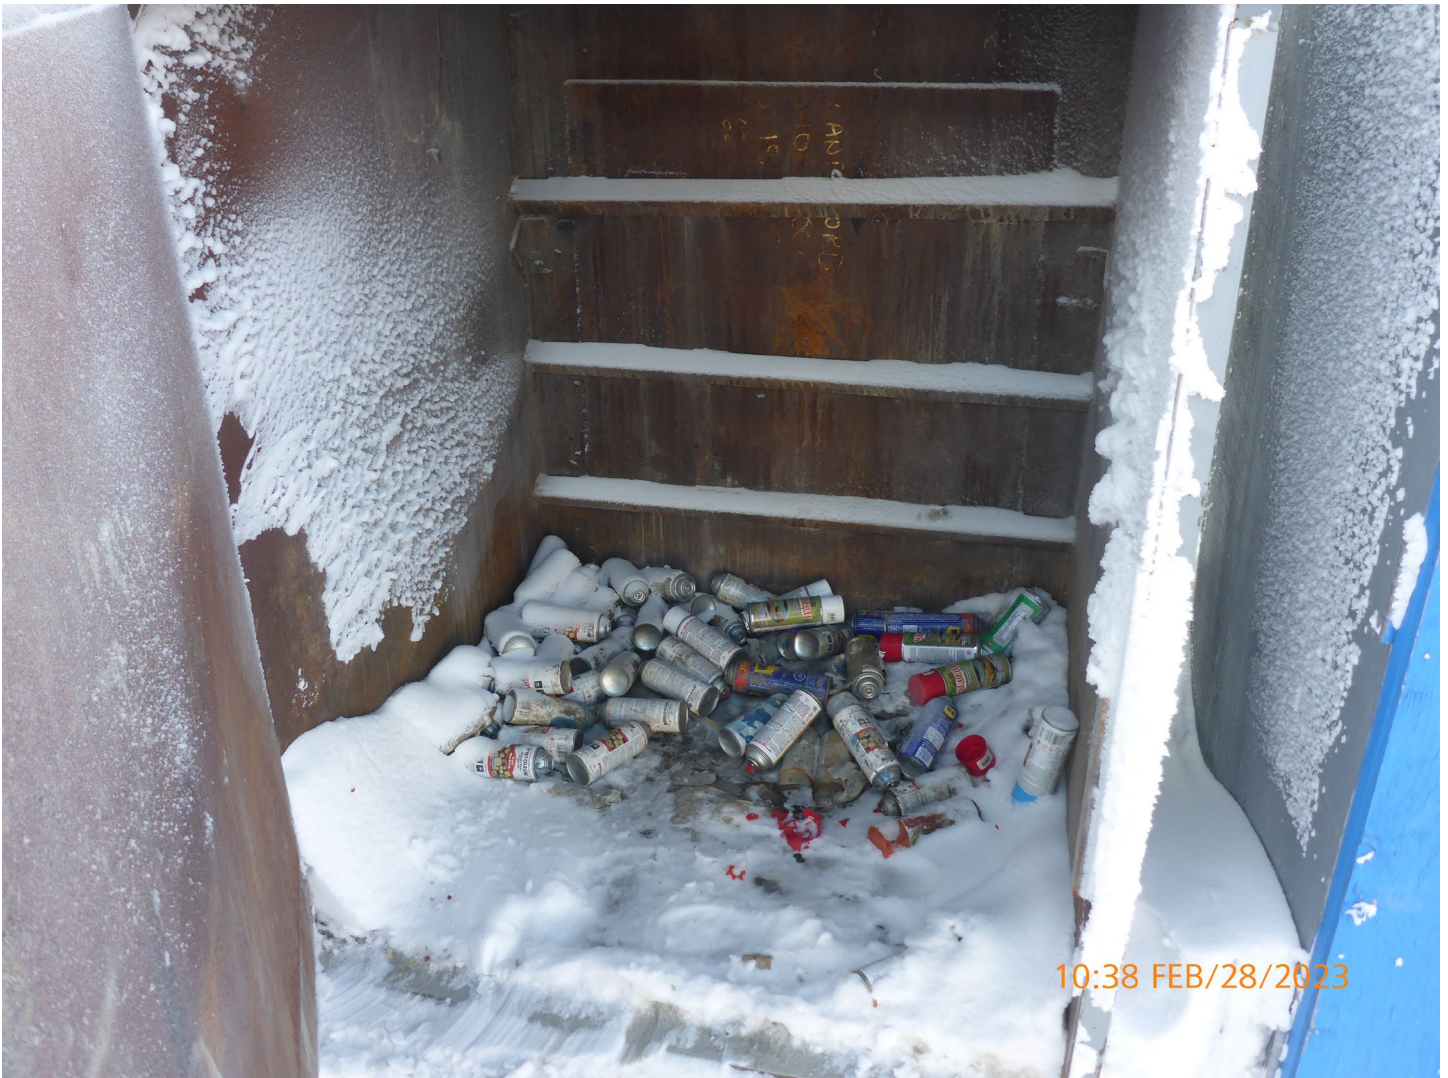
Photo 8 – Waste Management – Aerosol cans were being segregated into a labelled waste bin as per the approved Waste Management Plan.

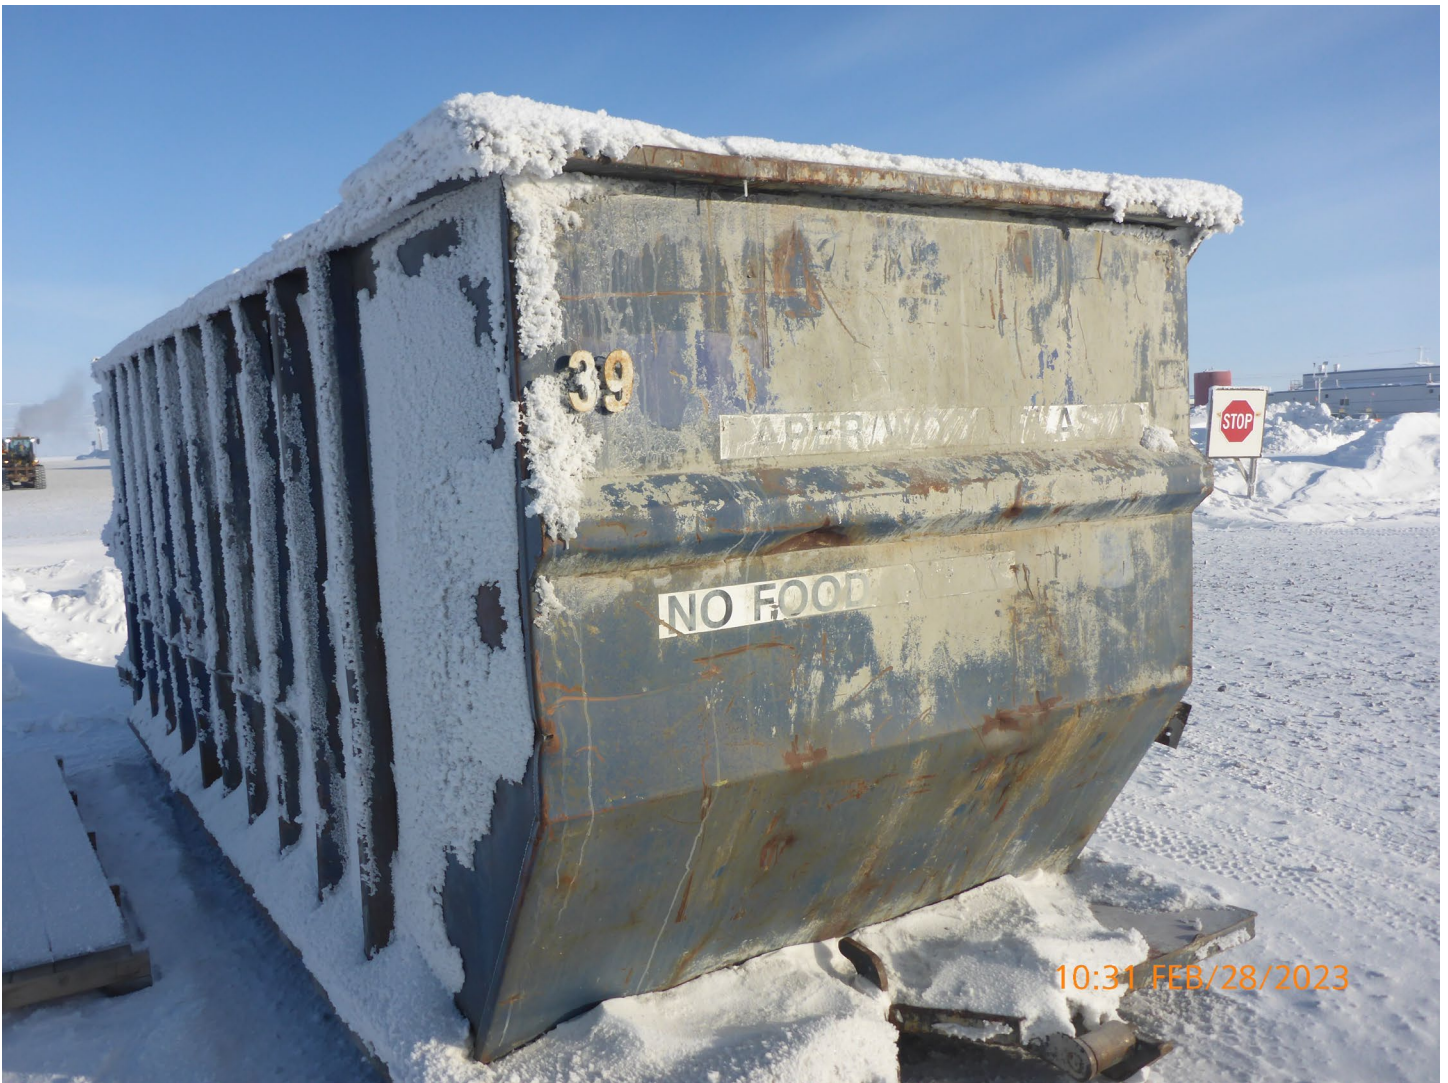
Photo 9 – Waste Management – Landfill was placed near the truckshop. The bin was properly labelled and had no indication of misdirected waste.

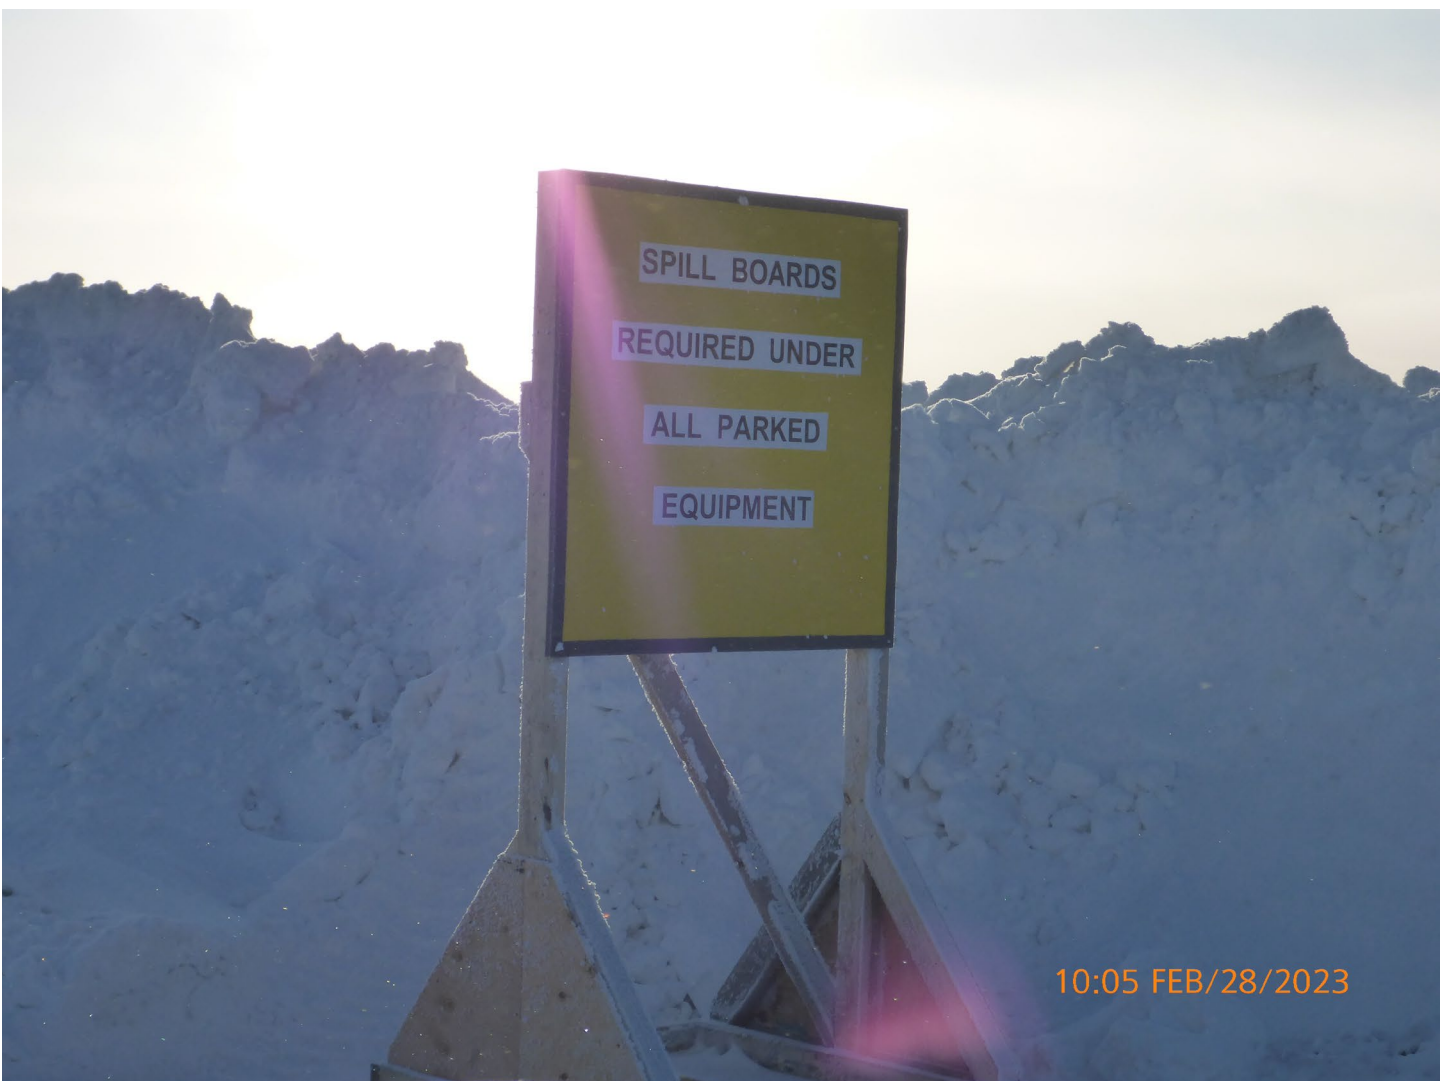
Condition 37 of the Land Use Permit W2017D0004 states that "All equipment that may be parked for two hours or more, shall have a haz-mat/drip tray under it or be sufficiently diapered". The Inspector noted that there is an active effort to ensure that drip trays are deployed under all parked equipment (Photo 10). A supply of drip trays are placed in common parking areas for vehicle operators to use (photo 11). Every piece of parked equipment inspected in the Misery Camp had a drip tray deployed (Photo 12).

Photo 10 – Drip Trays – A campaign at the misery camp has been initiated to ensure that all parked equipment deploys drip trays as per Condition 37 of the Land Use Permit.

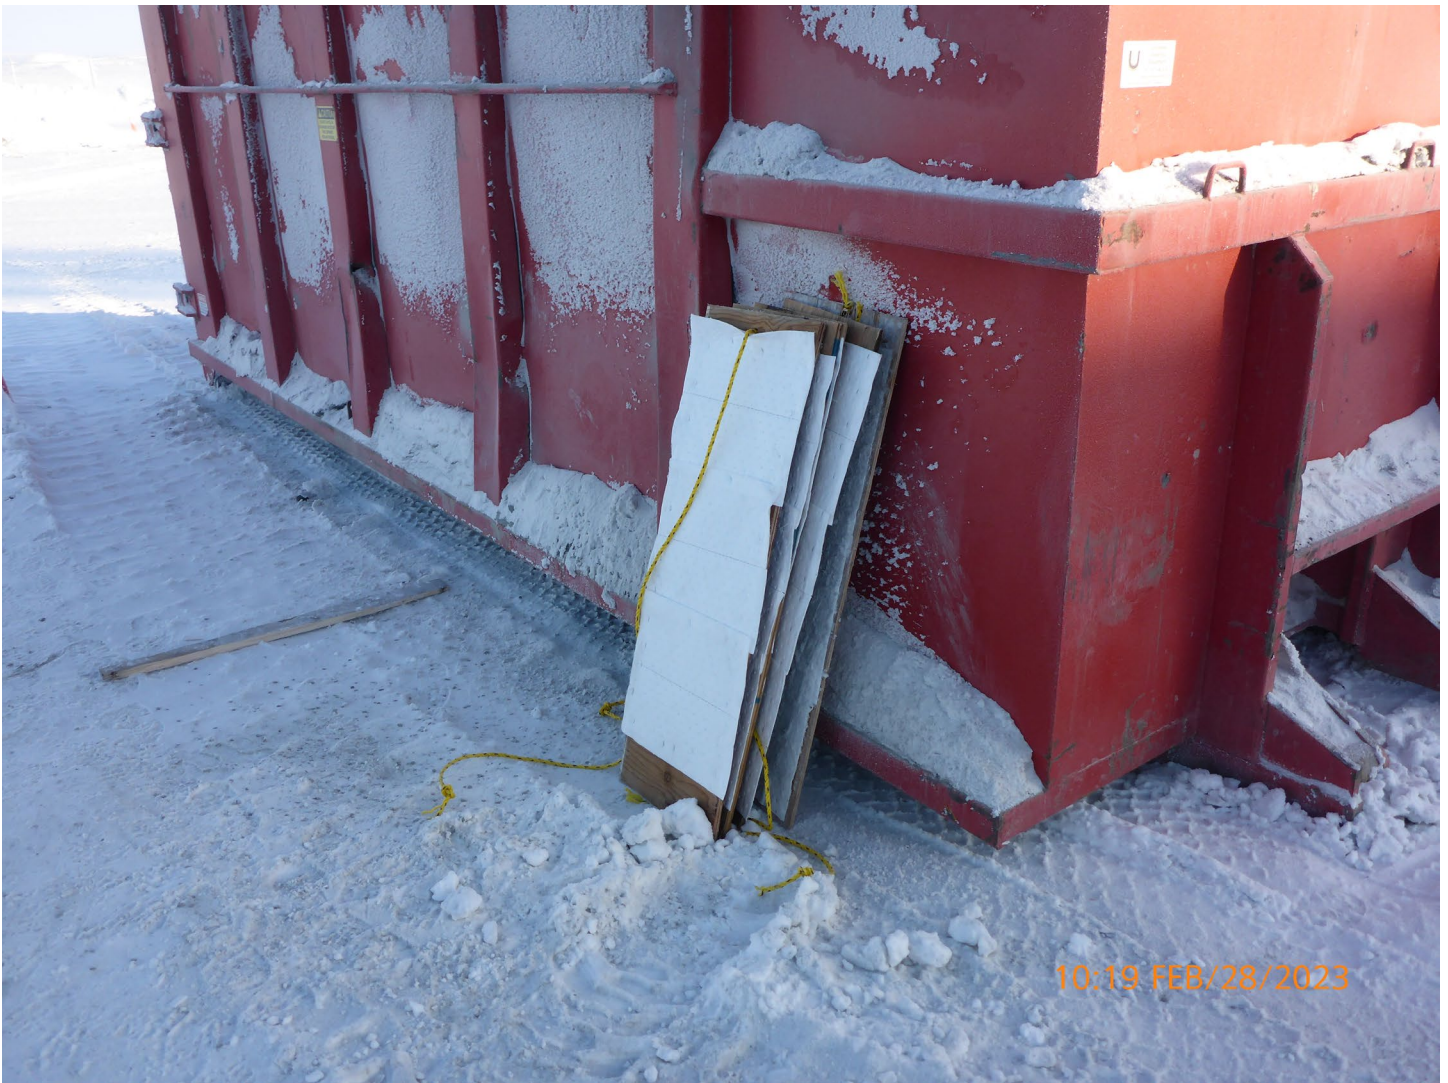
Photo 11 – Drip Trays – Drip trays are available at many of the common parking areas around the misery camp.

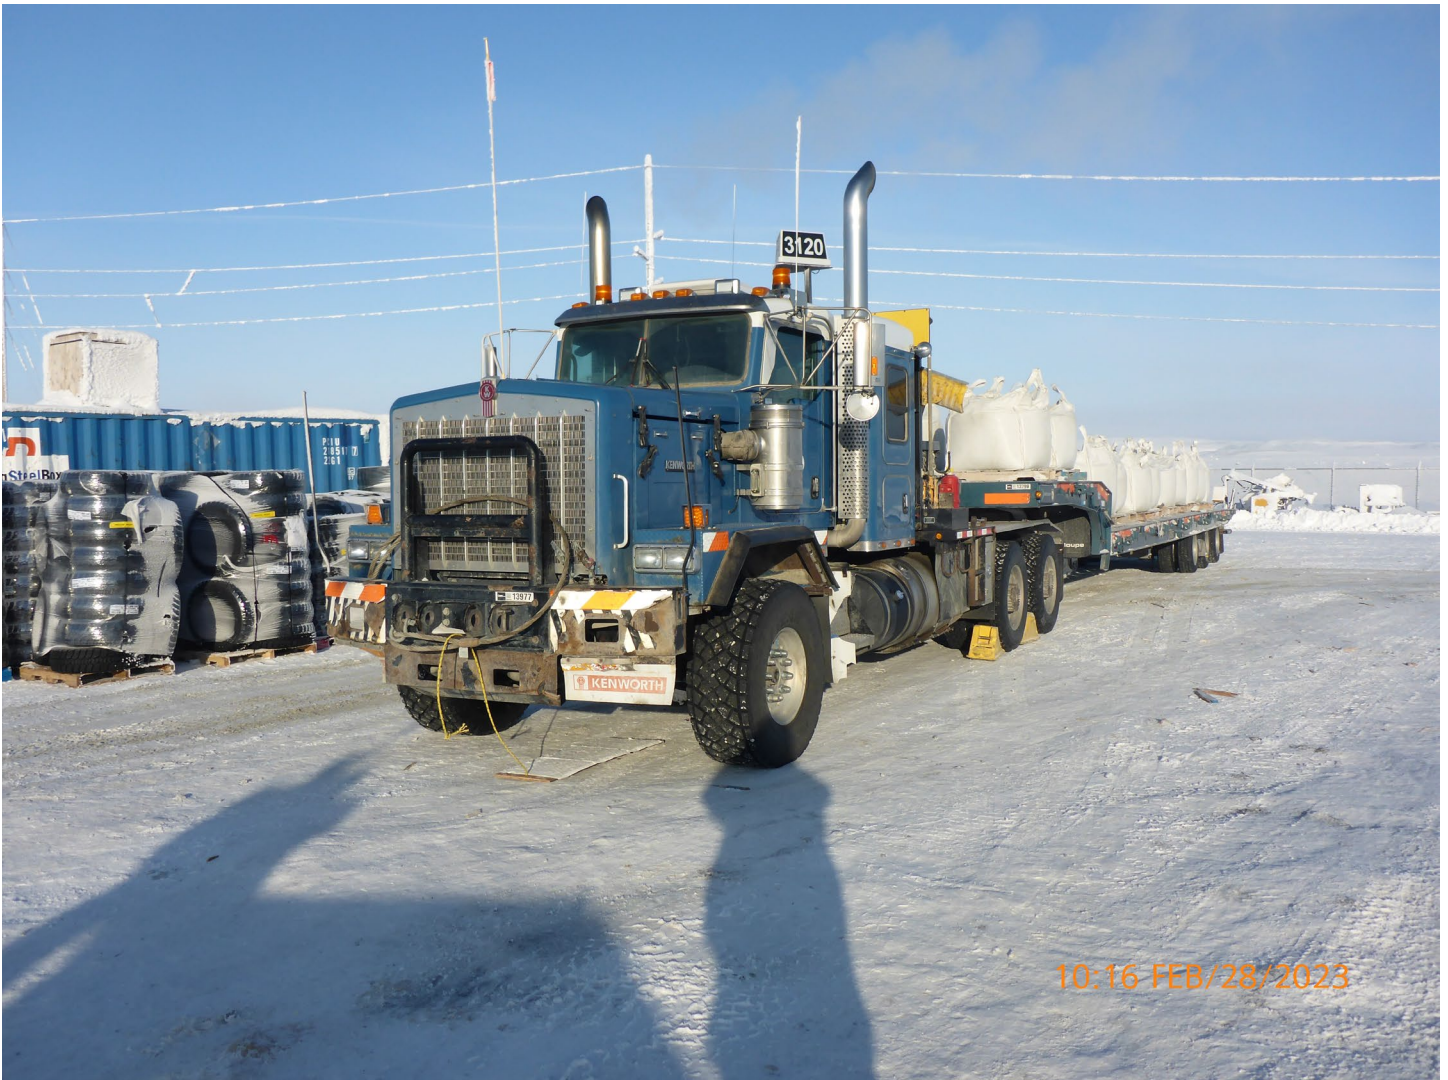
Photo 12 – Drip Trays – Drip tray placed under parked truck.

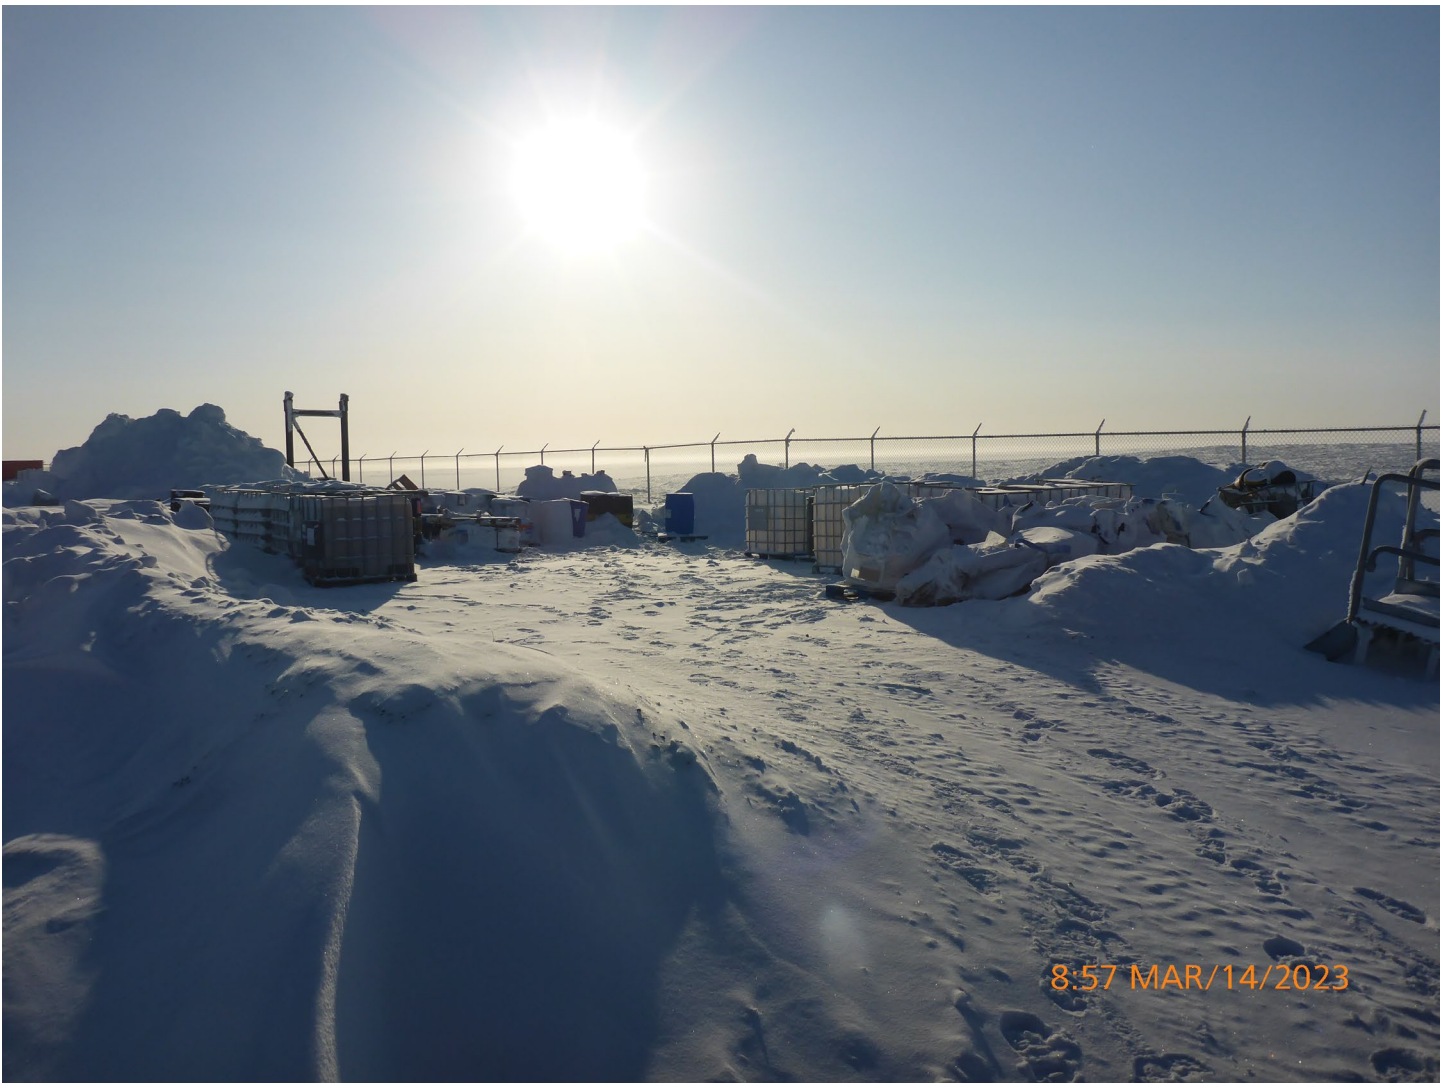
26.1(g)	Use, Storage, Handling and Ultimate Disposal of Any Chemical or Toxic Material	A*	The Inspector noted that several of the containers were not labelled and many of them appeared as though they had been there for quite a while. Details of observations noted below.

The hydrocarbon storage facility is located on the Misery Camp pad. The area is used to store hydrocarbons and other potentially hazardous materials. The facility is bermed and lined to contain any potential spills. The Inspector noted that several of the containers were not labelled and many of them appeared as though they had been there for quite a while (Photo 13). The Inspector recommends that proper labels be placed on all containers, and the facility be inventoried. Any materials that are no longer needed should be shipped off site.

Photo 13 – Misery Hydrocarbon Storage – The hydrocarbon storage area is a lined facility used to store hydrocarbon and other potentially hazardous materials. Several of the containers required labels, and many of the containers have been in the area for an extended period. The Inspector recommends that Arctic go through the area and review which containers are no longer needed and remove from site.
