Land Use Permit W2017D0004

Re: February 28th and March 14th, 2023, Misery Land Use Permit Inspection

ENVIRONMENTAL INSPECTION REPORT

Location(s) Inspected:	Misery Camp - Ekati Claim Block
---------------------------	---------------------------------

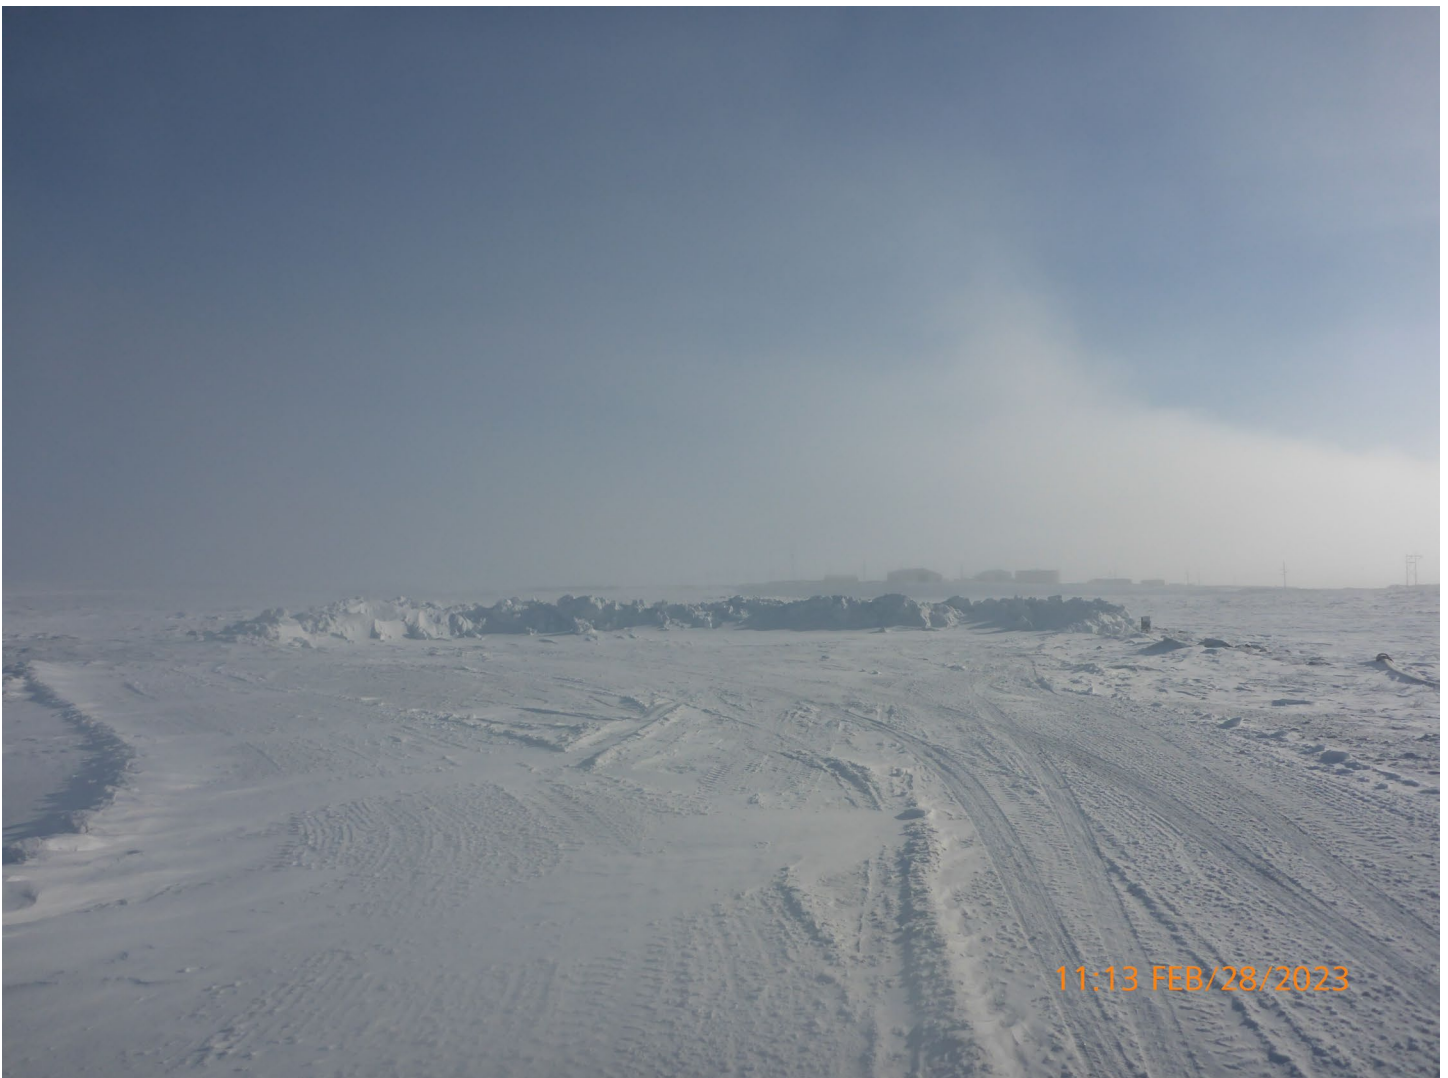
The Snow Dump is located adjacent to the King Pond Containment Facility. Snow from regular snow clearing within the camp and surrounding area is deposited into the snow dump, which will melt into the King Pond in the Spring. The snow within the Snow Dump was clean, with no visible debris, or any indication of hydrocarbon contamination (Photo 14).

Photo 14 – Misery Snow Dump – The Misery Snow Dump is located adjacent to King Pond. All the snow was clean and there was no indication of any debris or hydrocarbon staining.
