**RE: W2017D0004 – Spill-2024360**

Pursuant to Part C: Condition 26(1)(g) requirement 18. c) of Land Use Permit W2017D0004 – Ekati, Burgundy Diamond Mines Ltd. is providing a detailed report on Spill-2024360 which occurred on 19-Septemeber-2024, at 1:30 AM in Misery Development (i.e., disturbed ground).

**Summary**

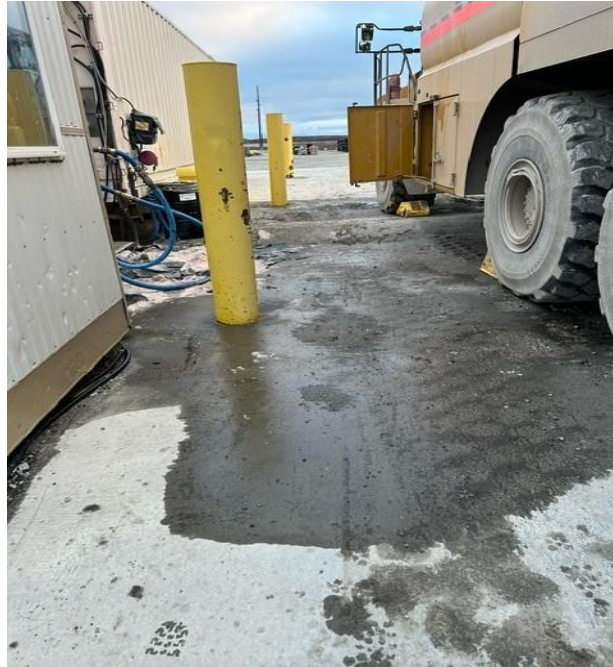
At 1:30 AM on 19-September-2024 Lube Truck (TKS6720) was refilling its bulk fuel tank at the Misery Fuel Station when diesel fuel overflowed out of the breather on the top of the tank (see photo 1). The investigation identified that the max level sensor inside the bulk tank of the lube truck failed causing the fuel island's pump not to kick off at 95% fuel level resulting in the fuel overflow. A recent heavy downpour caused water buildup in the subsurface sump beside the product transfer area, leaving it unable to capture the entire spill (see photo 2). Some of the fuel/water flowed from the product transfer area onto compacted gravel directly adjacent to the product transfer area.

Photo 1: View of the lube truck (TKS 6720) at the site of the diesel fuel spill, located in the product transfer area.

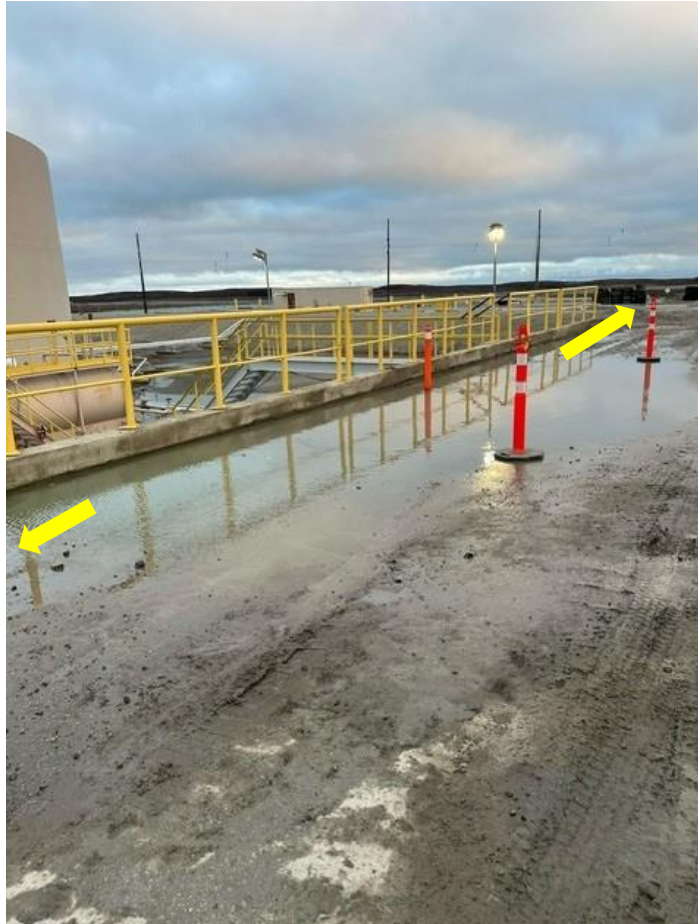
Photo 2. View of the subsurface sump that overflowed due to rainwater mixed with diesel. The arrows highlight the flow of diesel/water from the paved product transfer area onto compacted gravel adjacent to the fuel station. Photo facing northeast.

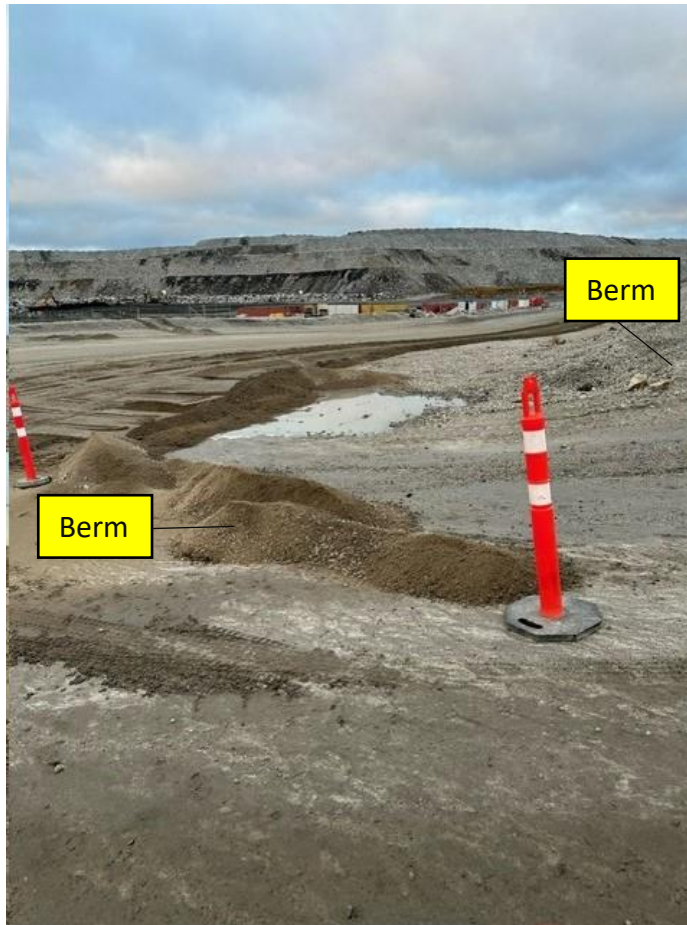
Photo 3. View of berms made directly adjacent to the fuel station to contain the diesel fuel spill. Photo facing north.

Upon noticing the spill, the operator immediately stopped the fuel flow manually, deployed spill pads, froze the area, and informed their supervisor. The supervisor dispatched a vacuum truck to suck up fuel from the product transfer area. They also arranged for equipment to deliver crush, enabling a loader to construct berms for containment beside the Misery Fuel Station (see photo 3). The vacuum truck disposed of the water fuel mix (20 L) at the Ekati Landfarm (suitable hydrocarbon disposal area).

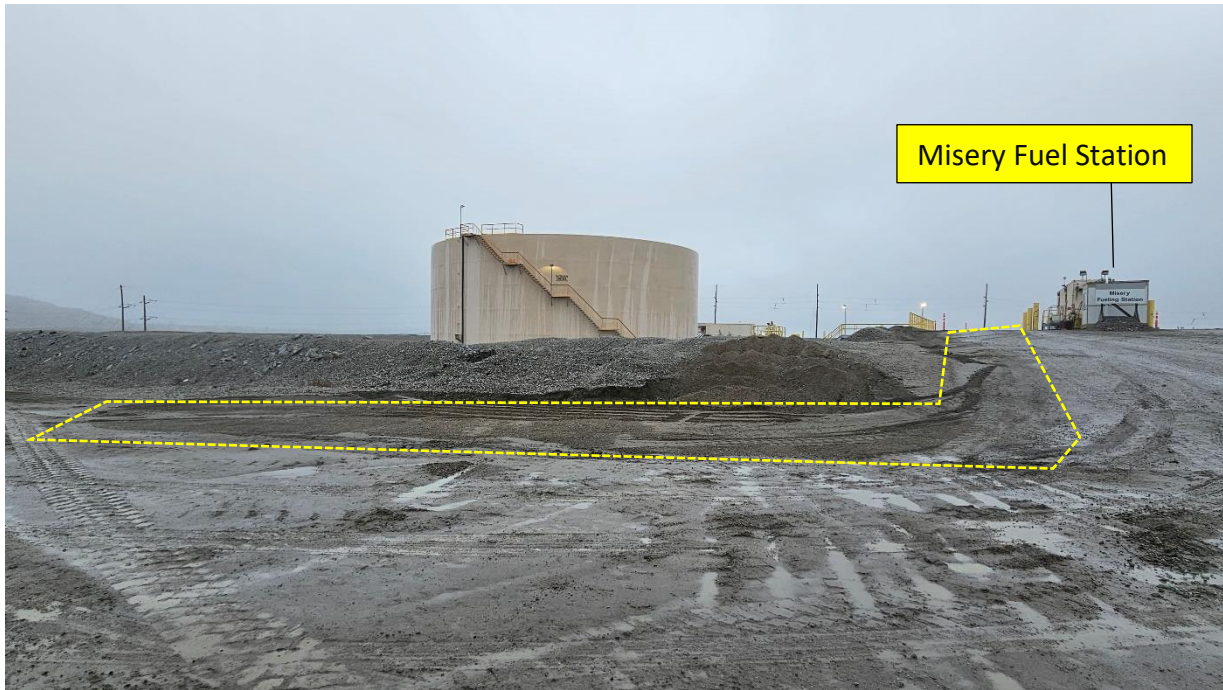
Photo 4. View of cleanup area (highlighted in yellow) adjacent to the Misery Fuel Station. Photo facing northeast.

At first day light, heavy equipment was deployed to the area to begin scraping and excavating the impacted ground. Extra attention was given to the depth to ensure impacted material was properly removed (see photo 4). 61.3 m<sup>3</sup> of impacted material were hauled and deposited in Zone S - Panda/Koala (suitable hydrocarbon disposal area). Environmental Specialists inspected the area after cleanup activities to ensure adequate cleanup of the spill. No concerns were noted. Burgundy initiated a 5-WHYS investigation to identify the root cause and key learnings of the spill incident and will implement corrective actions to help prevent similar occurrences in the future.
