## WATER USE INSPECTION REPORT

**File Number**                      **W2017L3-0001**  
**Type of Operation**            **CLASS B - MUNICIPAL**  
**Location**                         **Wekweètì, NT**

<b>LICENCE #:</b>	W2017L3-0001	<b>EXPIRY DATE:</b>	September 22, 2027
<b>LICENCEE:</b>	Community Government of Wekweètì	<b>PREVIOUS INSPECTION:</b>	May 30, 2023
<b>COMPANY REP:</b>	Fred Behrens	<b>INSPECTION DATE:</b>	March 28, 2024

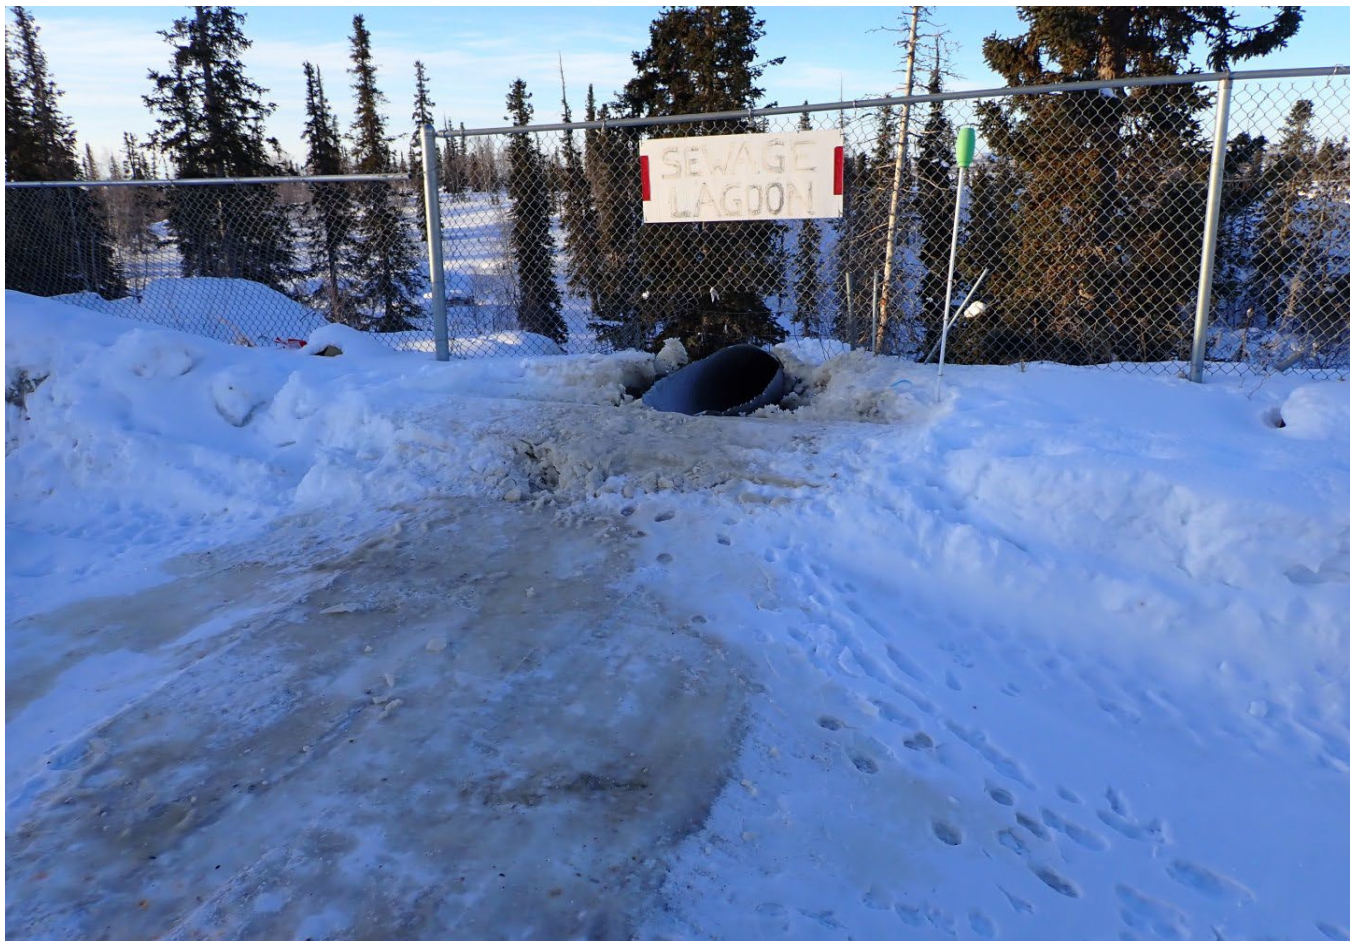
The sewage disposal facility off-loading location was clearly labelled (Figure 2). Given the time of year, the lagoon was frozen, and inspection of the lagoon was not possible.

Figure 2. Sewage Lagoon Off-load Location

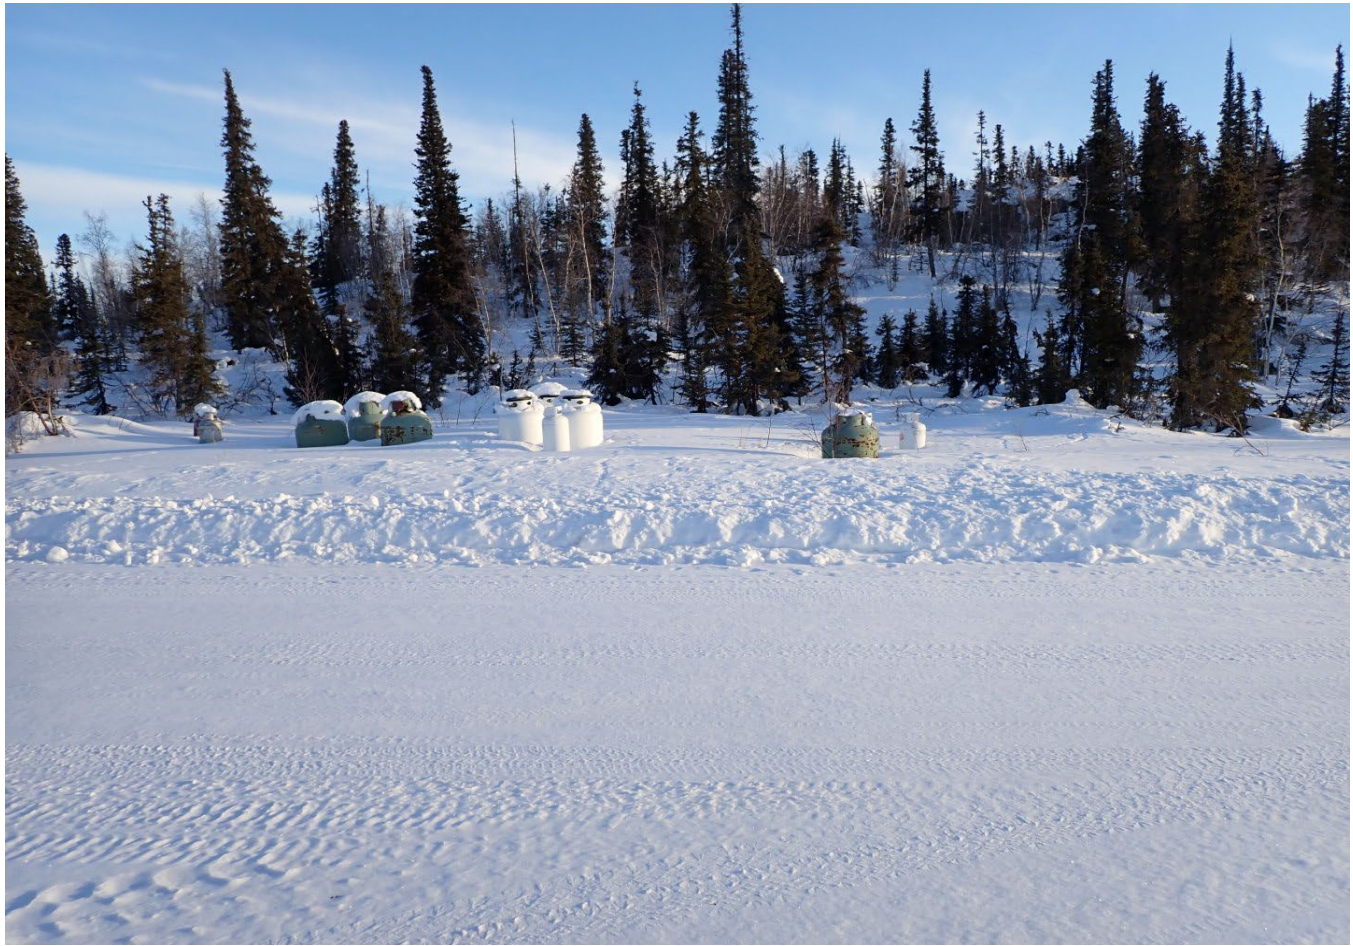
When the landfill was inspected, good separation of household and construction waste was noted. Some waste remains outside of the containment (Figure 3). All waste to be disposed of should be stored according to the Waste Management Plan.

**Explanatory Remarks:** Several large propane tanks were stored outside of containment at the Solid Waste Facility. According to the Operation and Maintenance Plan, propane tanks must be stored within the Hazardous Waste Compound at the Solid Waste Facility. All propane tanks must be moved within the Hazardous Waste Compound prior to freshet.

Figure 3. Waste Propane Tanks Outside of Containment.
