MUNICIPAL WATER USE INSPECTION REPORT

Community Government of Wekweeti

File Number **W2017L3-0001**
Type of Operation **CLASS B - MUNICIPAL**
Location **Wekweètì, NT**

An inspection of the above noted operation was conducted on May 30, 2023 by Water Resource Officers Meaghan MacIntyre-Newell and Meg McCluskie.

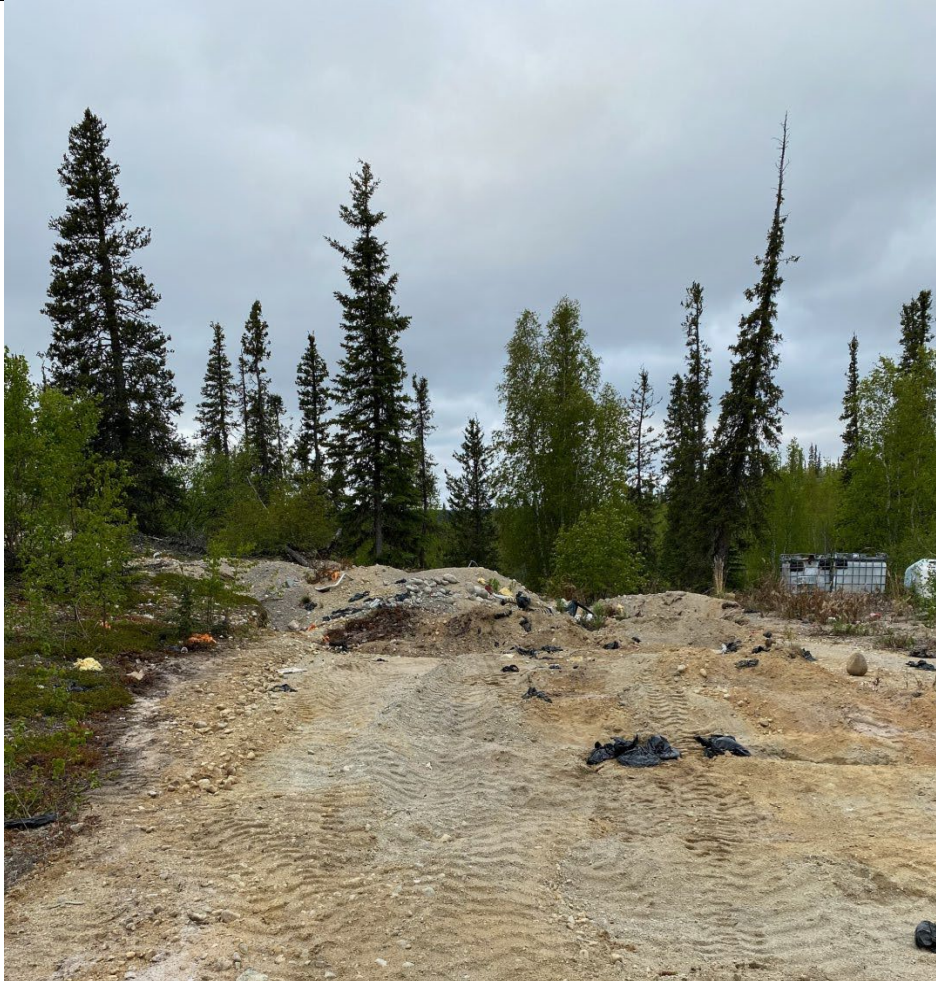
Figure 1

Explanatory Remarks: The Bagged Toilet Waste Disposal Facility is generally well maintained; however, the Inspector noted some hard plastic material in the area which should be removed and discouraged from happening in the future. Additional signage may be helpful in discouraging individuals from disposing of hard plastics in the Bagged Toilet Waste Disposal Facility.

Honey bag disposal facility

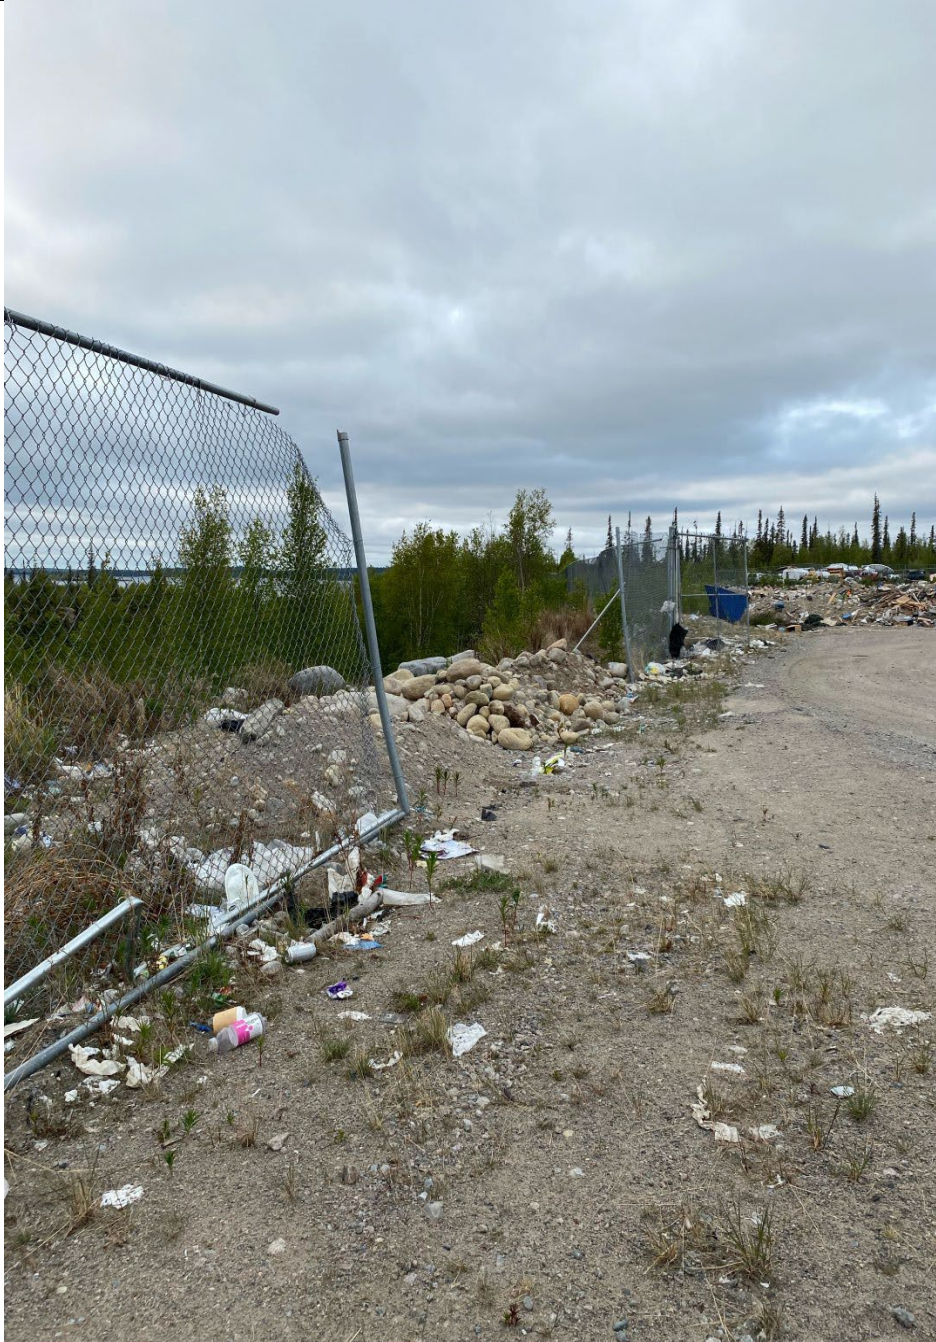
Figure 2

When the landfill was inspected, there were some minor concerns identified. The Inspectors noted that the fencing requires repair or replacement to prevent wildlife encounters, wildlife scavenging, and to contain windblown waste (Photo 2). Additionally, waste segregation efforts must be improved. Garbage must be separated appropriately so hazardous materials can be removed from the landfill and not buried with residential waste. Several one-hundred pound propane tanks appeared to have been disposed of outside of the fencing of the Solid Waste Facility (Photo 3). These tanks should be moved within the Solid Waste Facility and disposed of appropriately.

Solid waste facility fencing in need of repair

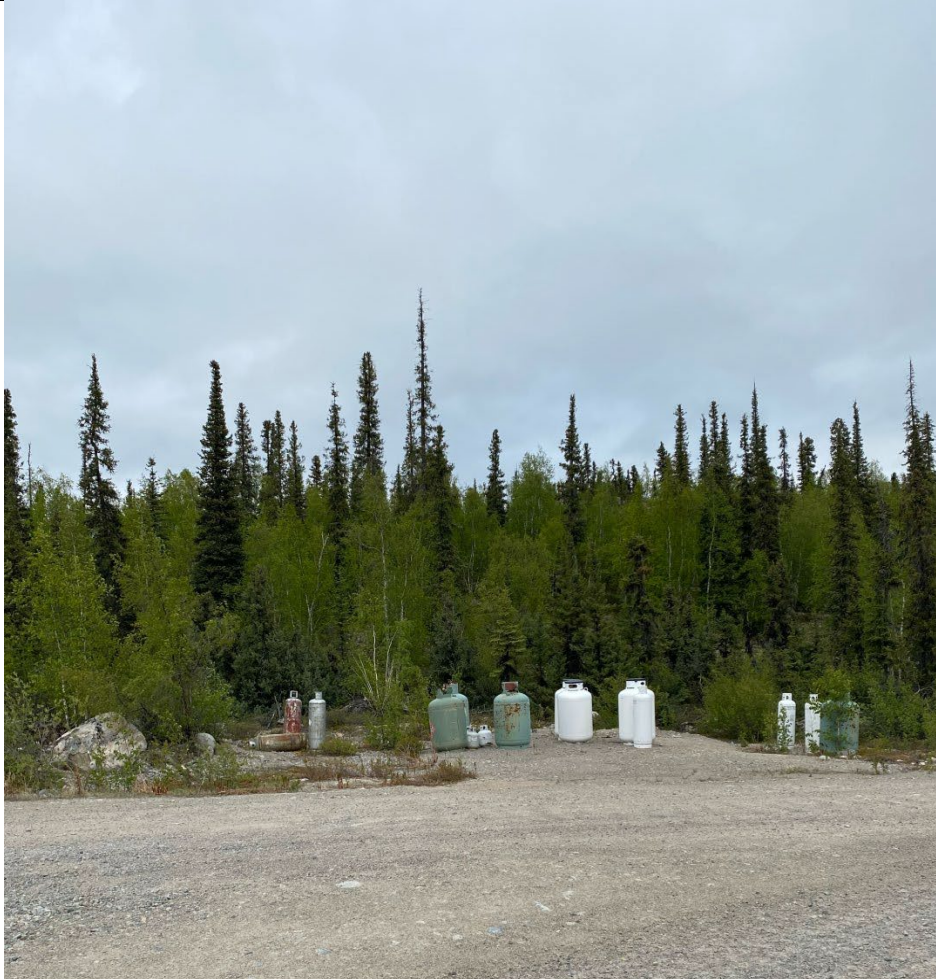
Figure 3

Propane tanks disposed of outside of solid waste facility
