**File Number** W2017L3-0002  
**Type of Operation** CLASS B - MUNICIPAL  
**Location** Whatì, NT

An inspection of the above noted licence was conducted on April 12<sup>th</sup>, 2024 by Water Resource Officer Nahum Lee. Enclosed is a copy of the municipal water use inspection report.

### MUNICIPAL WATER USE INSPECTION REPORT

<b>LICENCE #:</b>	<b>W2017L3-0002</b>	<b>EXPIRY DATE:</b>	<b>September 21, 2027</b>
<b>LICENCEE:</b>	<b>Community Government of Whatì</b>	<b>PREVIOUS INSPECTION:</b>	<b>June 07, 2023</b>
<b>COMPANY REP:</b>	<b>Senior Administrative Officer</b>	<b>INSPECTION DATE:</b>	<b>April 12, 2024</b>

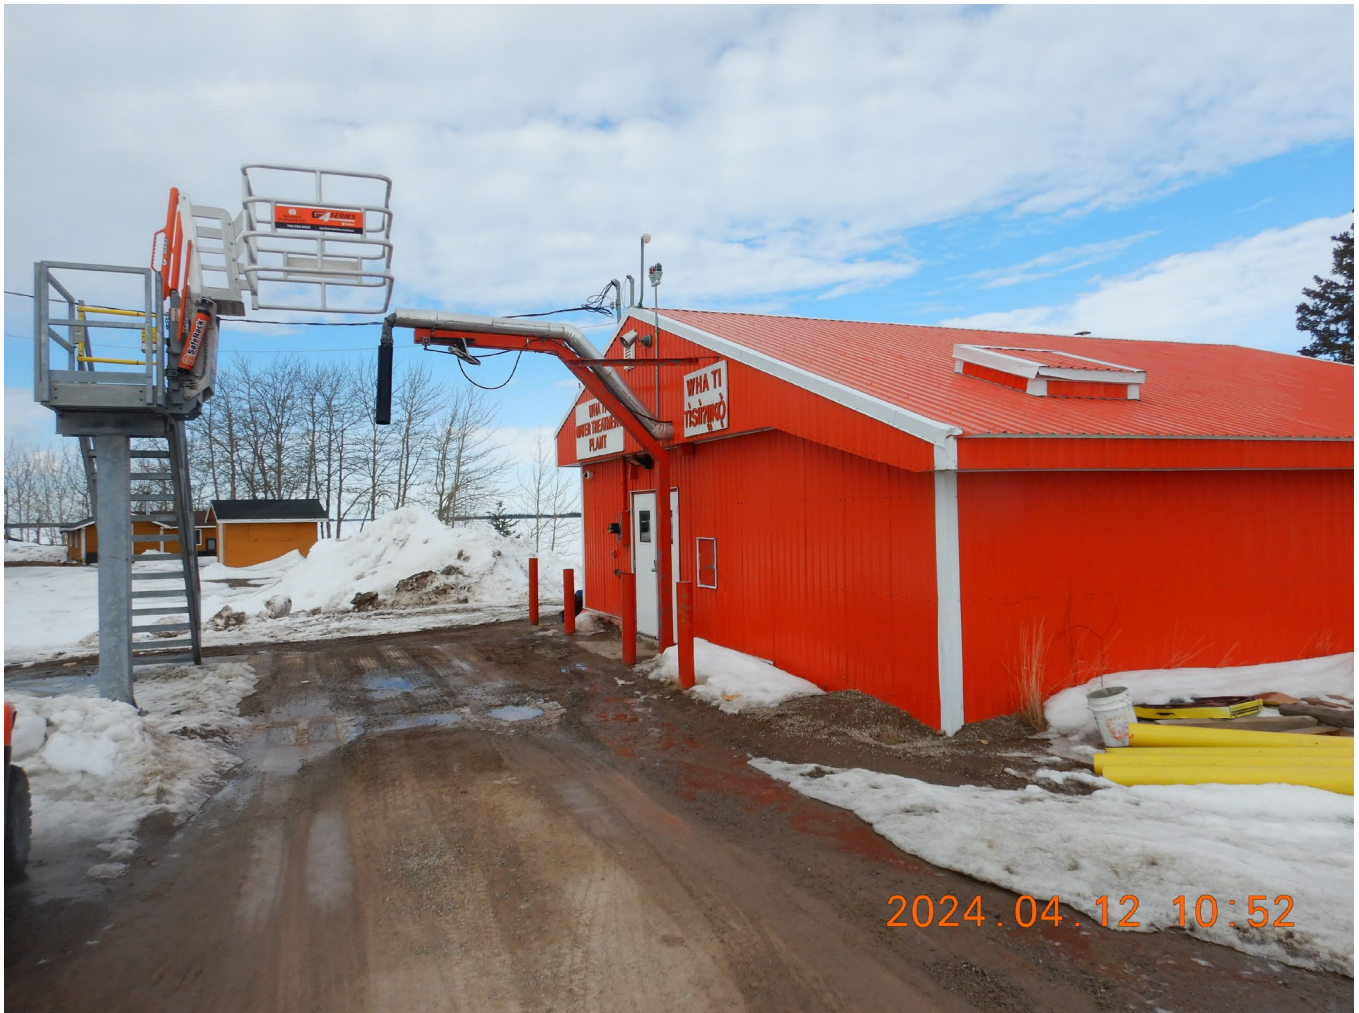
The water intake facilities (Photo 1) were inspected and found to be in good condition. All meters used to measure water volumes were operational and logbooks were up-to-date. No concerns were identified at this location.

Photo 1: Water treatment plant.

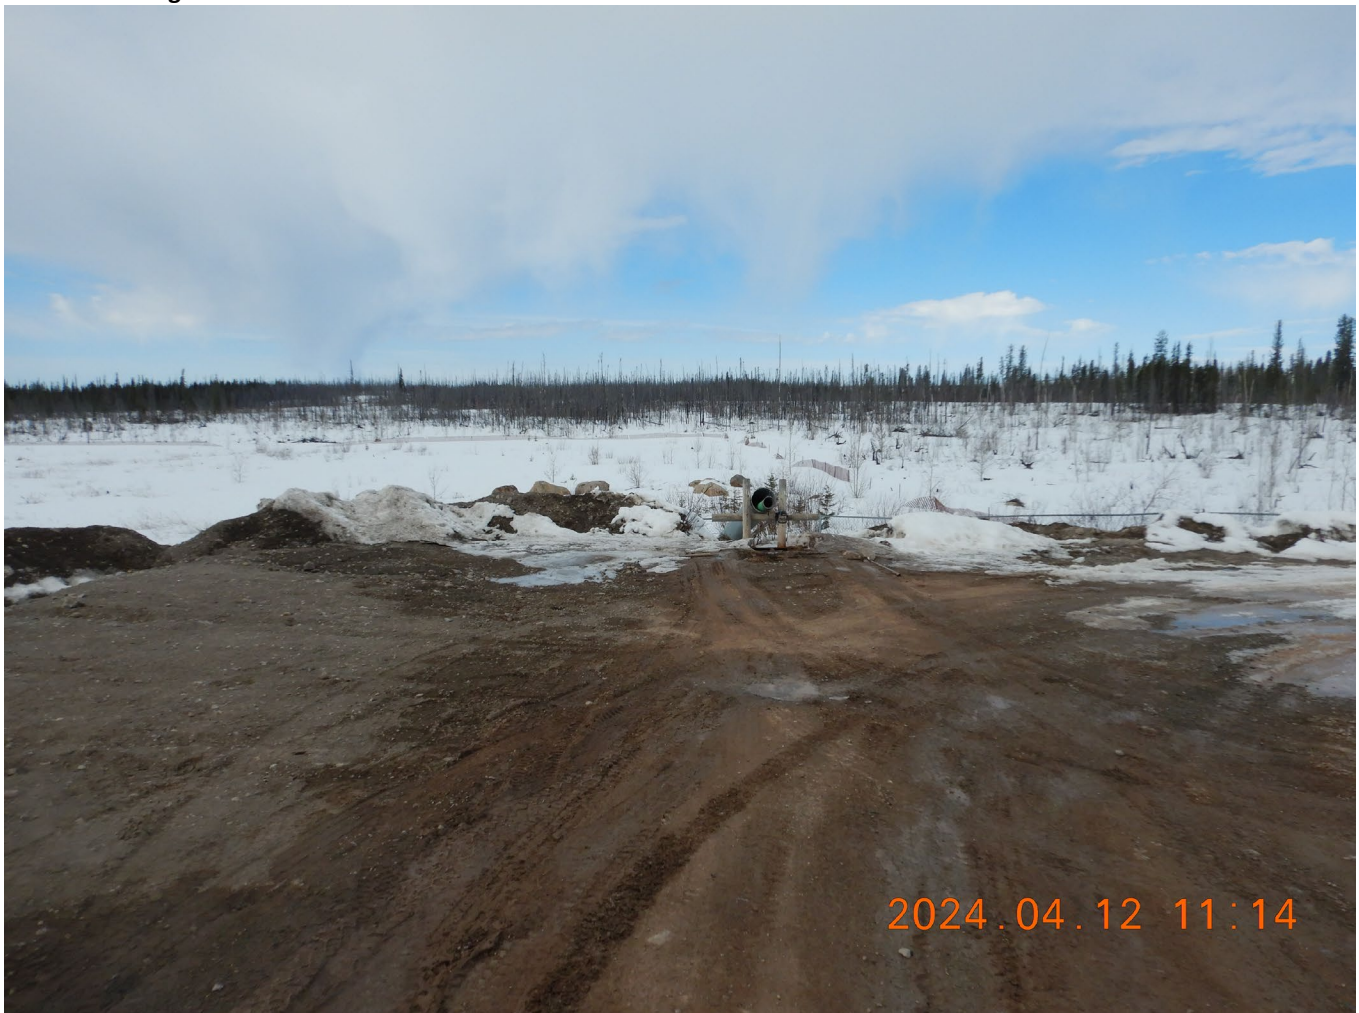
Freeboard at the area of discharge was acceptable and there was very little effluent in the wetland area (Photo 2). The honey bucket disposal area was inspected and disposal of hard plastics in this area should be avoided where possible (Photo 3).

Photo 2: Sewage outfall.

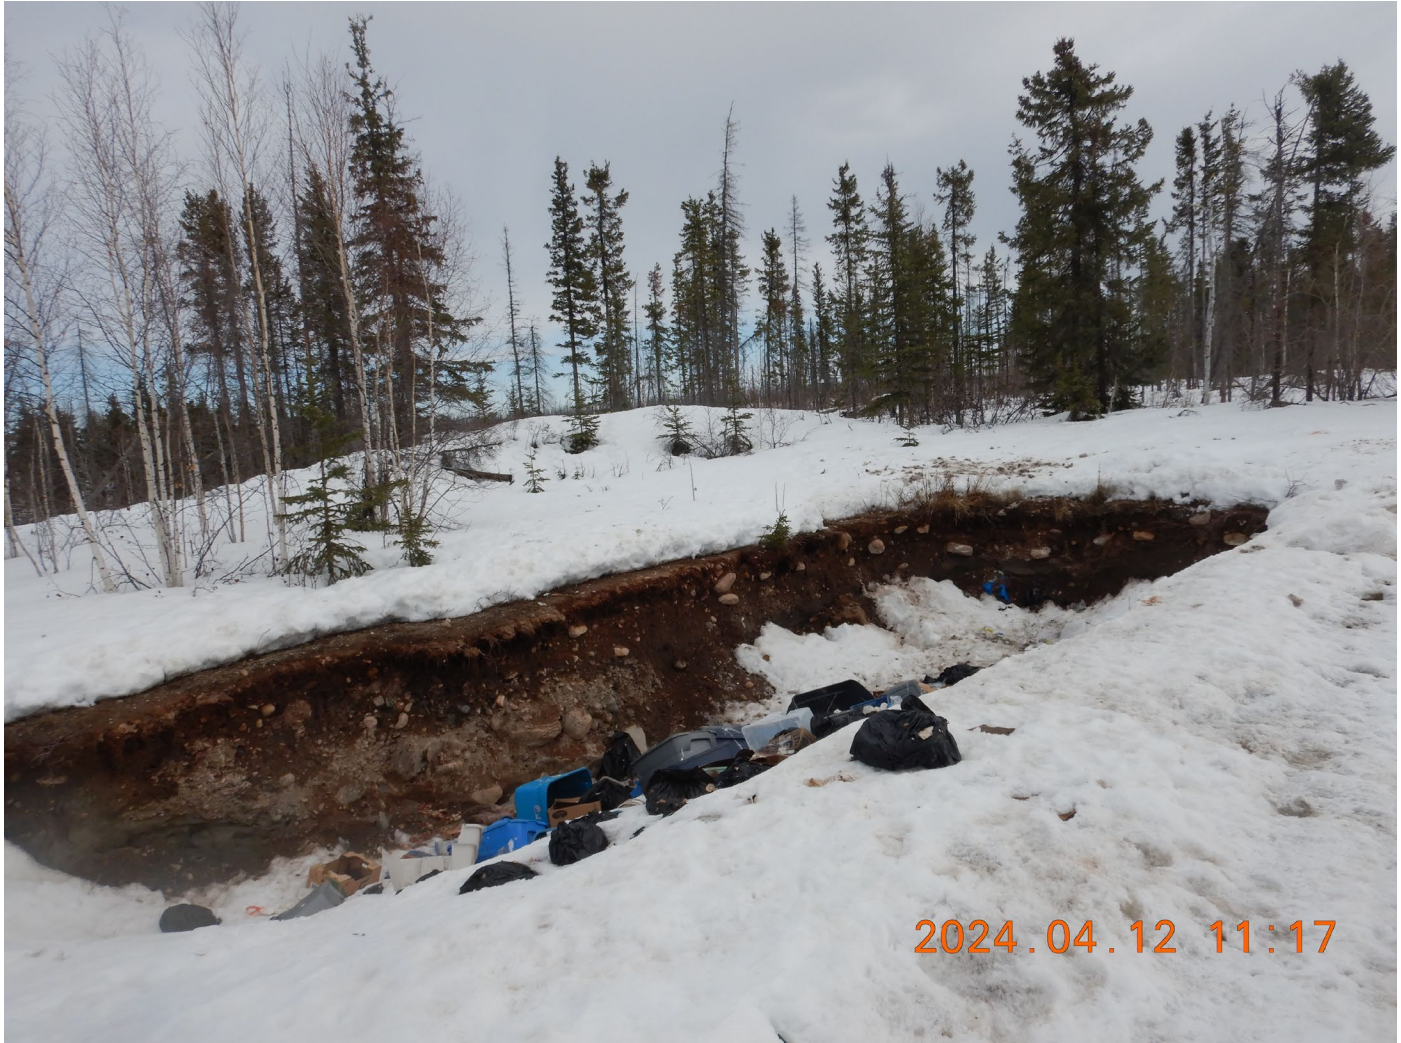
Photo 3: Bagged sewage disposal area. Avoid disposing of hard plastics in this area.

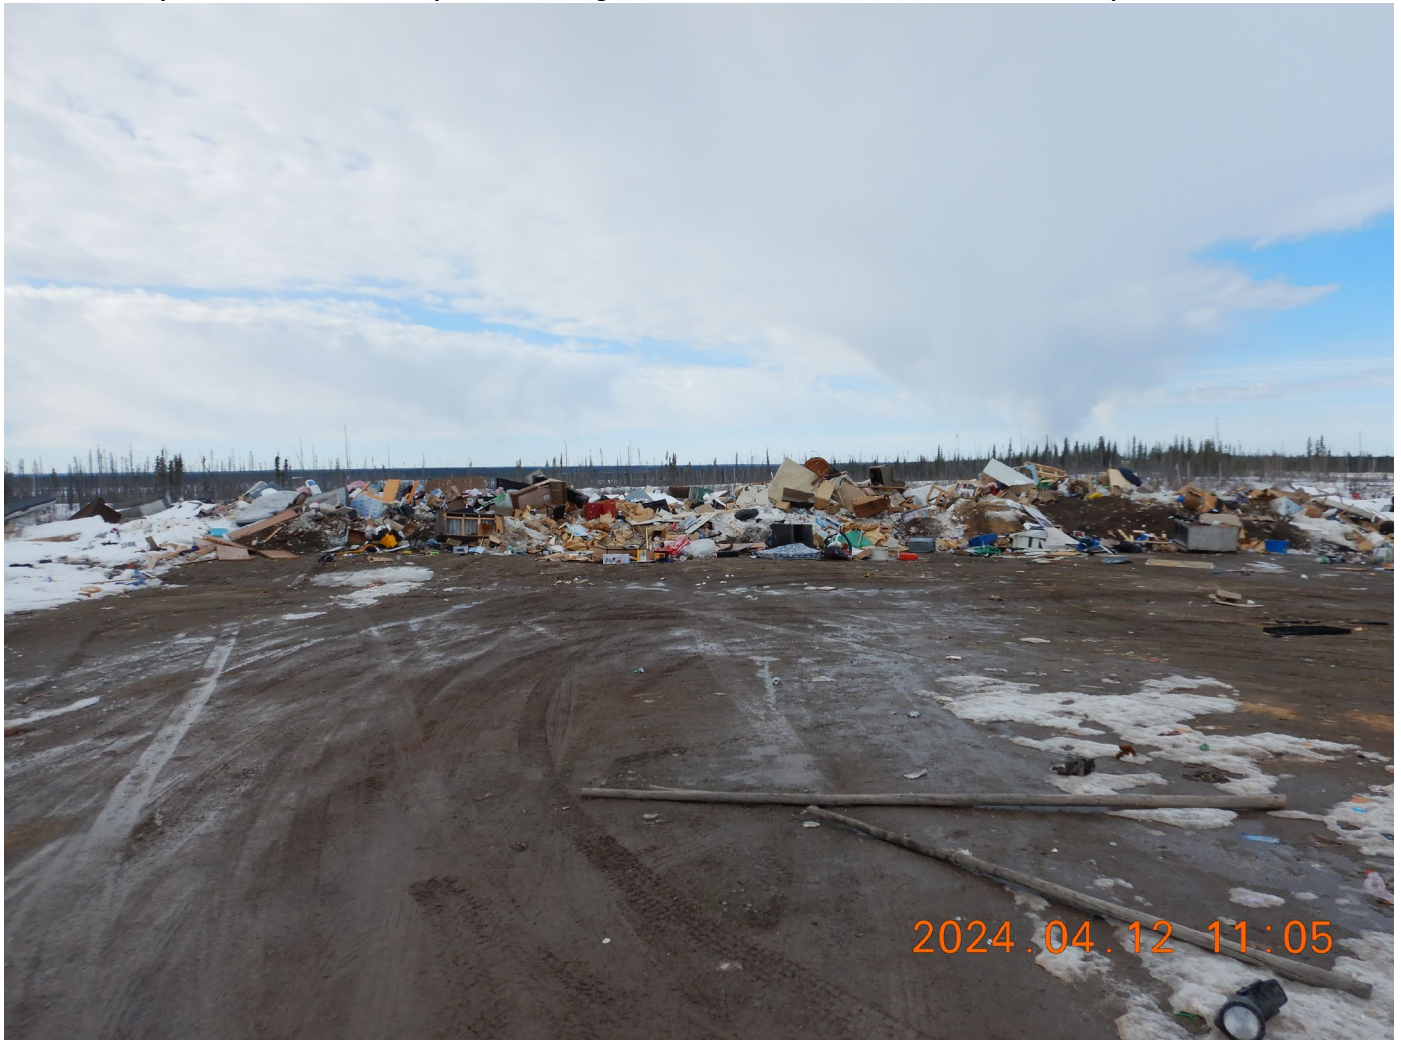
Both solid waste facilities were inspected (Photos 4-6). It appears that regular household waste items are being disposed of at the construction waste and bulky waste disposal area on a regular basis. Regular house hold waste items must be disposed of at the trench disposal area during future operations.

**Explanatory Remarks:** Although there was still a significant amount of snow cover, it appears that the construction waste disposal area is being used for the disposal of regular household wastes. All regular household waste items must be disposed of in the trenched disposal area and the area of concern is reserved for larger waste items and construction waste.

Photo 4: Bulky/Construction waste disposal area. Regular household waste items should not be disposed of at this location.

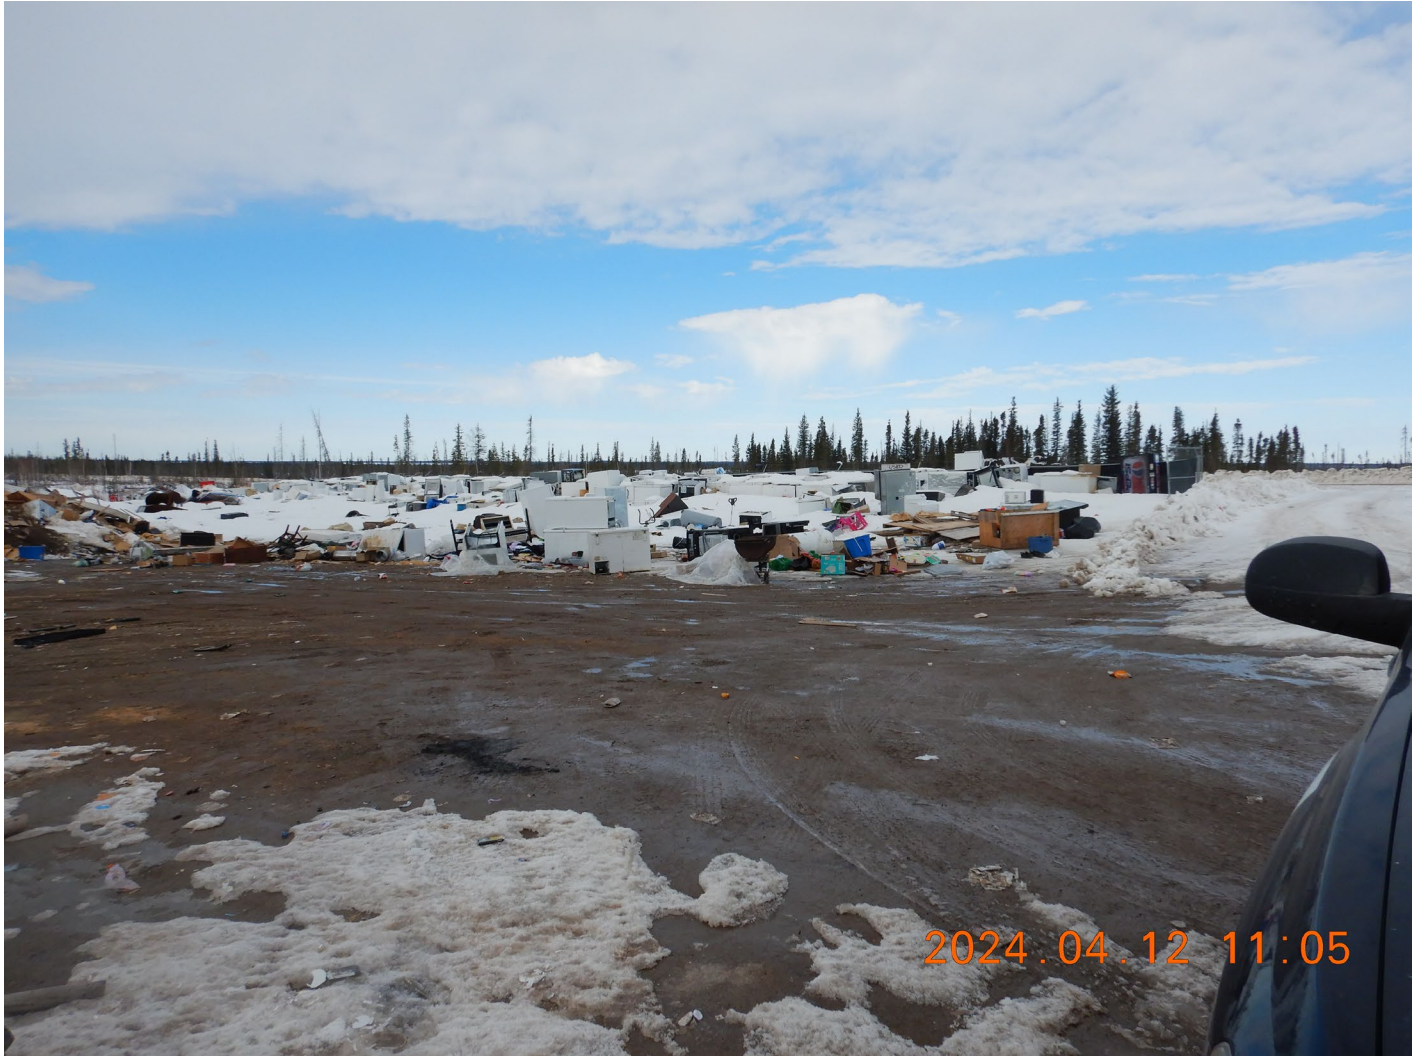
Photo 5: Better segregation of bulky wastes is required.

The bulky waste area requires better segregation of waste types and the area must be covered to prevent windblown waste from being scattered.

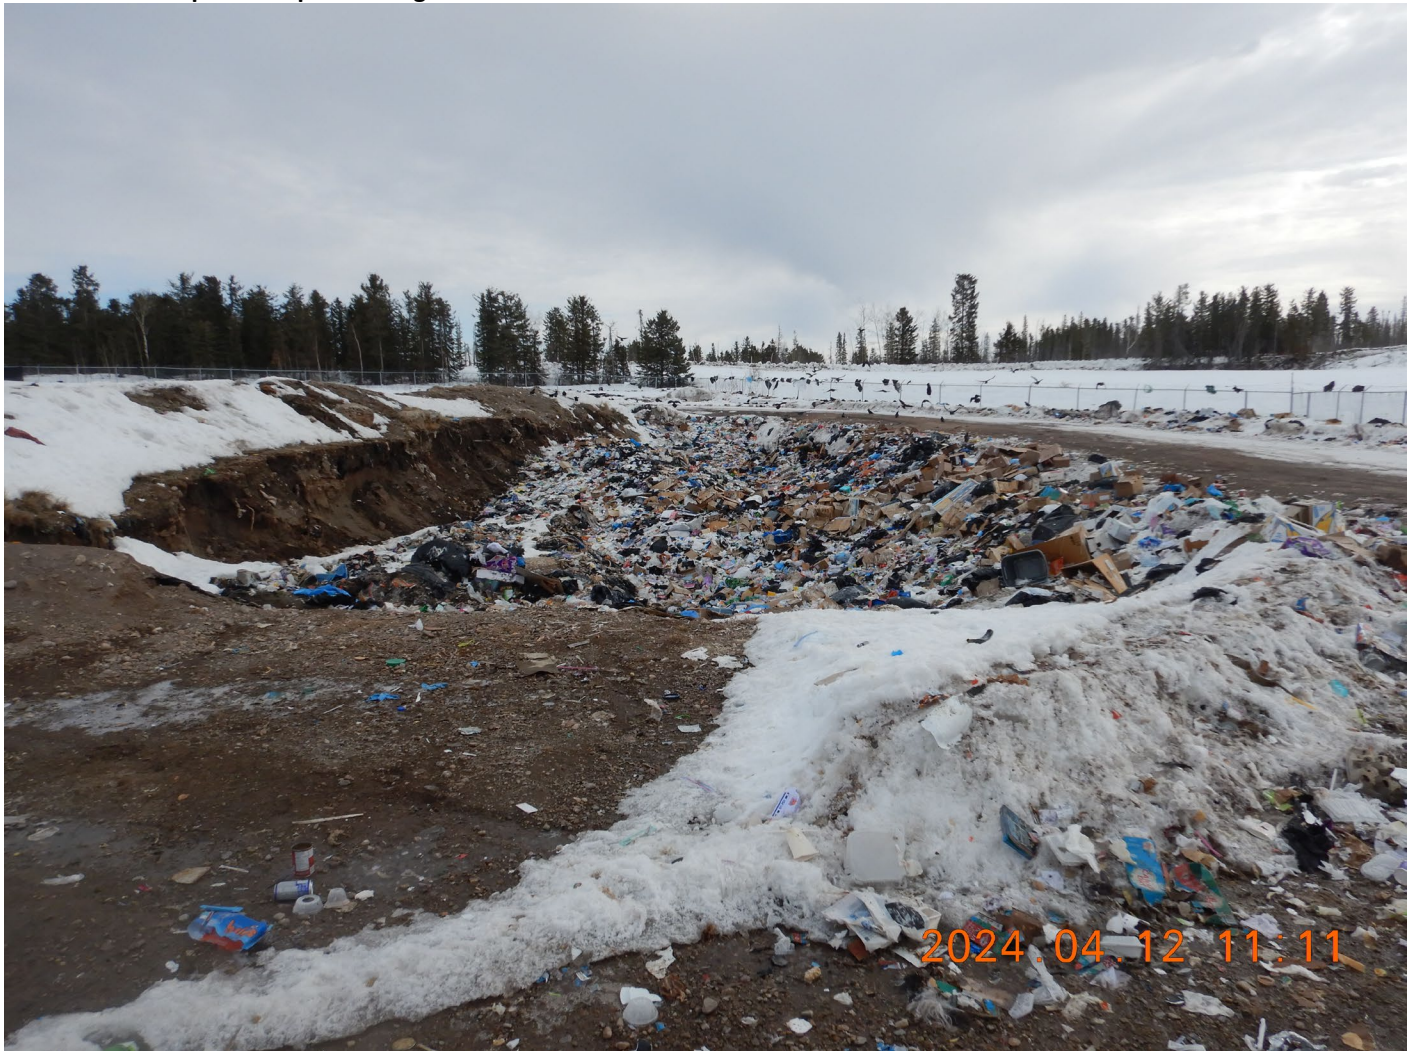
Photo 6: Trench pit for disposal of regular household waste.
