| <b>File Number</b> | <b>W2017L3-0002</b> |
| <b>Type of Operation</b> | <b>CLASS B - MUNICIPAL</b> |
| <b>Location</b> | <b>Whatì, NT</b> |

### MUNICIPAL WATER USE INSPECTION REPORT

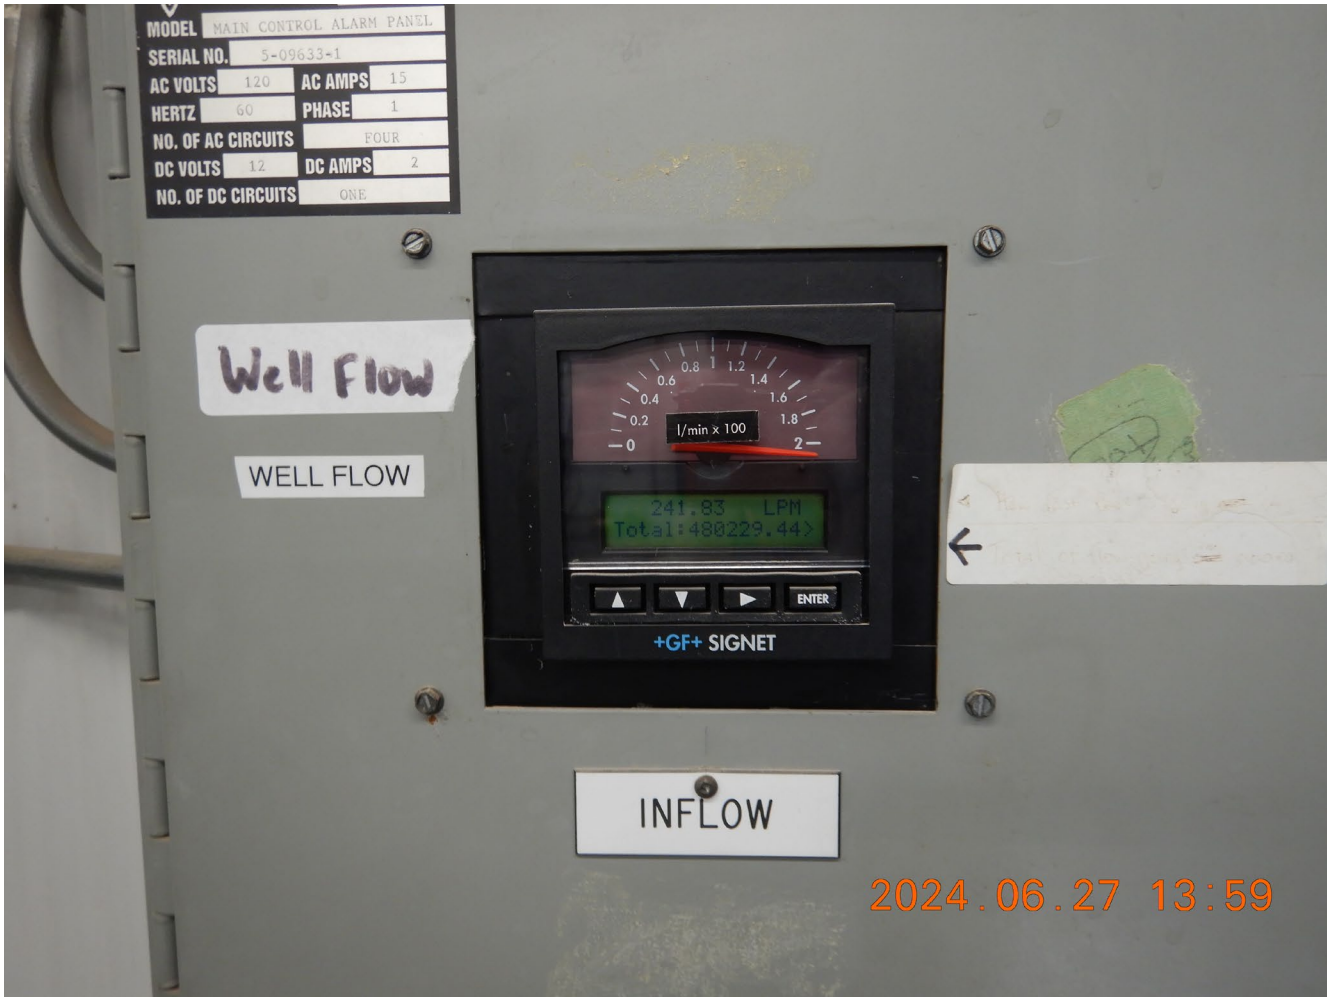
Photo 1: Meter for well water.

The water intake facilities (Photos 1-3) were inspected and found to be in good condition. All meters used to measure water volumes were operational and logbooks were up-to-date. No concerns were identified at this location.

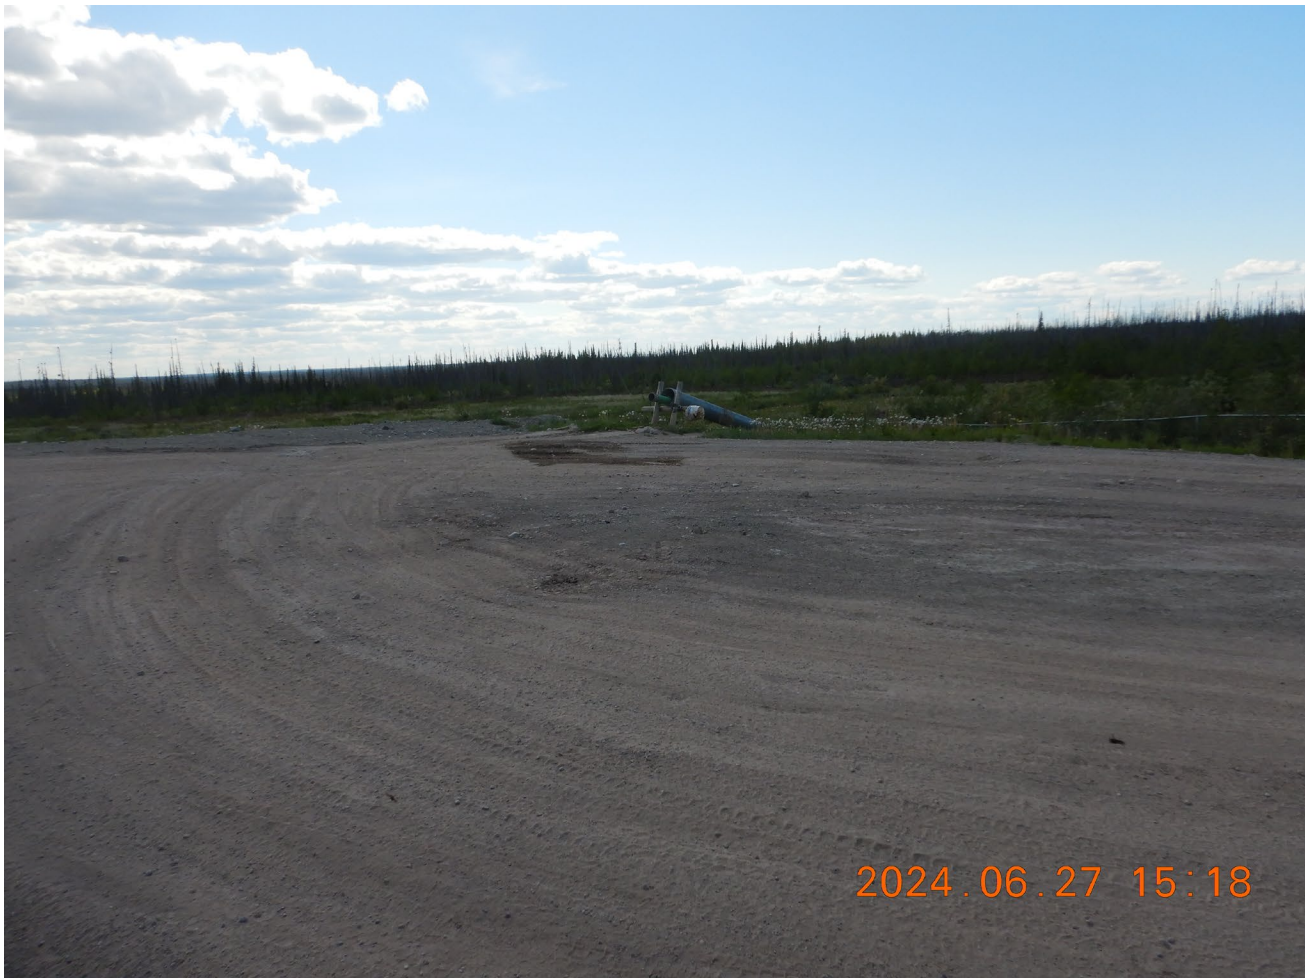
Photo 4: Sewage outfall.

No concerns were identified at the sewage disposal location (Photo 4).

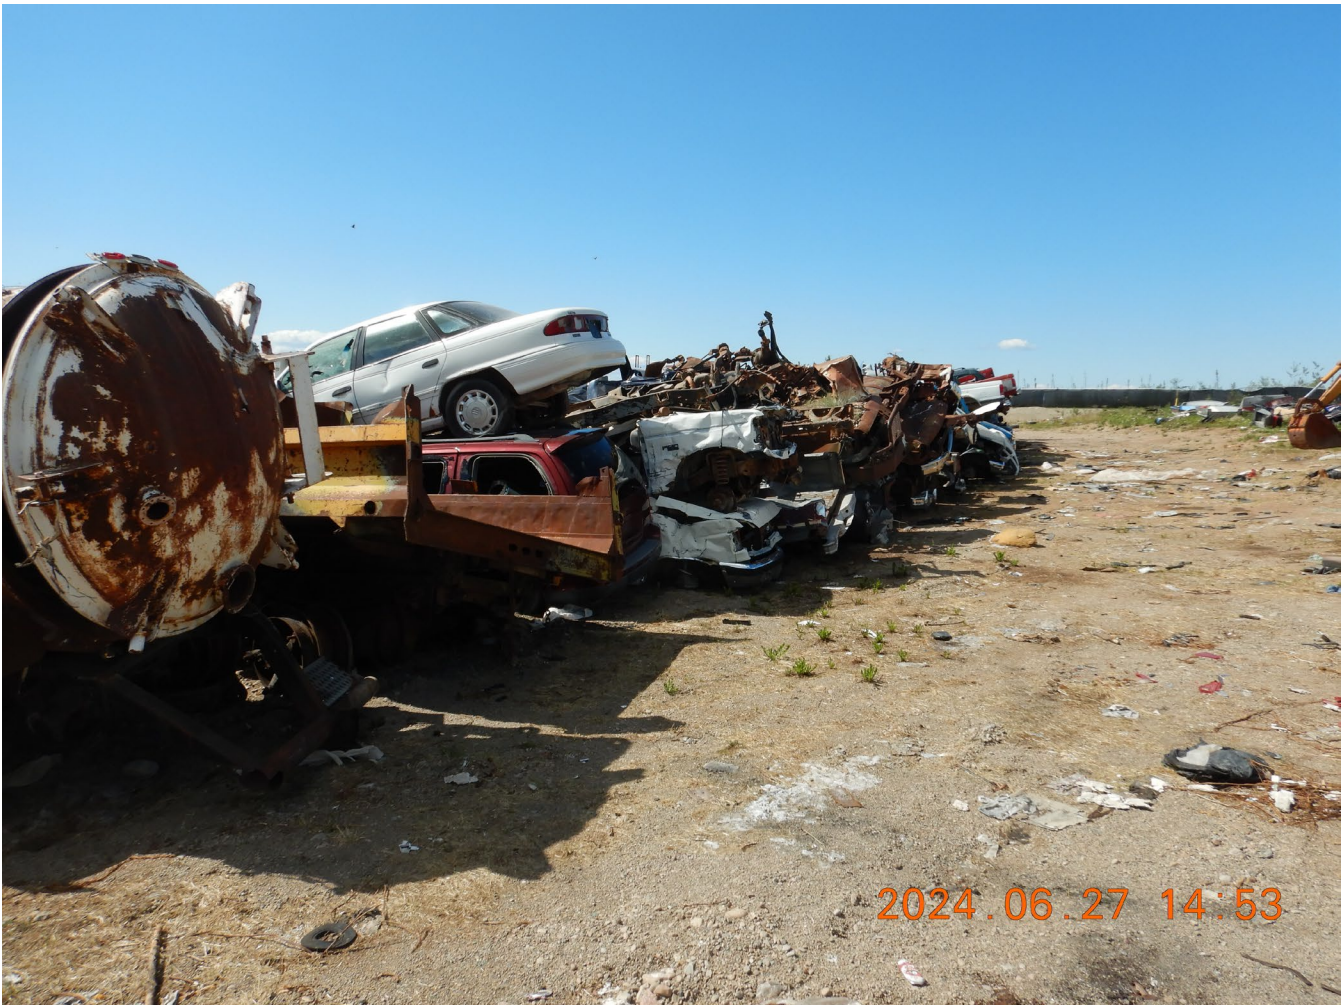
Photo 5: Vehicles with hazardous wastes removed.

Both solid waste facilities were inspected. At the bulky waste disposal area, all vehicles had been stripped of hazardous wastes and staged for removal (Photo 5), all appliances had been stripped of refrigerant (Photo 6), and all fuel tanks had been emptied, cut up and staged for removal (Photo 7).

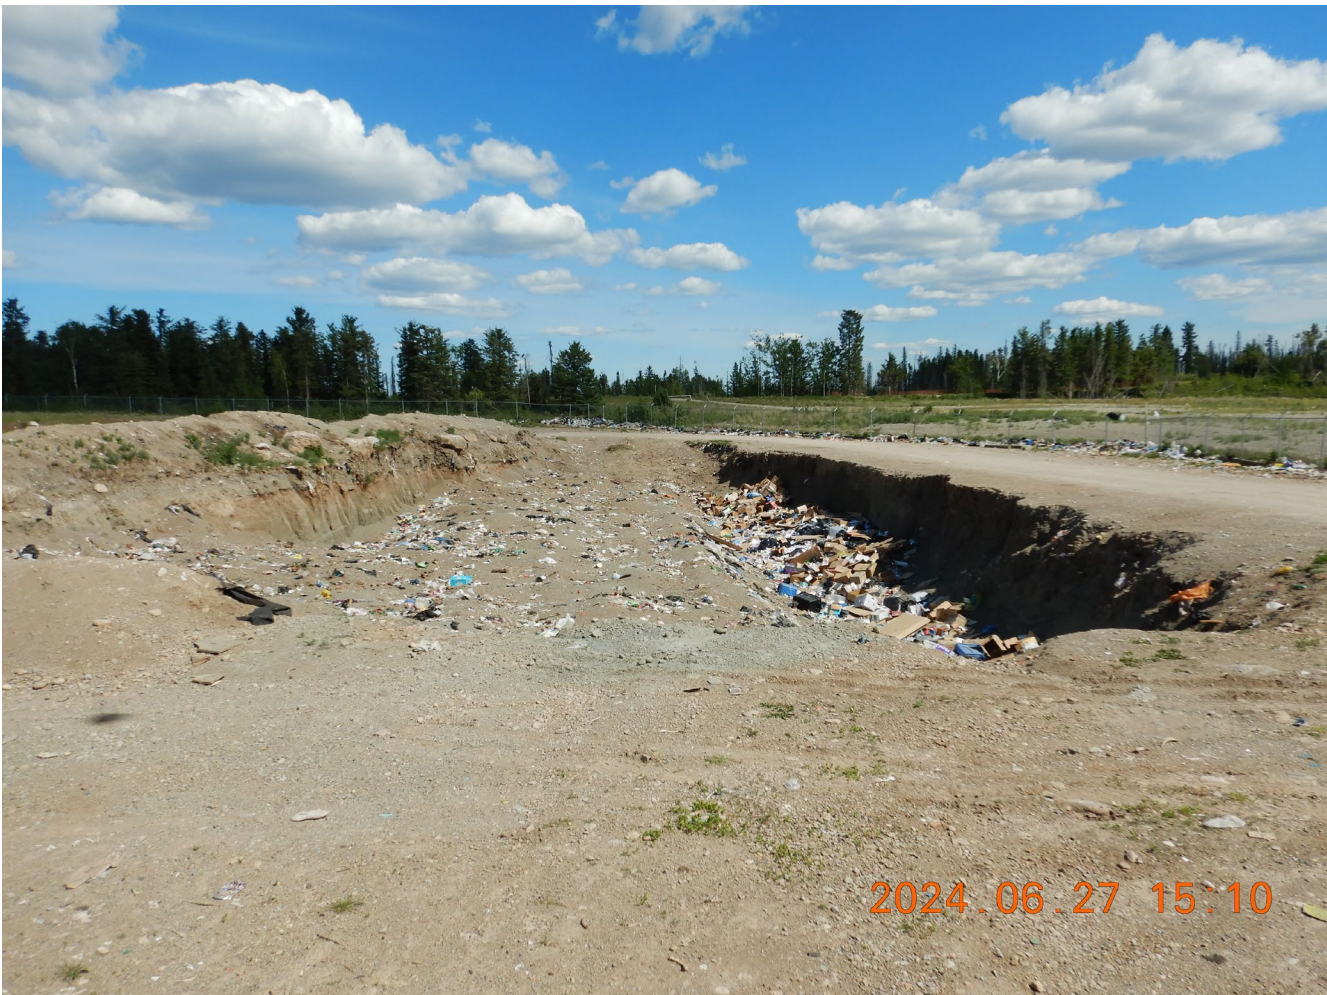
Photo 8: Household waste disposal area.

The household waste disposal area was well managed (Photo 8). The burn tanks were not operational at the time of inspection (Photo 9). Propane cannisters at the solid waste disposal area were de-valved and ready for disposal (Photo 10).
