File Number W2018L3-0001
Type of Operation CLASS B - MUNICIPAL
Location Gamètì, NT

WATER USE INSPECTION REPORT

LICENCE #:	W2018L3-0001	EXPIRY DATE:	December 21 st , 2028
LICENCEE:	Tłjichq Community Government of Gamètì	PREVIOUS INSPECTION:	September 19, 2024
COMPANY REP:	Richard Leong	INSPECTION DATE:	February 12, 2025

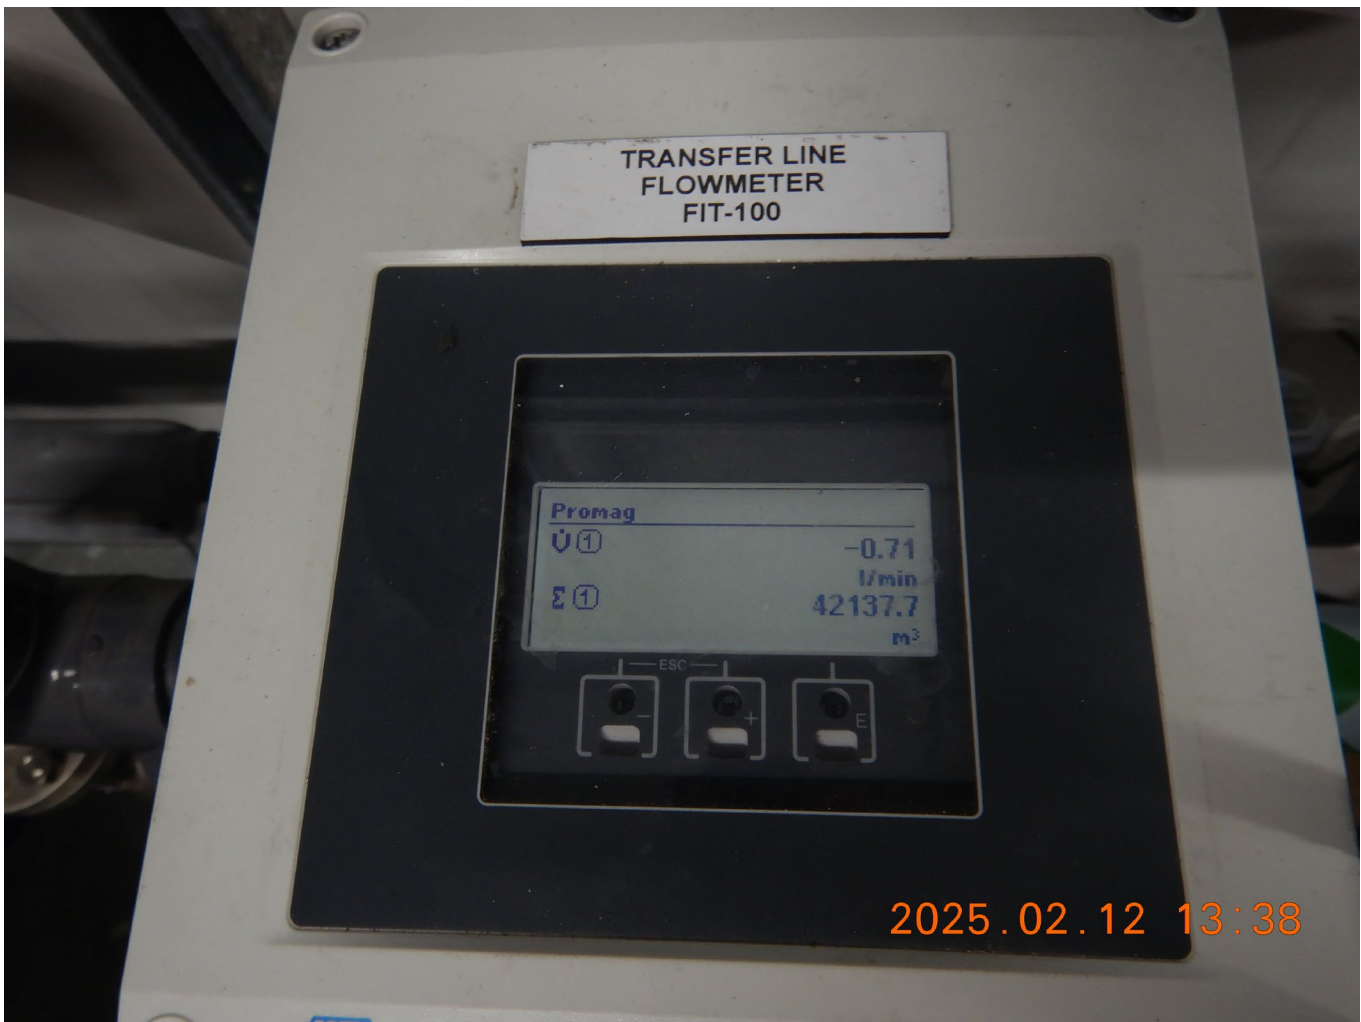
Photo 1: Meter was operational.

The meter in the water treatment plant appears to have stopped working properly as the reading is identical to last inspection from September 2024. If you have any questions, please contact me at 867-767-9187 ext. 24187.

The water supply facilities were inspected and no major issues were noted. Sensors were all online, log books were being filled out (Photo 1), and chemicals were stored appropriately (Photo 2). Meters appeared operational but the meter reading is identical to the reading from the previous inspection. The meter must be repaired immediately (Photo 3).

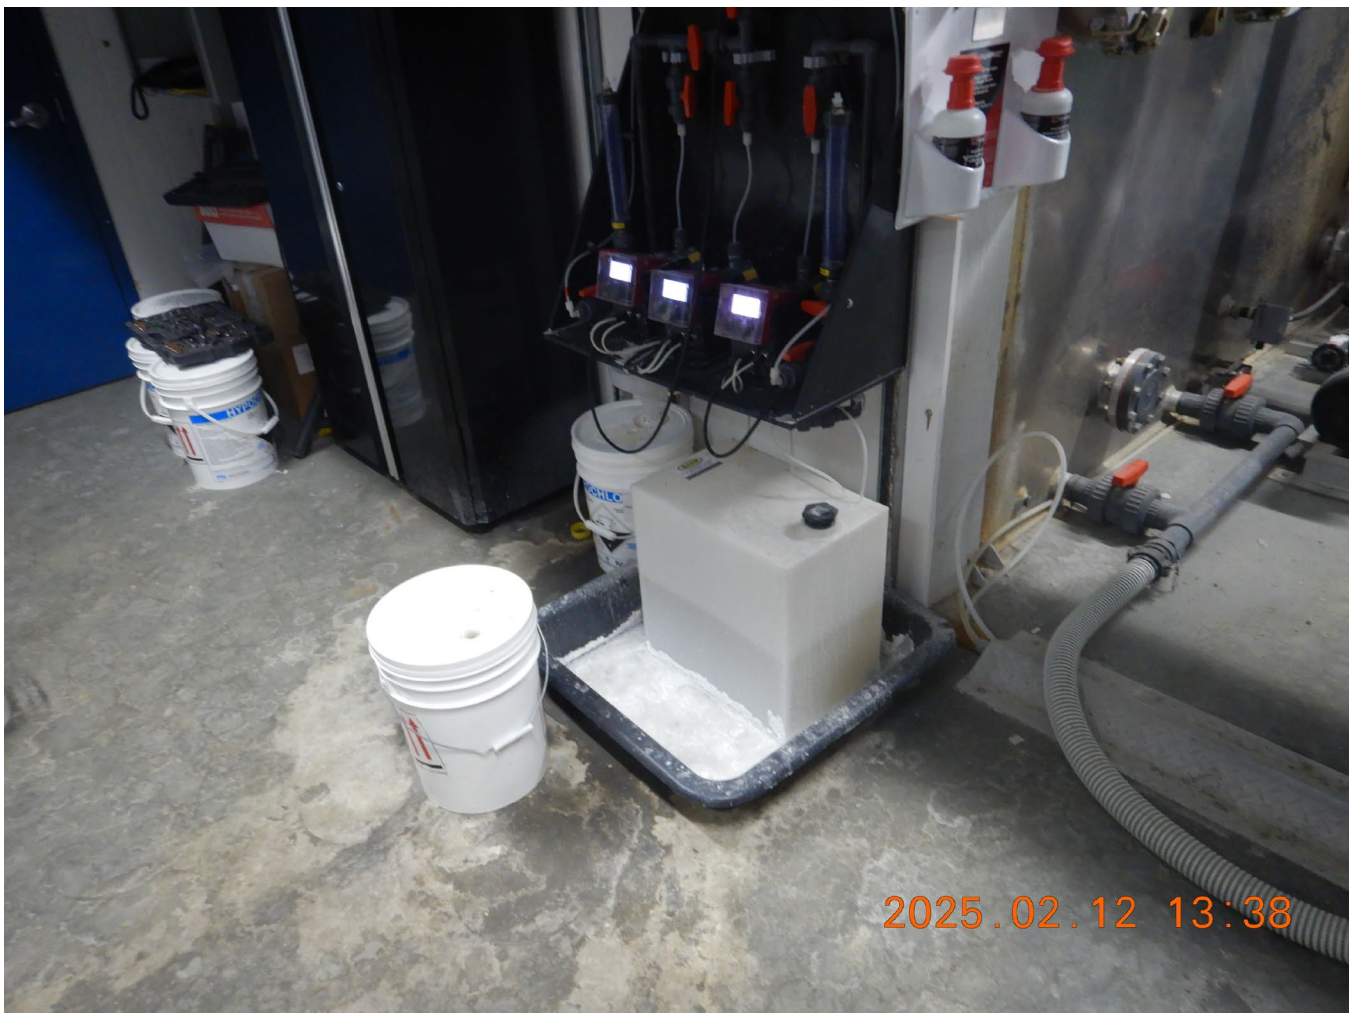
Photo 2: Chemicals stored properly.

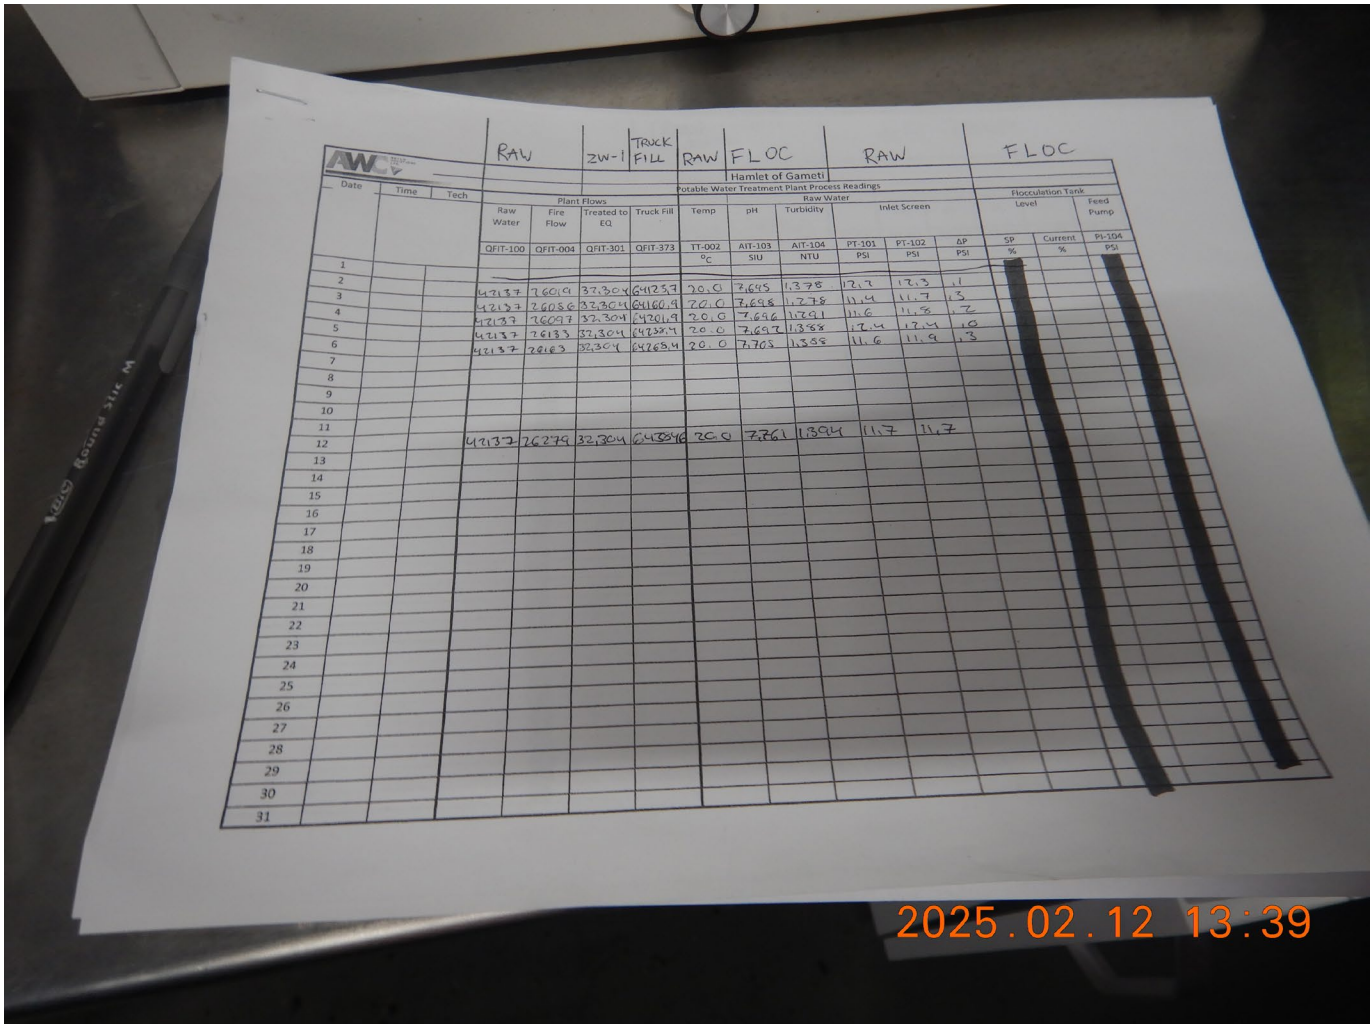
Photo 3: Logbook was being filled out.

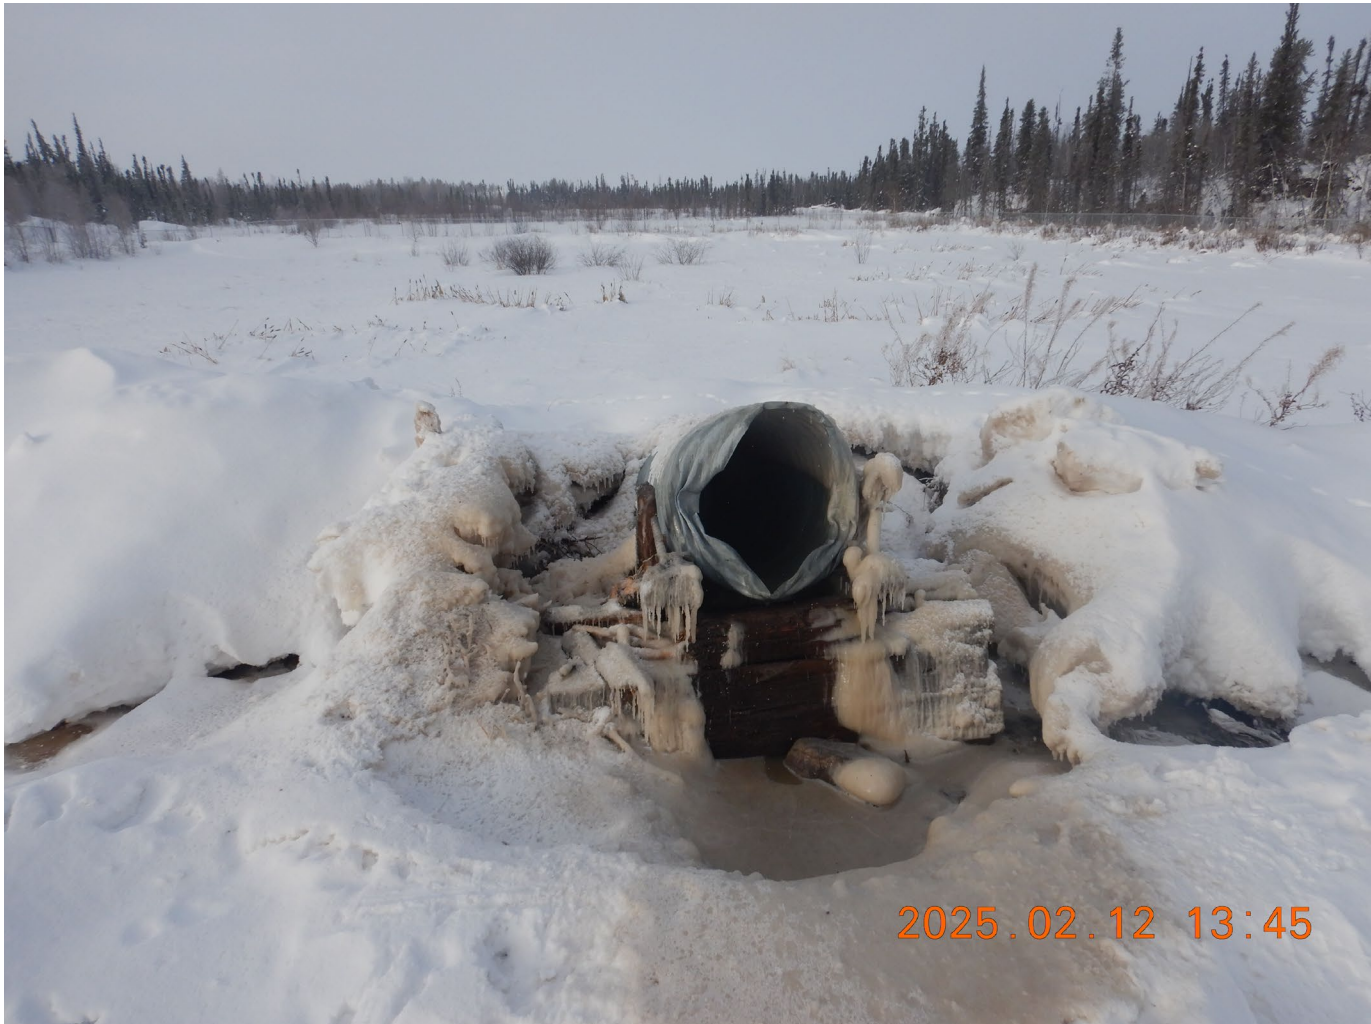
The lagoon appeared to be in working order (Photo 4). It appears that the outfall piping is damaged causing some sewage effluent to be discharged in the wrong location, although this is not an environmental concern due to the design of the lagoon, repairs should be made and efforts to discharge sewage in the proper location must be made.

Photo 4: Lagoon. Better efforts to direct sewage to the primary cell must be made.

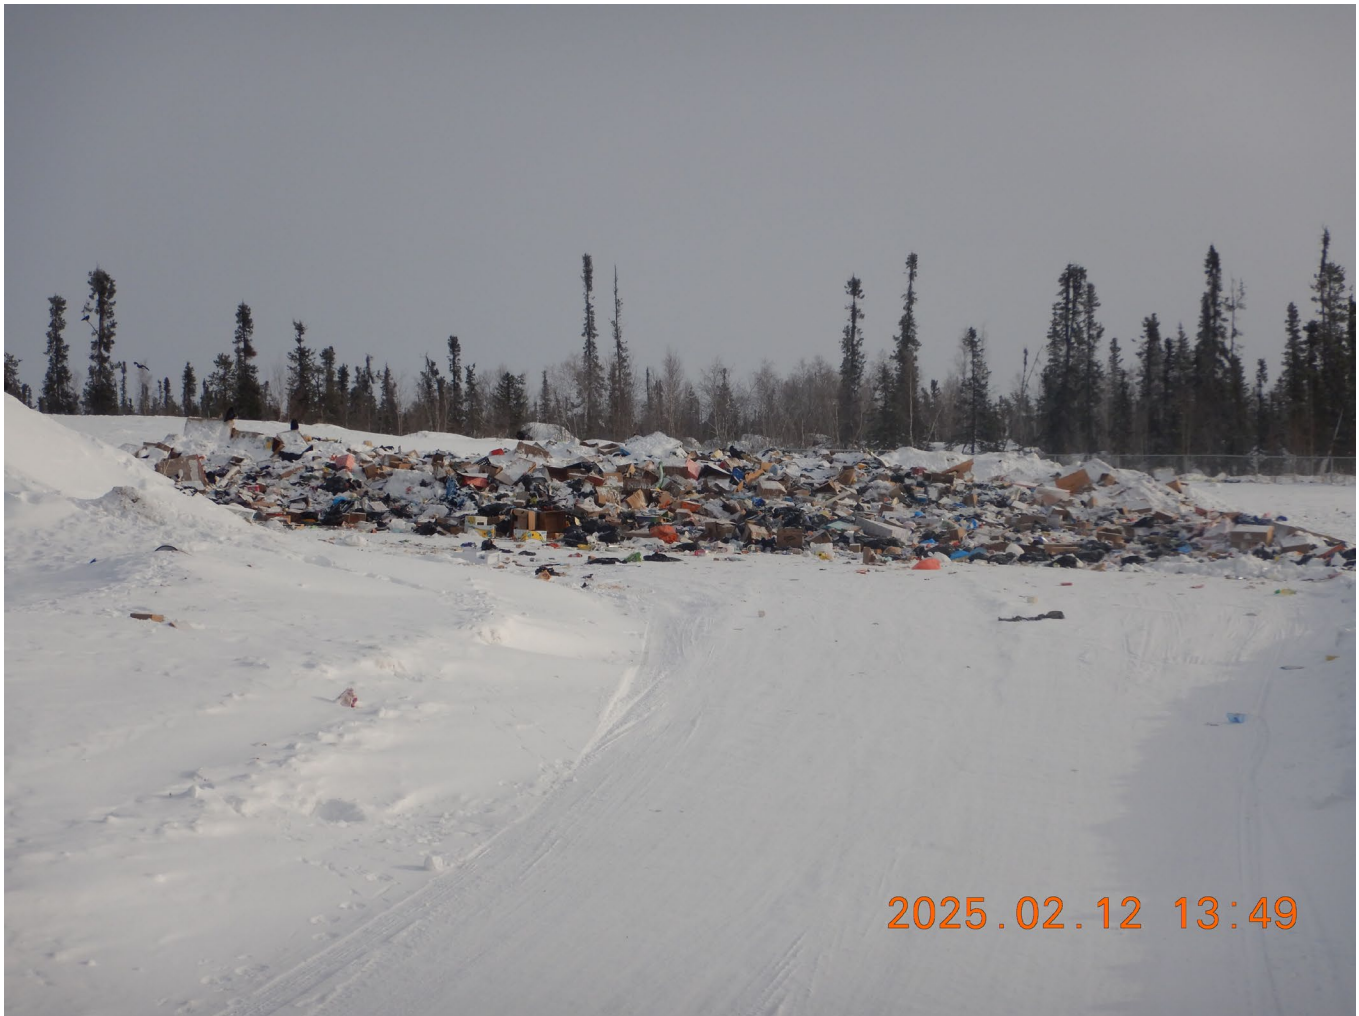
The landfill was inspected and no major concerns were identified at this location (Photo 5). Waste segregation was excellent (Photos 6). Access to the waste segregation area was minimal which may make segregation during winter months difficult.

Photo 5: No unauthorized waste items were identified at the solid waste facility.

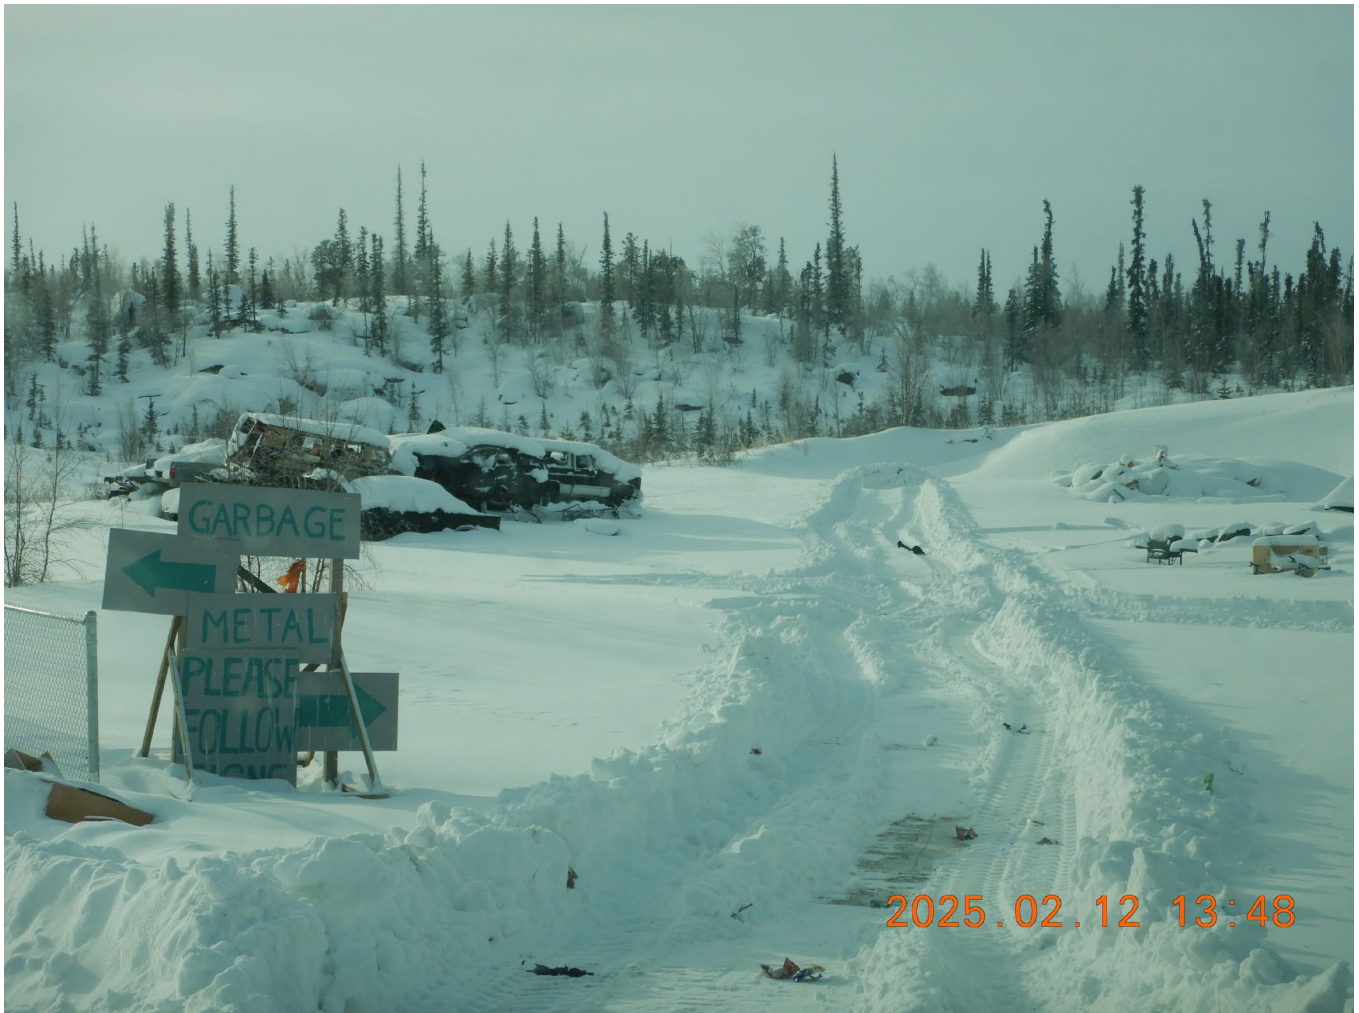
Photo 6: Waste segregation. Access to the waste segregation area could be improved.
