File Number **W2018L3-0001**
Type of Operation **CLASS B - MUNICIPAL**
Location **Gamètì, NT**

An inspection of the above noted operation was conducted on June 2, 2023 by Water Resource Officer Meaghan MacIntyre-Newell and Water Resource Officer Meg McCluskie. Enclosed is a copy of the municipal water use inspection report. Danny Rabesca of the Community Government of Gamètì accompanied the Inspectors to complete the inspection.

MUNICIPAL WATER USE INSPECTION REPORT

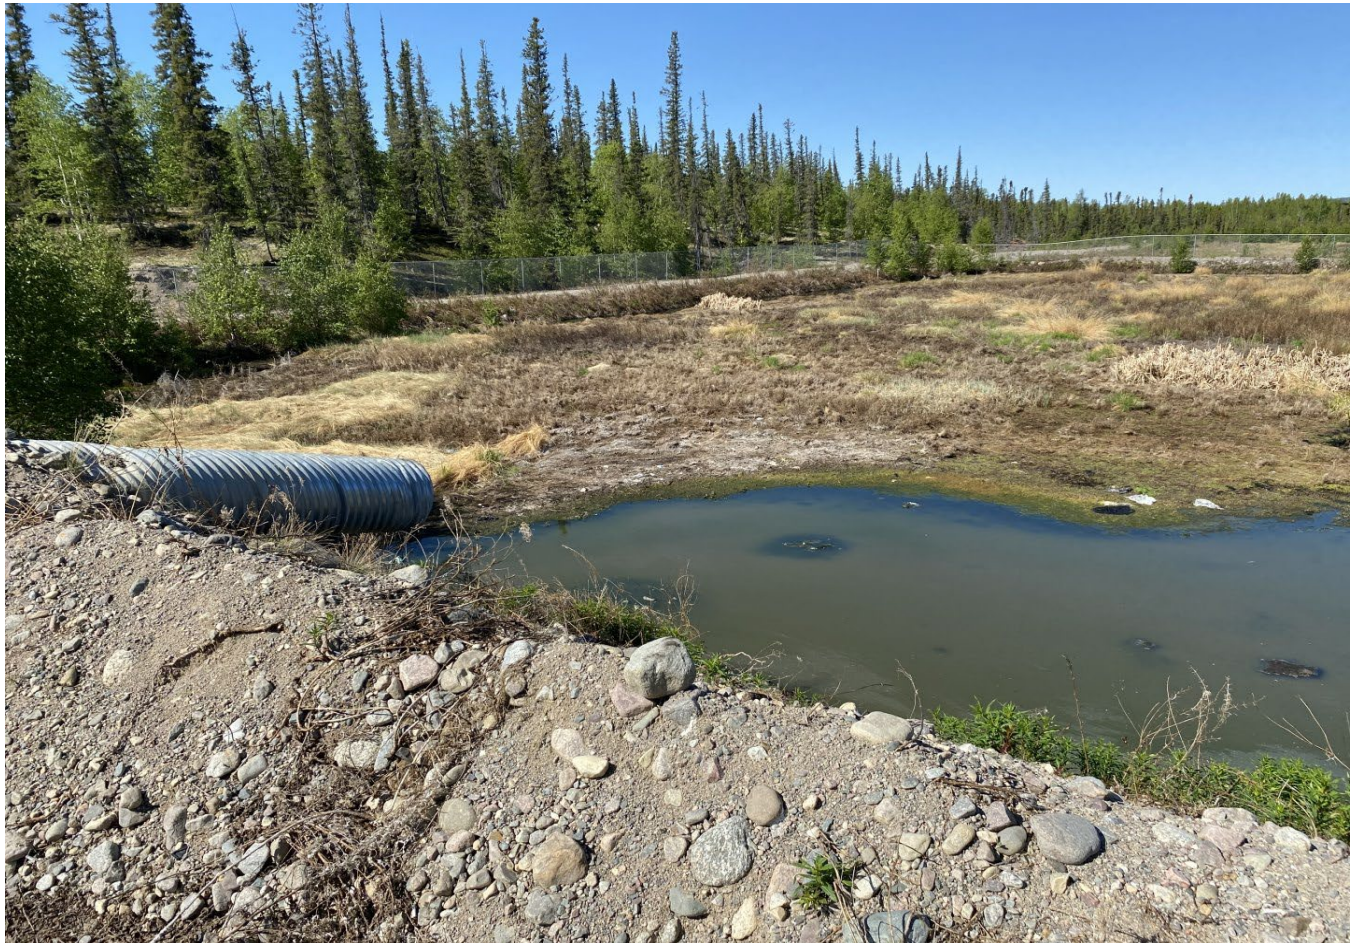
The existing sewage lagoon appears to be working very well. Freeboard levels in the lagoon were acceptable, truck off-loading structures appeared to be well maintained, and infiltration berms appear to be operating effectively (Figure 1).

Figure 1 – Discharge location and infiltration berm

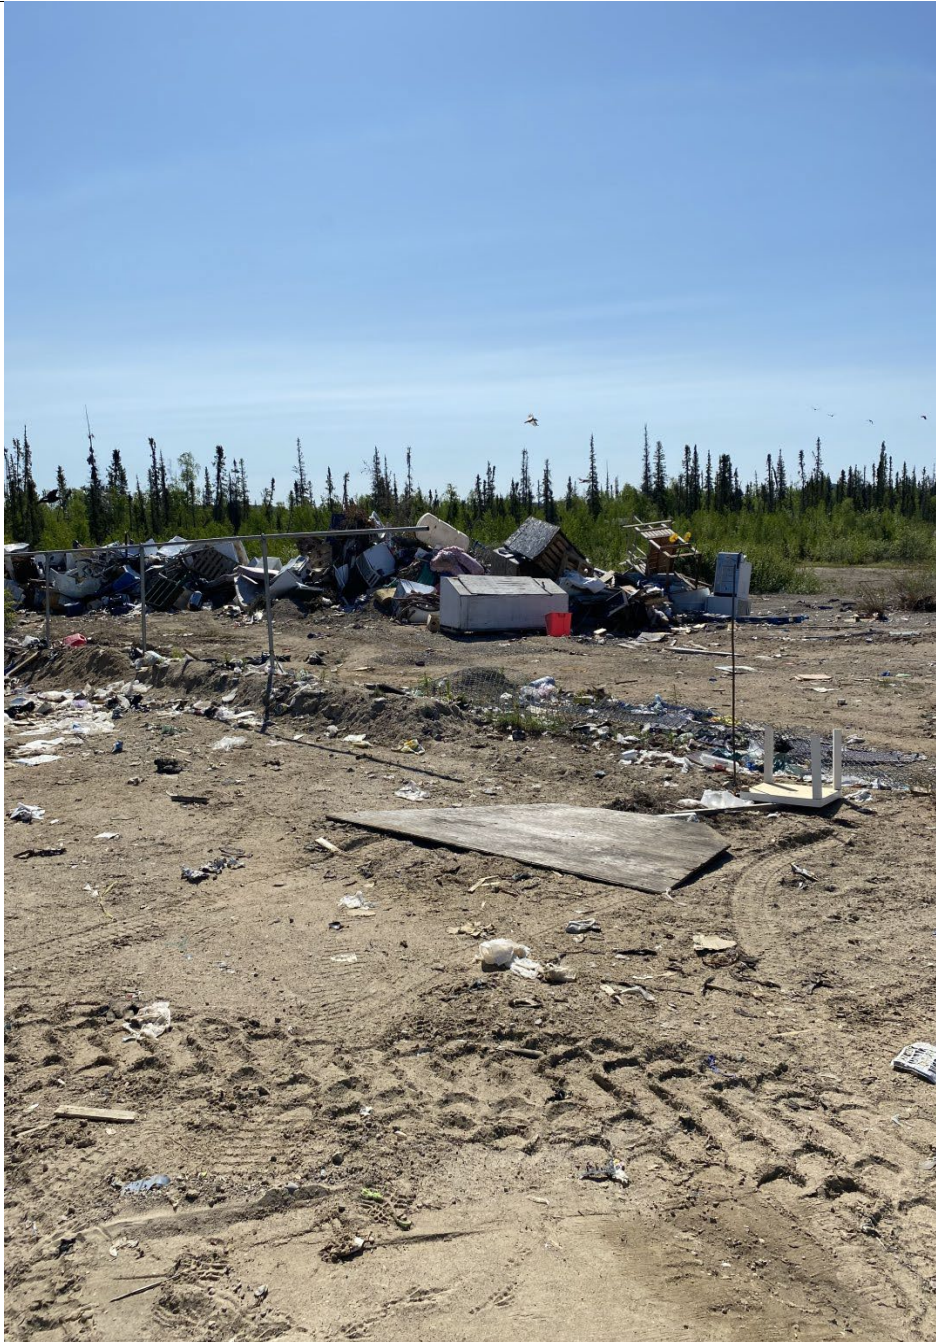
The landfill was inspected and found to be in acceptable condition. It appears that waste is being segregated appropriately prior to entering the landfill. The Inspector noted there was a significant amount of windblown waste and several sections of fence were either broken or missing (Figure 2 and Figure 3). The Inspector recommends repairing the broken fence and conducting a cleanup of the windblown waste. Historically, a clean-up of windblown waste was conducted annually, however, the representative that accompanied the Inspector was unaware of a clean-up in 2023.

Figure 2 - Fencing the requires repair

Explanatory Remarks: As noted in the above report, fencing around the Solid Waste Facility had sections that were damaged and/or missing. These must be repaired or replaced to capture windswept Waste, deter wildlife, and prevent unauthorized persons from entering the site.

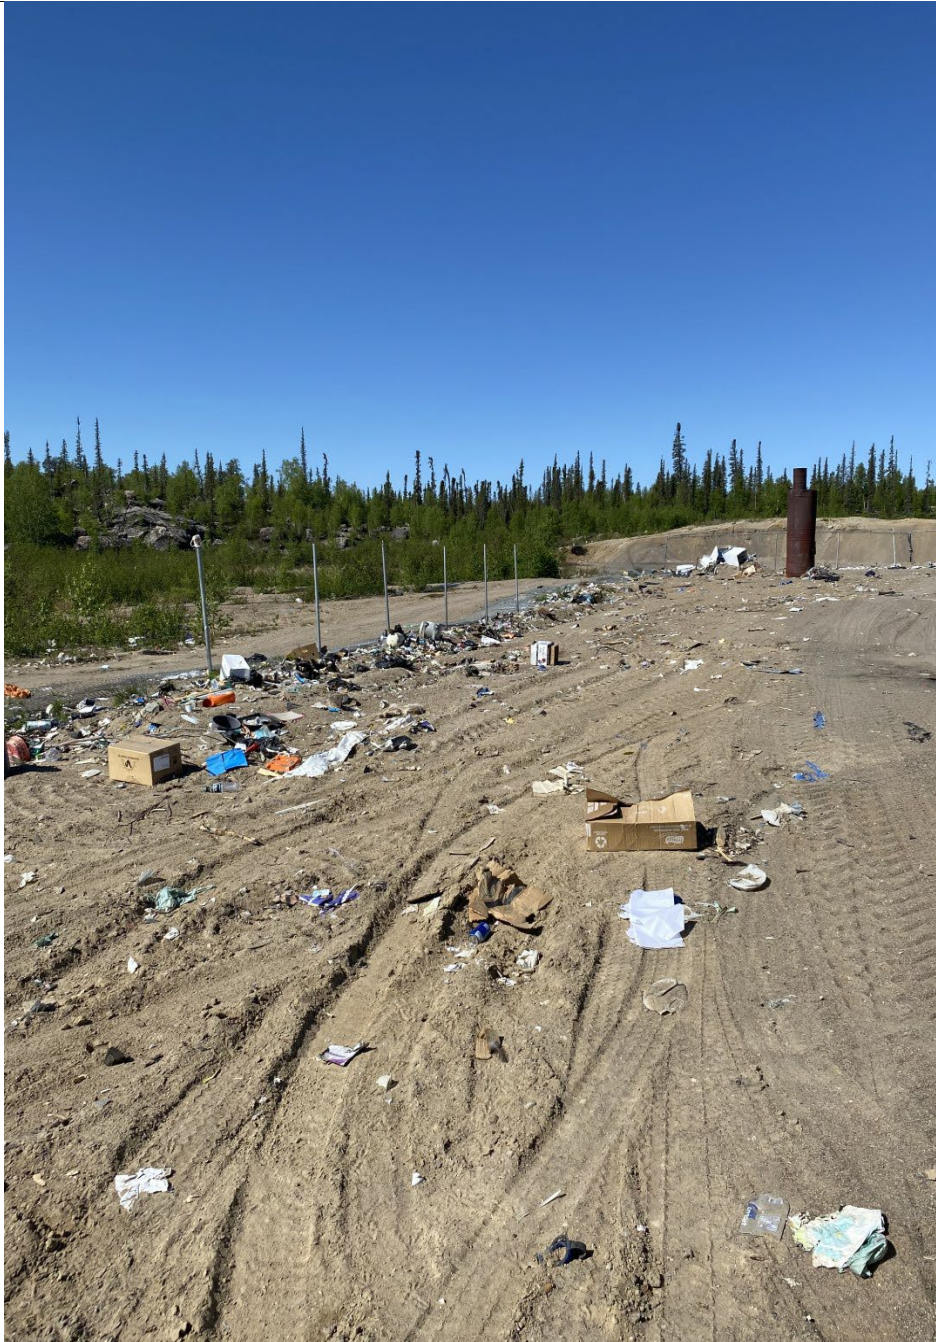
Figure 3 - Windblown waste and missing fencing
