File Number	W2018L3-0001
Type of Operation	CLASS B - MUNICIPAL
Location	Gamètì, NT

WATER USE INSPECTION REPORT

LICENCE #:	W2018L3-0001	EXPIRY DATE:	December 21 st , 2028
LICENCEE:	Tłjchq Community Government of Gamètì	PREVIOUS INSPECTION:	June 2 nd , 2023
COMPANY REP:	Sherbaz Muhammad	INSPECTION DATE:	March 12 th , 2024

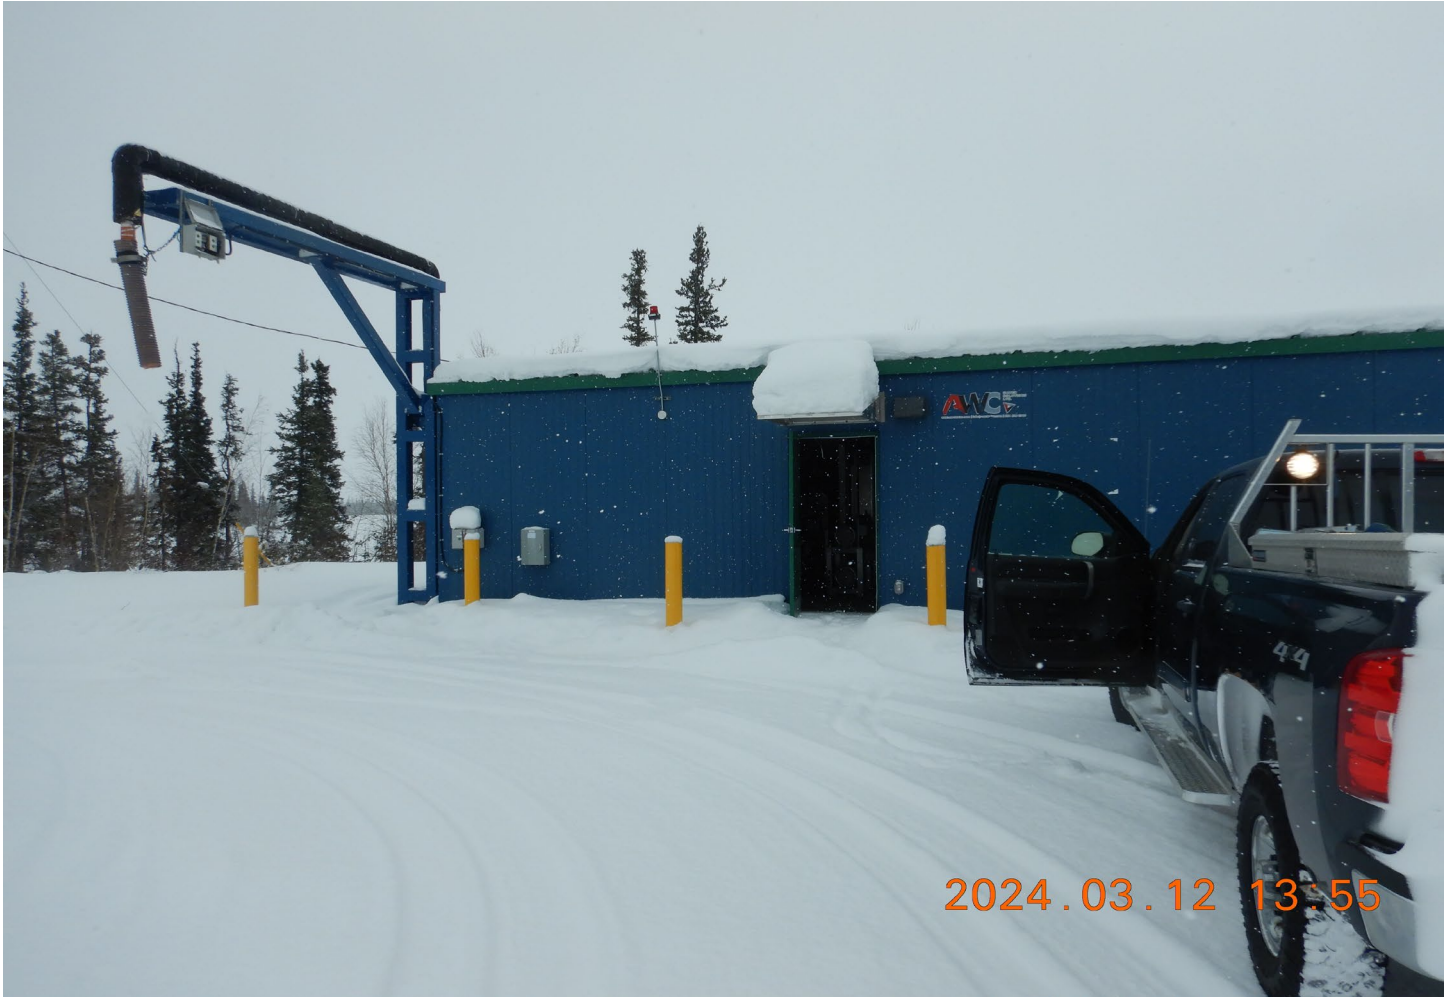
Photo 1: Water Treatment Plant.

The water supply facilities were inspected and no major issues were noted (Photo 1). Sensors were all online, log books were being filled out, and chemicals were stored appropriately. Meters were operational (Photo 2).

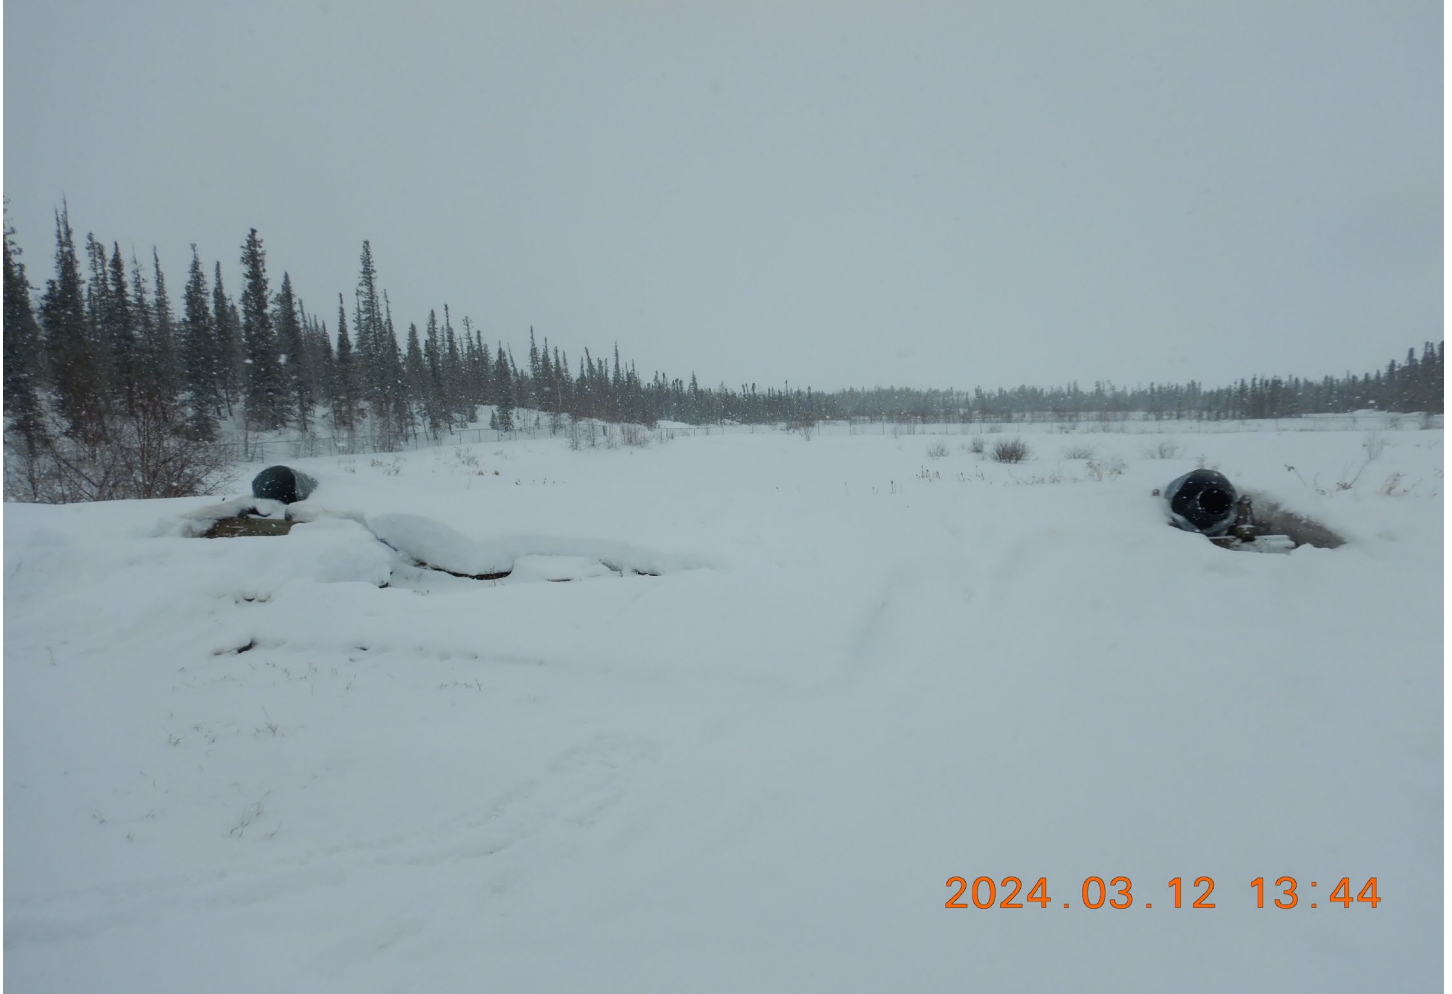
Photo 3: Sewage truck outfall.

The lagoon appeared to be in working order. Photo 3 shows the truck outfall. No concerns were identified at this location.

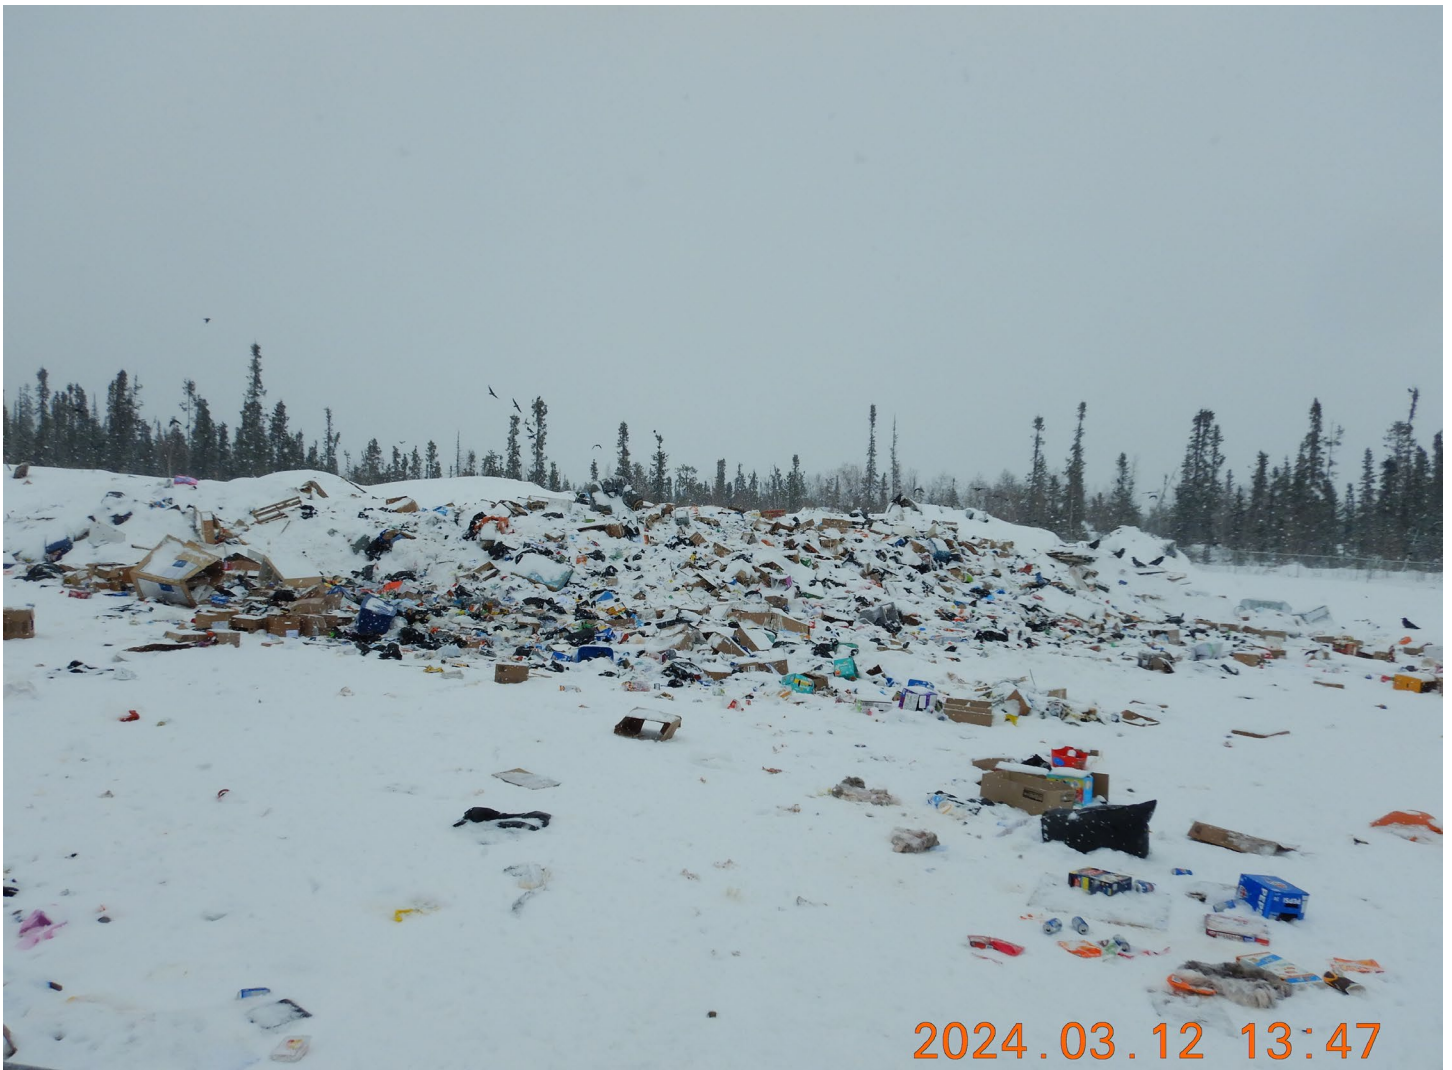
Photo 4: Landfill.

The landfill was inspected and no major concerns were identified at this location (Photo 4). Better segregation of white goods (appliances) is required and appliances with refrigerant (refridgerators, freezers) must not be disposed of prior to having the refrigerant properly removed (Photo 5).

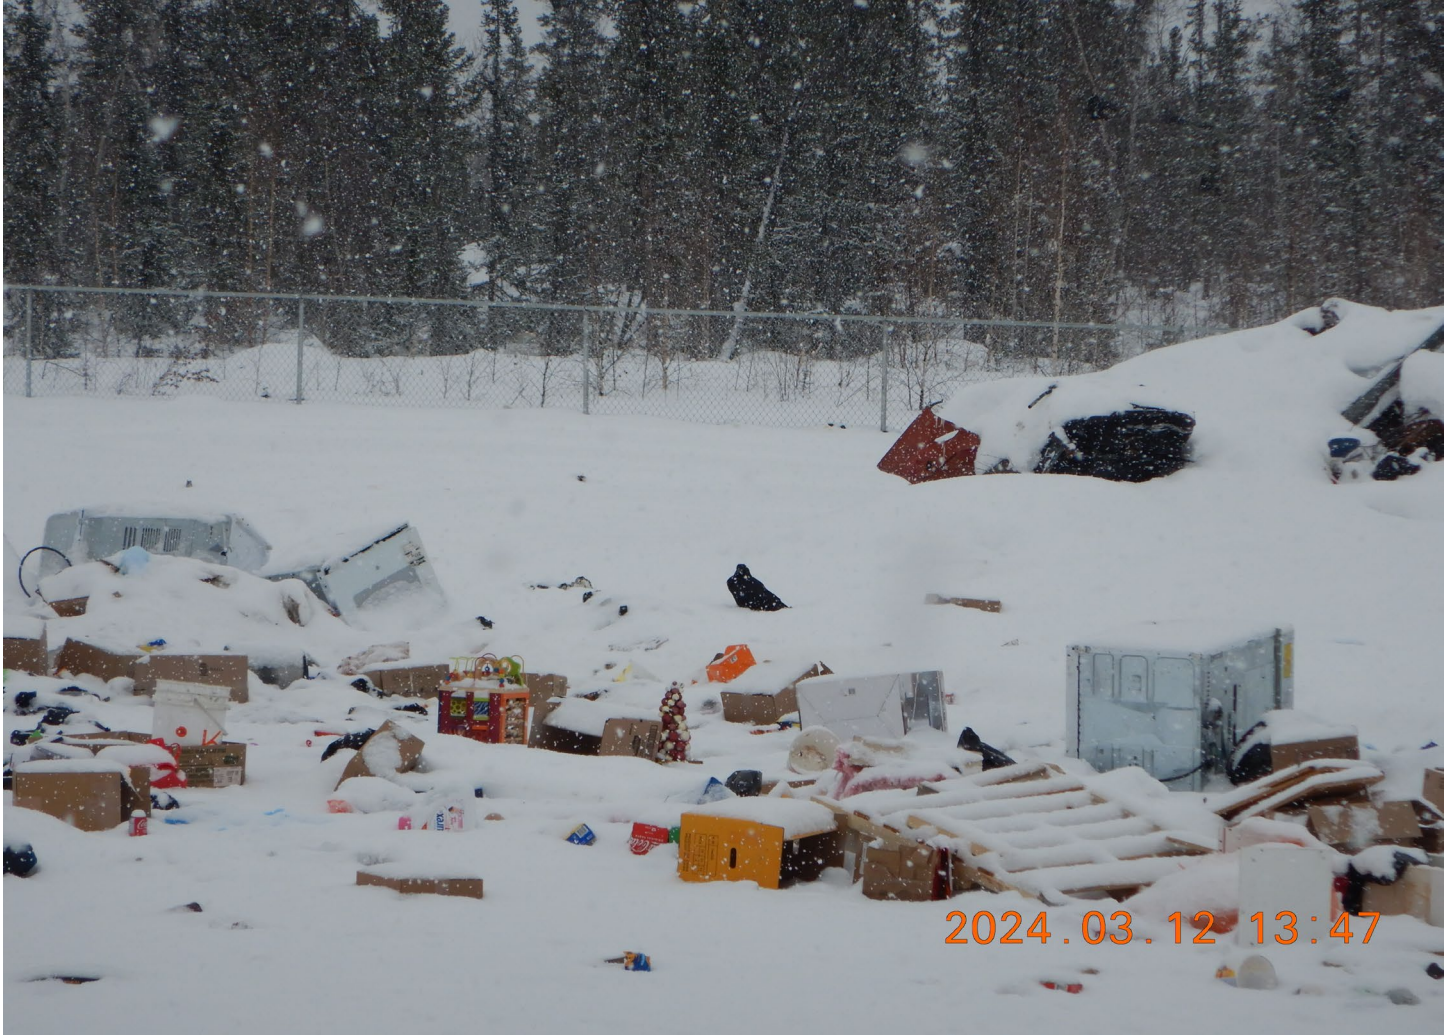
Photo 5: White goods appliances need better segregation.

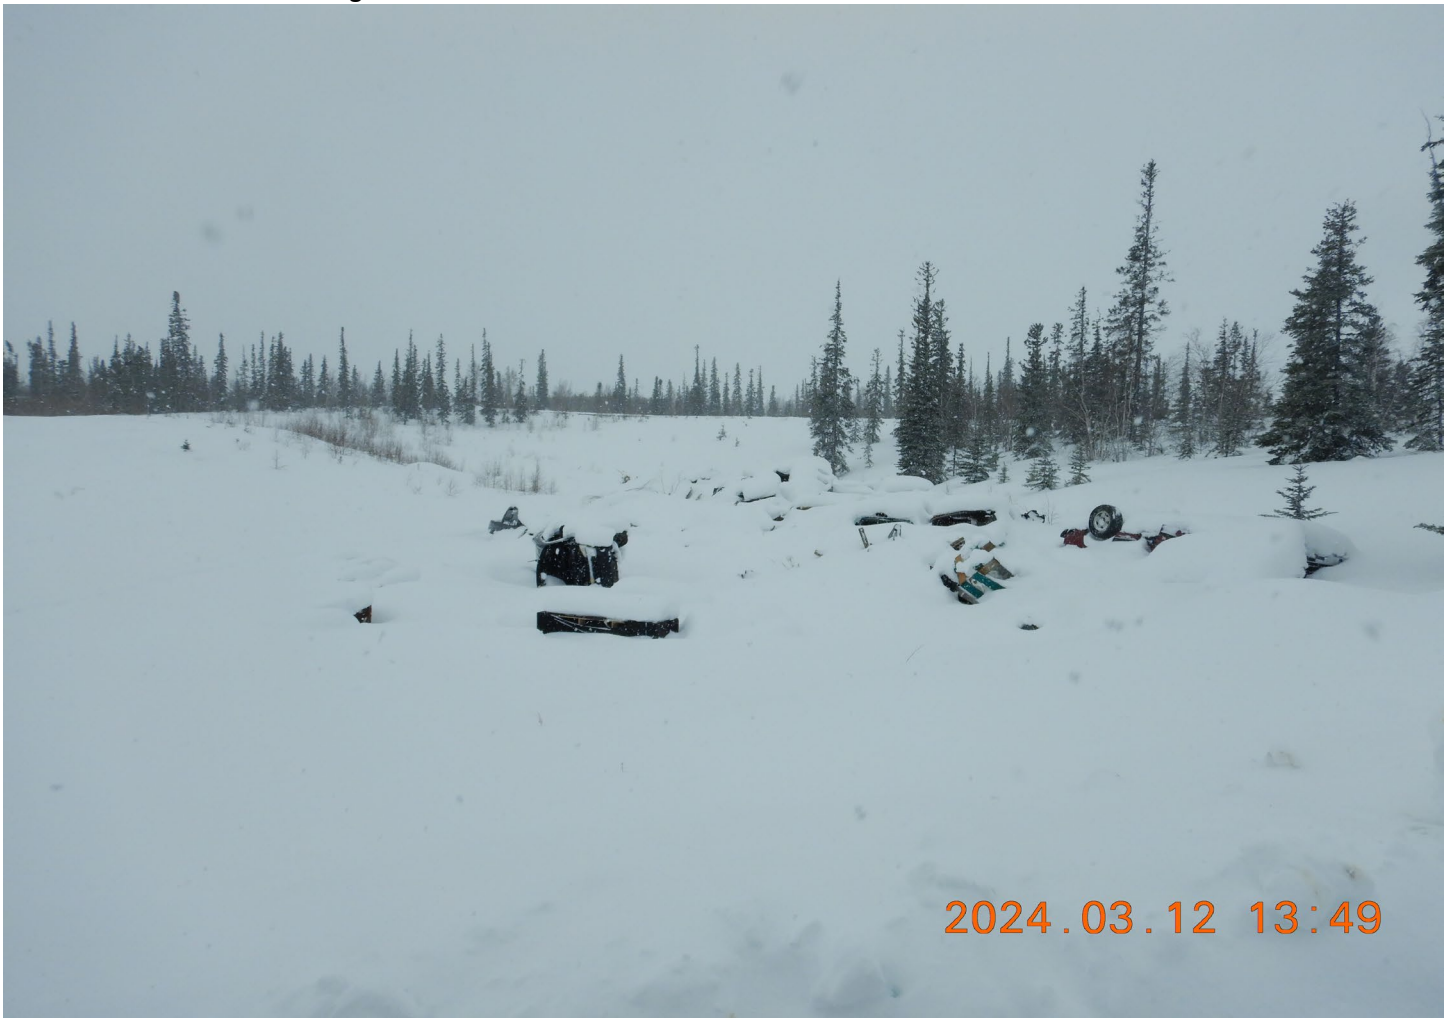
Photo 6: Derelect vehicle storage.
