**Re: Land Use Permit W2020F0004  
ROADS, all season (during const)  
Yellowknife, NT**

## ENVIRONMENTAL INSPECTION REPORT

Location(s) Inspected:	Parking lot and access roads on the North side of Highway #3 at Km 292 + 100.
------------------------	---

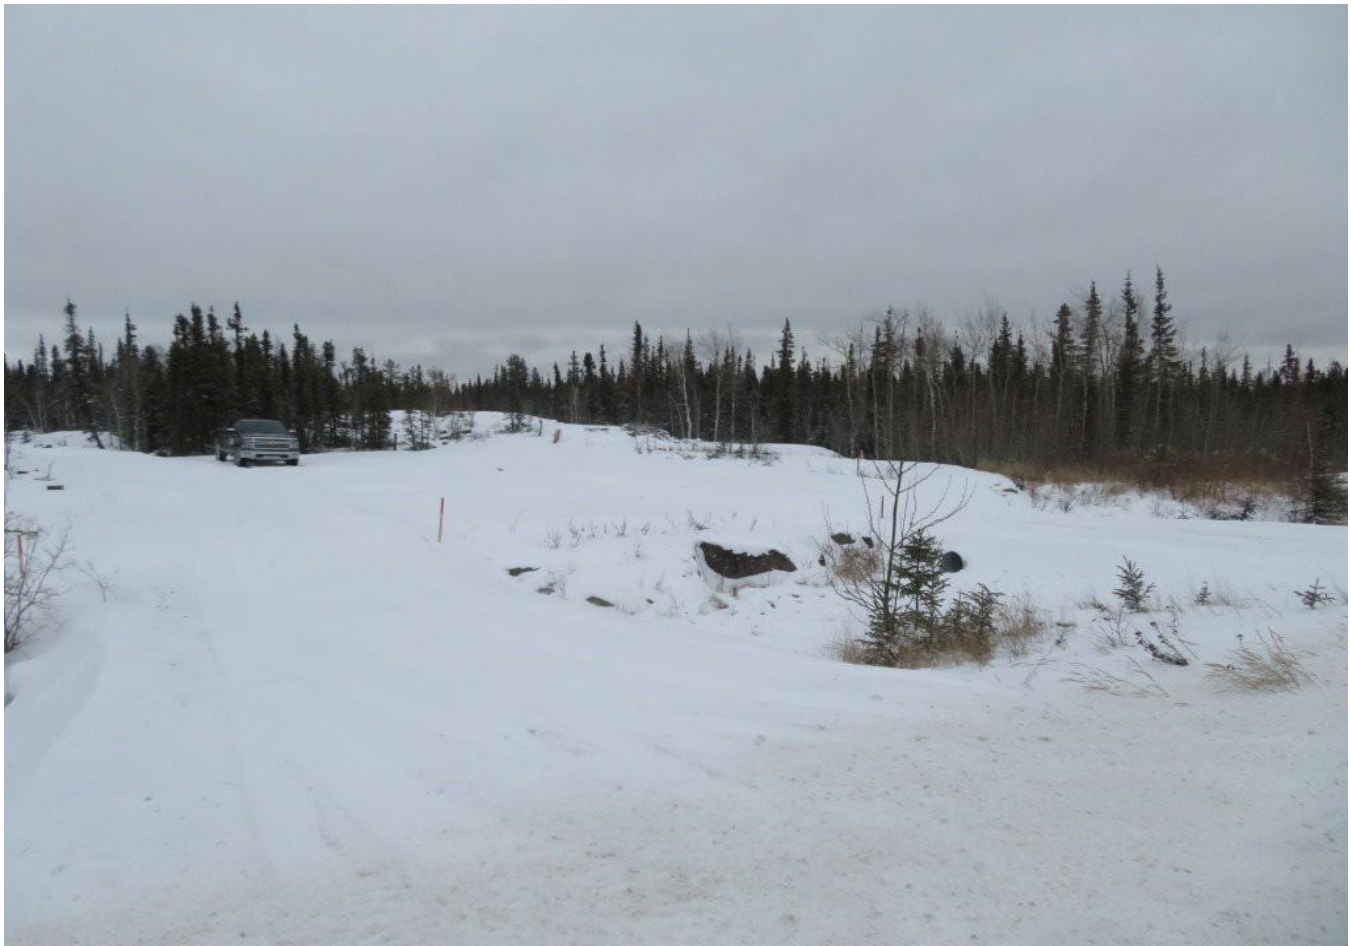
**Figure 1**

The surface of the parking lot was properly leveled using imported fill and there was no overburden displaced prior to placement. Culverts were installed (Figure #1) in each access road to minimize the potential for erosion and allow proper drainage. (Condition #10-11) in the ditch line of Highway #3.

General view of the parking lot, starting ~10m past the sticks marking the access roads. (looking east)

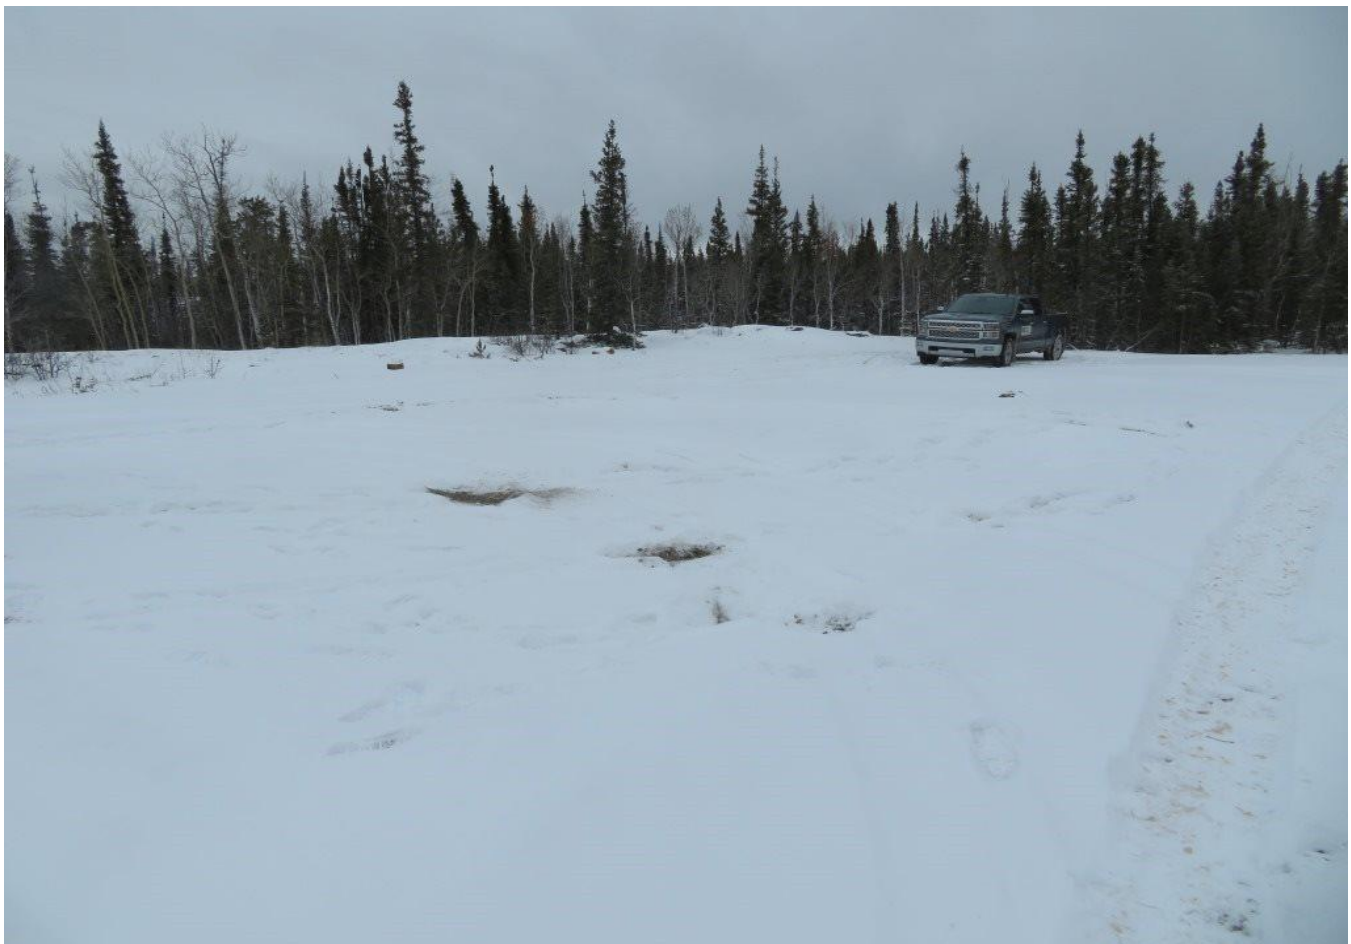
**Figure 2**

Another view of the area looking north.

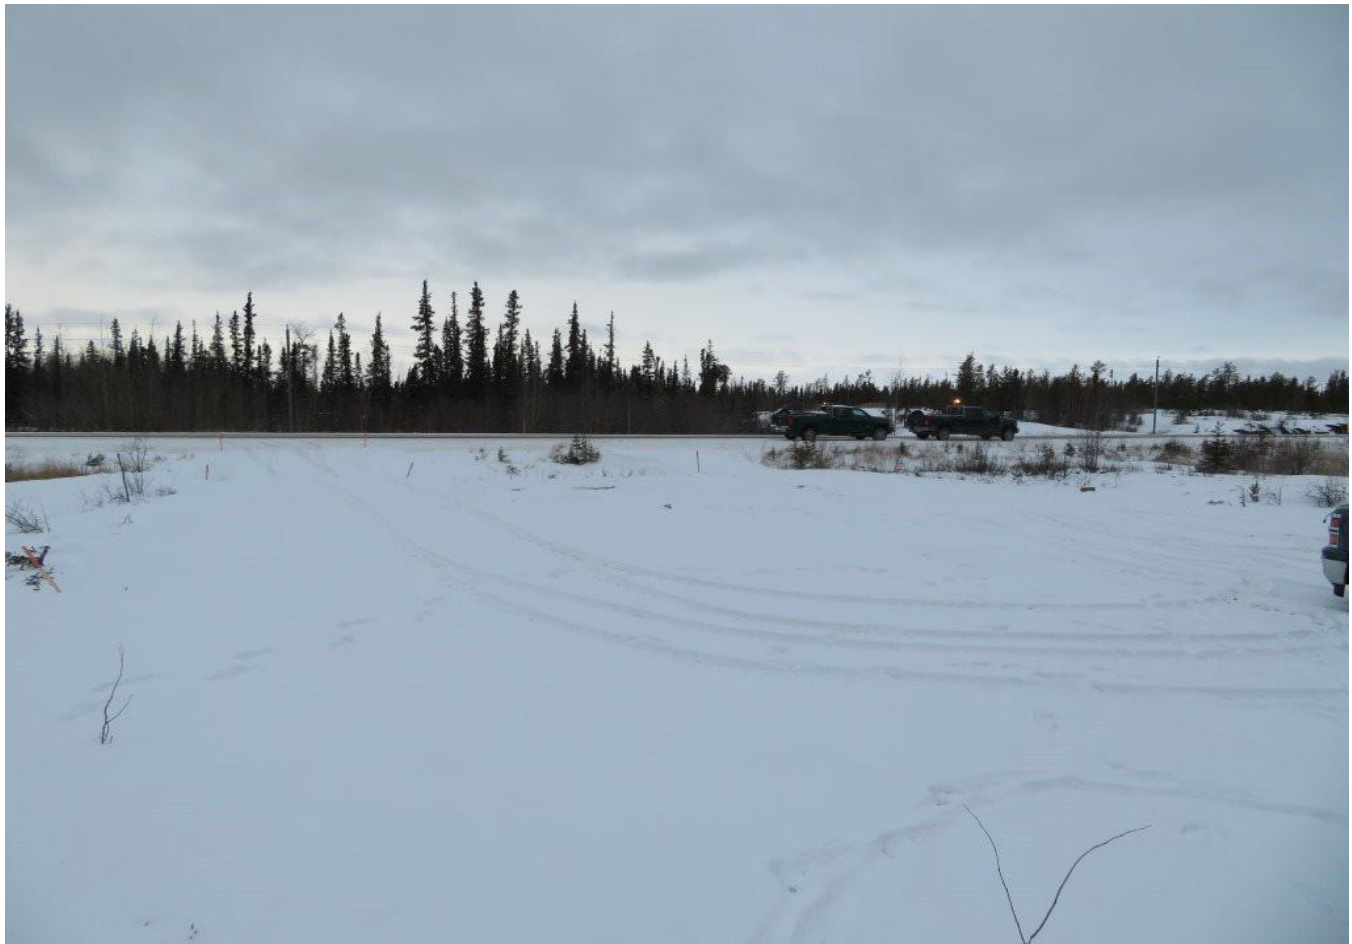
As required and requested by GNWT-INF, the Permittee confirmed each access is one way circulation only (in and exit) and that they will be identified as such with proper signage.

**Figure 3**  
One way access roads for entrance and exit. Looking west.

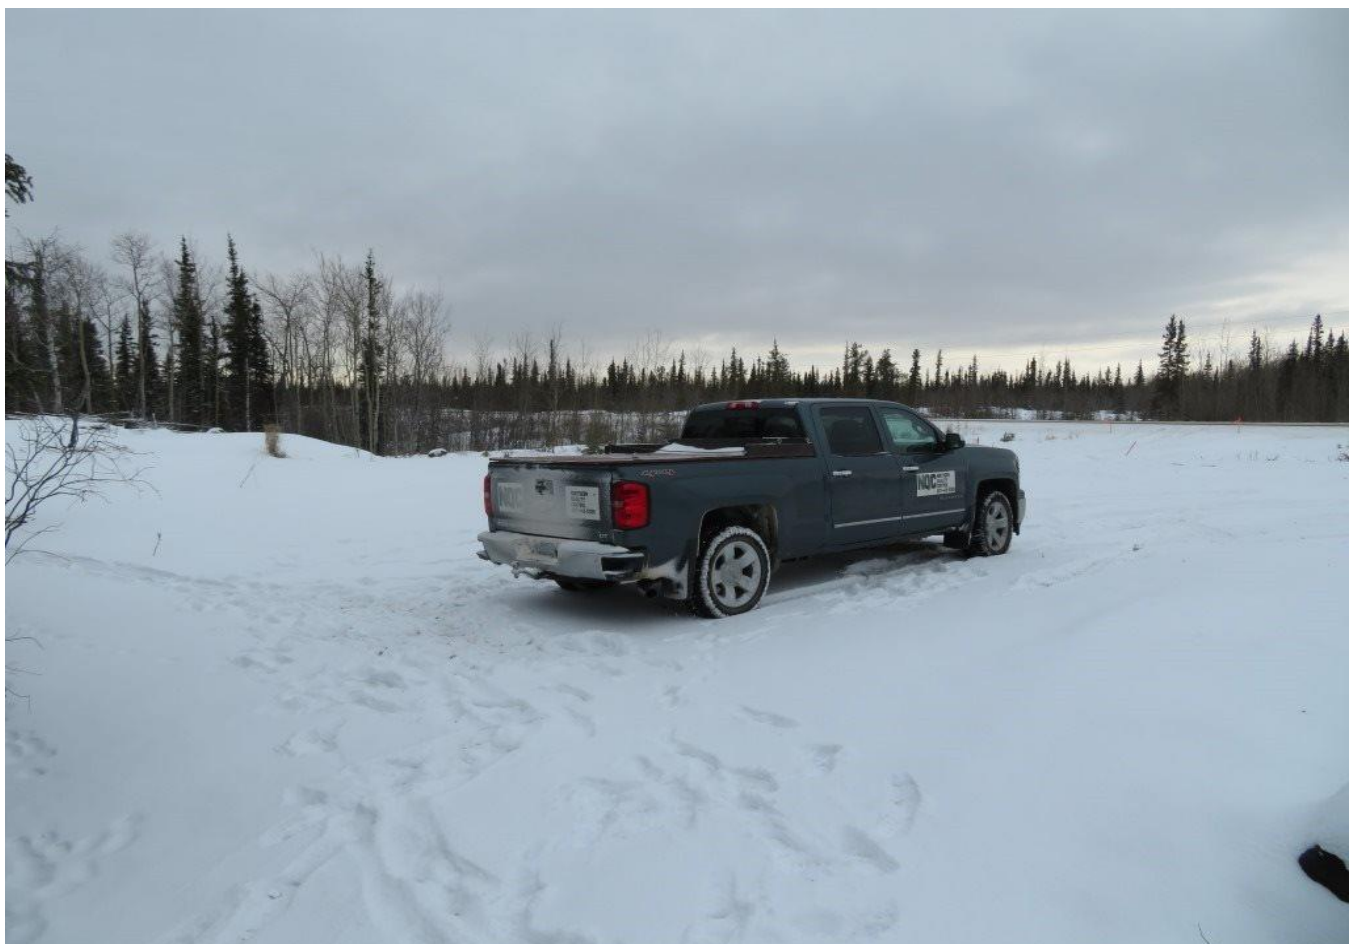
**Figure 4**  
View from the back corner looking South.
