Memo

To: Dave Green, North Star Infrastructure
From: Blair Baldwin, Natural Resource Solutions Inc.
Date: June 9, 2023
Re: Northwest Territories 2023 Tlicho Highway Crossing Flow Monitoring

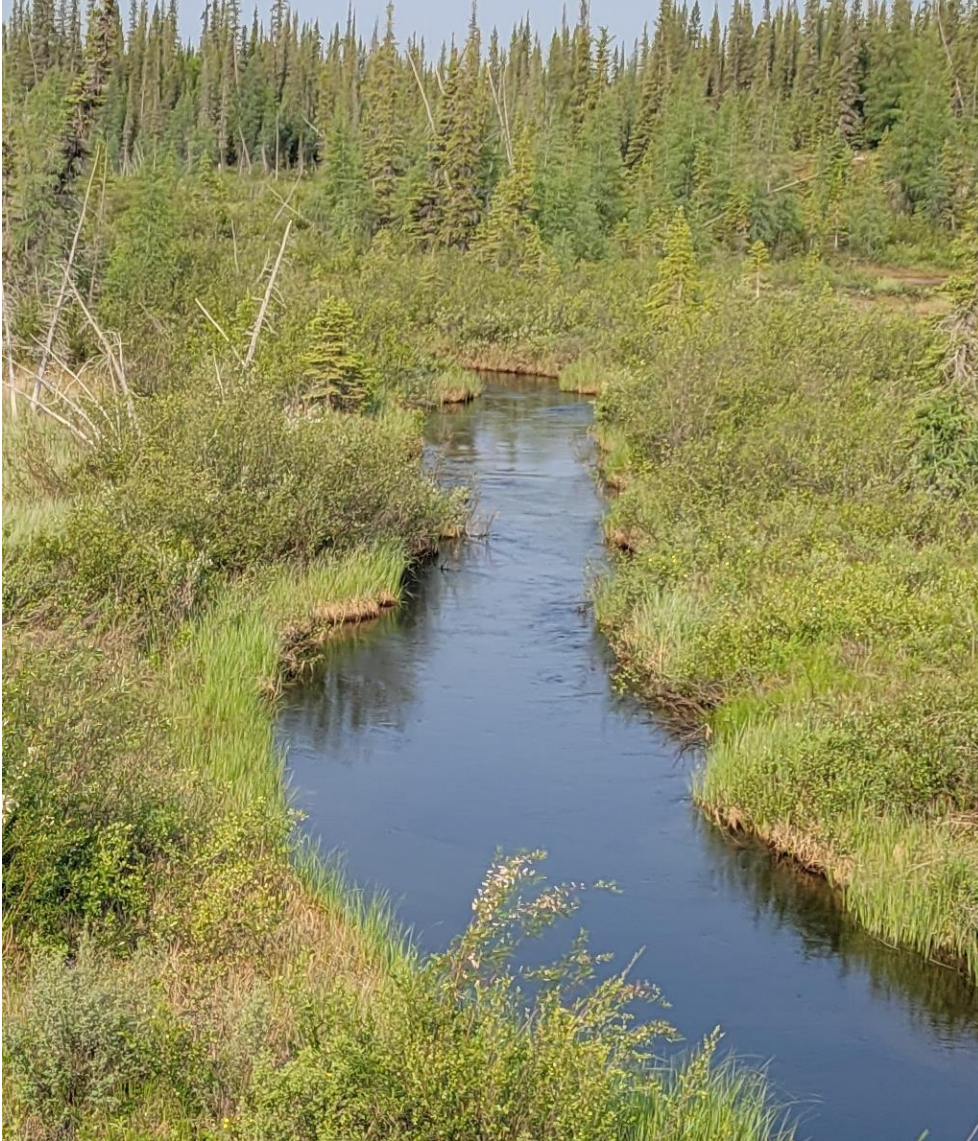
Picture 1. Duport River Flow Monitoring Station

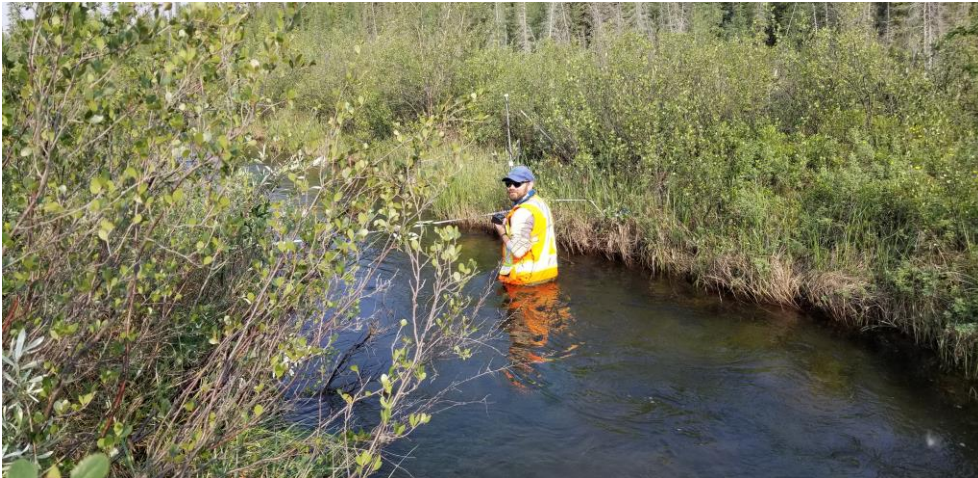
Instantaneous flow discharge at the Duport River on June 9, 2023 was 1.001145 m³/sec. The Duport River instantaneous flow discharge was characterized approximately 25m upstream of the existing Duport River crossing location, upstream of the highly braided reach in the immediate vicinity of the Duport River bridge. The Duport River crossing location is characterized by soft highly organic substrates with abundant overhanging bank vegetation (primarily herbaceous shrubs and terrestrial grasses) and instream woody debris. Abundant small bodied fish were observed throughout the Duport River.

Picture 2. Duport River Flow Monitoring

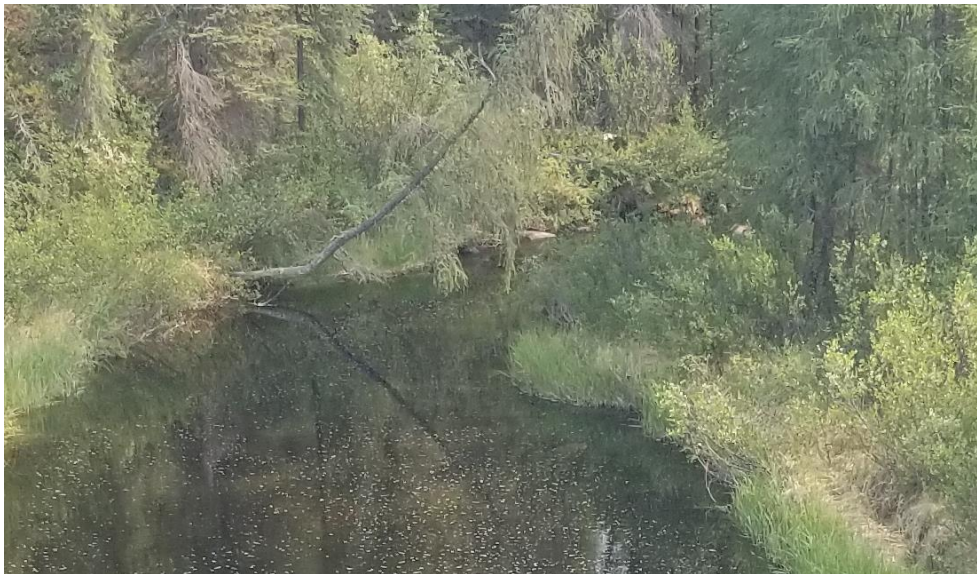
Picture 3. James River Flow Monitoring Station

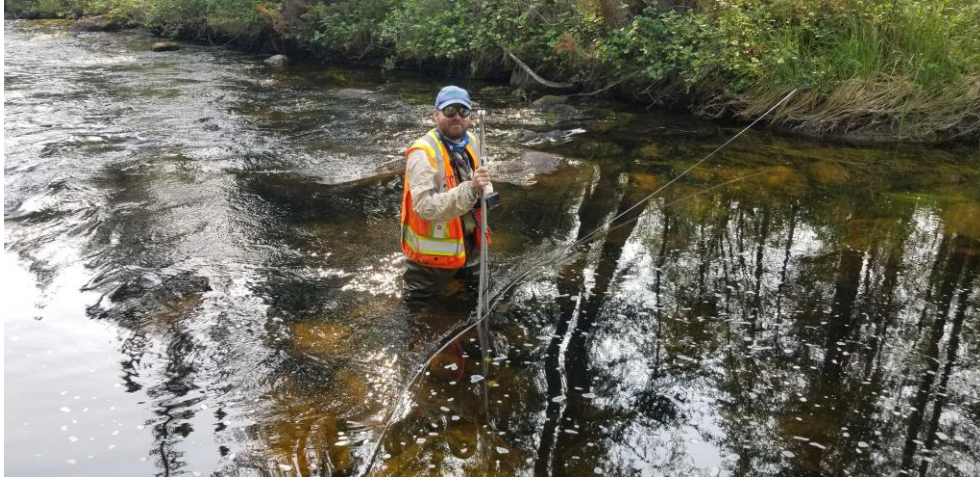
Instantaneous flow discharge at the James River on June 9, 2023 was 1.153656 m³/sec. The James River instantaneous flow discharge was characterized approximately 35m downstream of the existing James River crossing location, downstream of unwadeable habitat in the immediate vicinity of the James River bridge. The James River crossing location is characterized by shallow boulder riffle habitat with abundant encrusting algae and overhanging bank vegetation (primarily coniferous trees). Abundant small bodied fish and fragmentary freshwater mussel shells were observed throughout the James River crossing location.

Picture 4. James River Flow Monitoring
